***Water Main Break Rates
In the USA and Canada:
A Comprehensive Study
April 2012***

Utah State University
Buried Structures Laboratory

Steven Folkman, Ph.D., P.E.

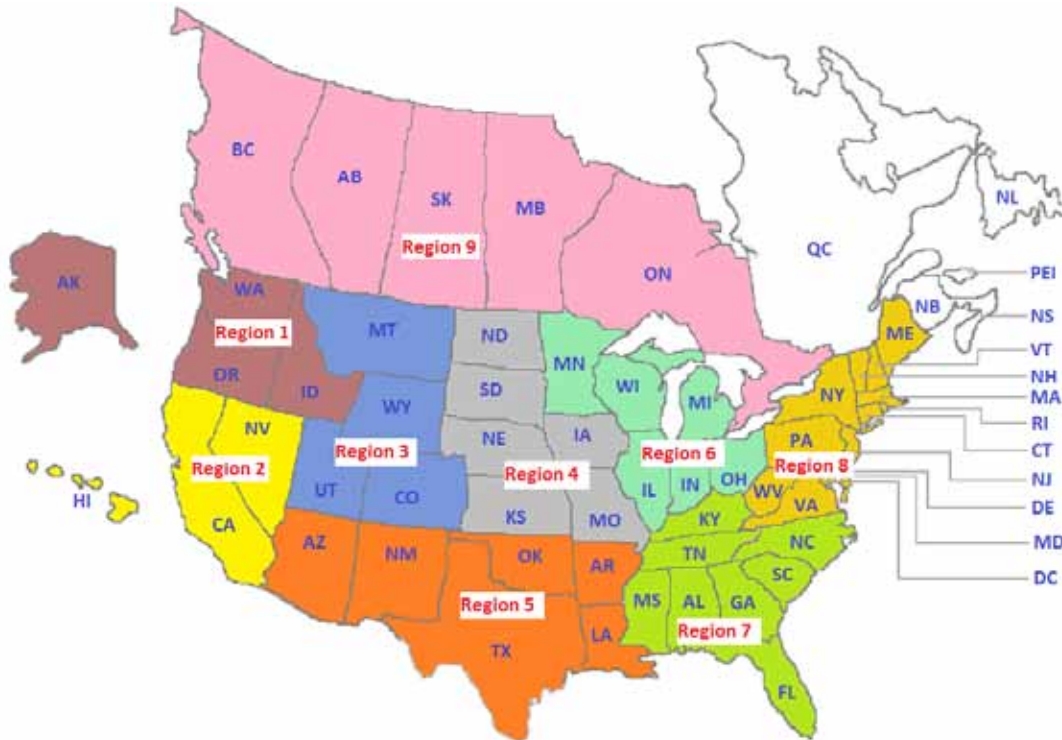
Figure 1. Regions used to report survey results.

The regions defined in the study are used here to indicate the wide geographical distribution of the respondents. Table 1 lists the number of respondents in the basic and detailed surveys from each region, and Figure 1 illustrates the locations of the nine different regions used in this report. The provinces in Canada with a white color did not have respondents to the survey. Figure 2 illustrates the miles of water main pipe that were reported in the basic survey on a regional basis. Similarly, Figure 3 illustrates the miles of water main pipe on a regional basis from the detailed survey. A total of 32,130 miles of pipe was reported by respondents in the detailed survey. It is noted that the respondents were distributed across a large survey area, but this study is still more comprehensive than other studies to date.

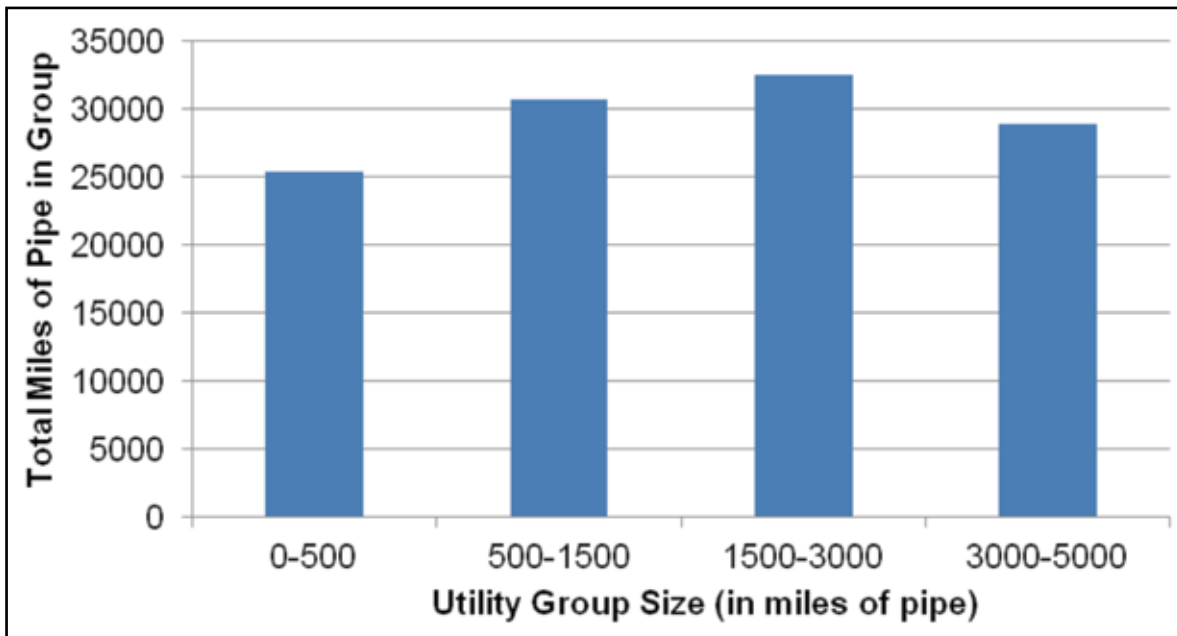
Figure 4. Total miles of pipe in each size group defined in Table 2 based on the basic survey respondents.

Four categories were established as shown in Table 2 and each survey participant was allocated to one of the categories. Figure 4 shows the distribution of total miles from the basic survey based on these categories. Respondents covered the range from very small to very large with each group from Table 2 well represented.

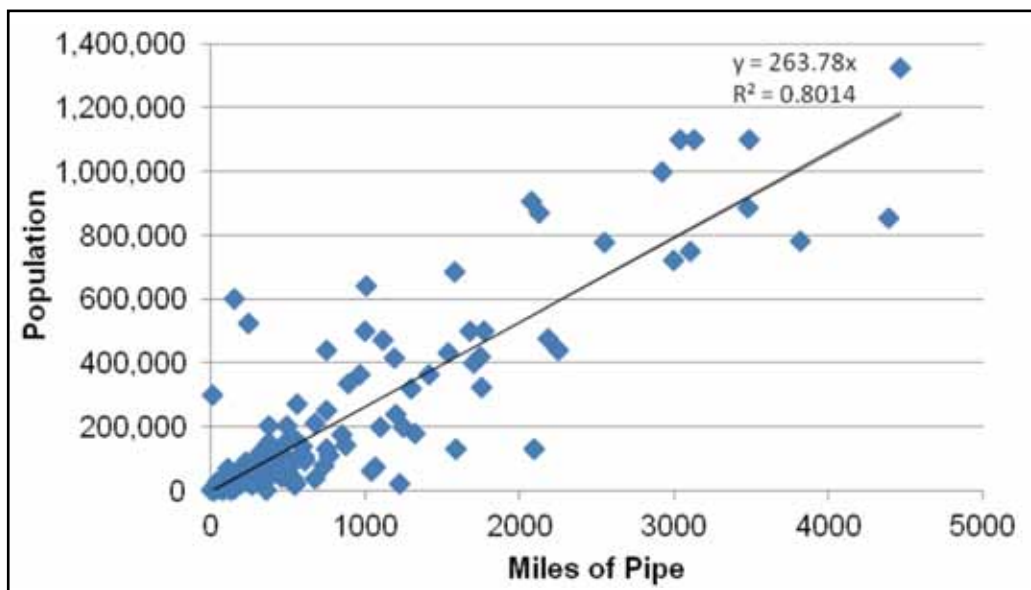
Figure 5. Population served relative to total pipe line miles from the basic survey.

Figure 5 illustrates the relationship between the population served by the utilities participating in the basic survey and the number of miles of water main pipe. The trend line and equation are a best fit to the data. The slope of this line indicates that there are on average 264 people served for each mile of water main installed.

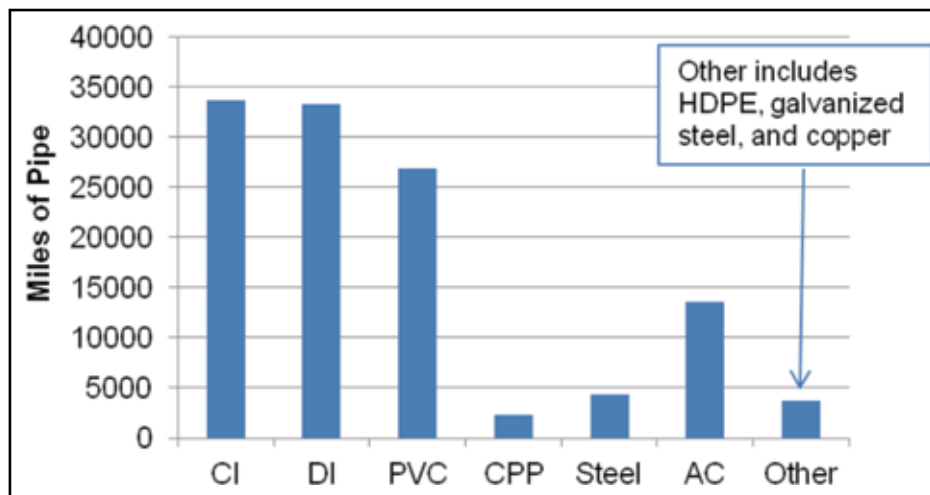
Figure 6. Length of pipe broken down by material type from the basic survey.

Figure 6 illustrates the length of pipe reported in the basic survey broken down by pipe material. The “Other” category in Figure 6 includes materials such as HDPE, galvanized steel, and copper. Figure 7 illustrates the length of pipe reported in the detailed survey broken down by pipe material. Figure 8 illustrates the pipe material distribution as a percentage of the total length from both the basic and detailed surveys. The distribution of miles of pipe is quite similar in Figure 8 indicating that the detailed survey with a smaller number of respondents still gives similar results.

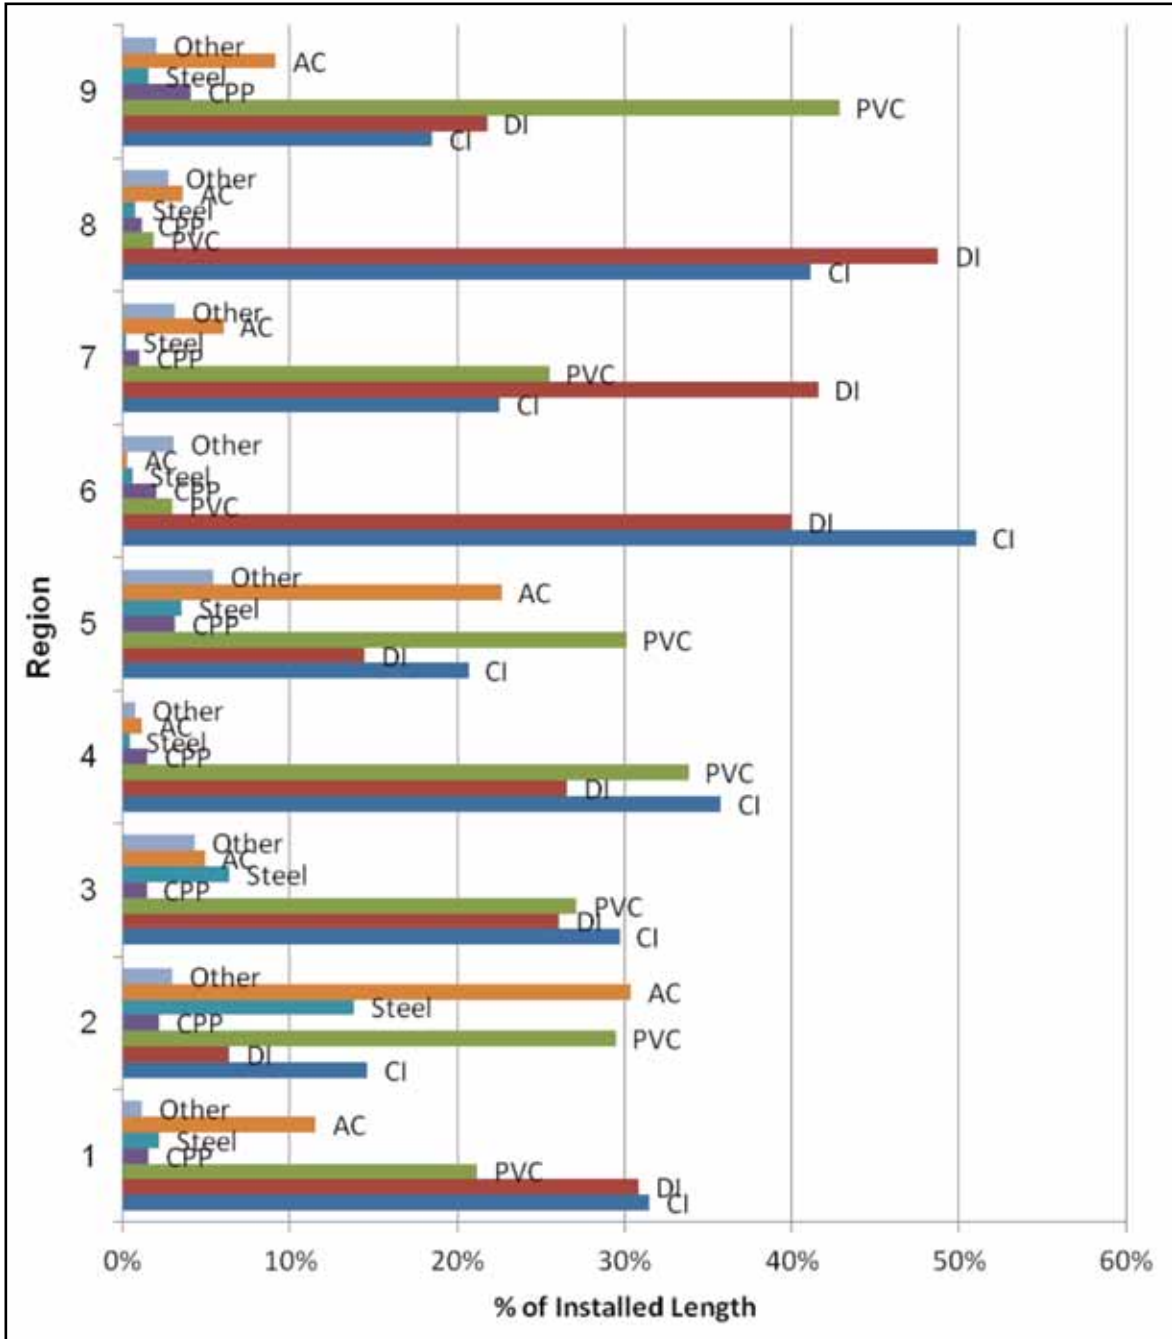
Figure 9. Regional percentage of length of pipe by material type from the basic survey.

Figure 9 illustrates the regional distribution of pipe material usage as a percentage of the total length in that region. It is interesting to note the significant differences in regional pipe material utilization. Cast and Ductile Iron represent approximately 90% of the pipe in regions 6 and 8. PVC has a dominant role in region 9 and is well established in regions 2, 3, 4, 5, and 7.

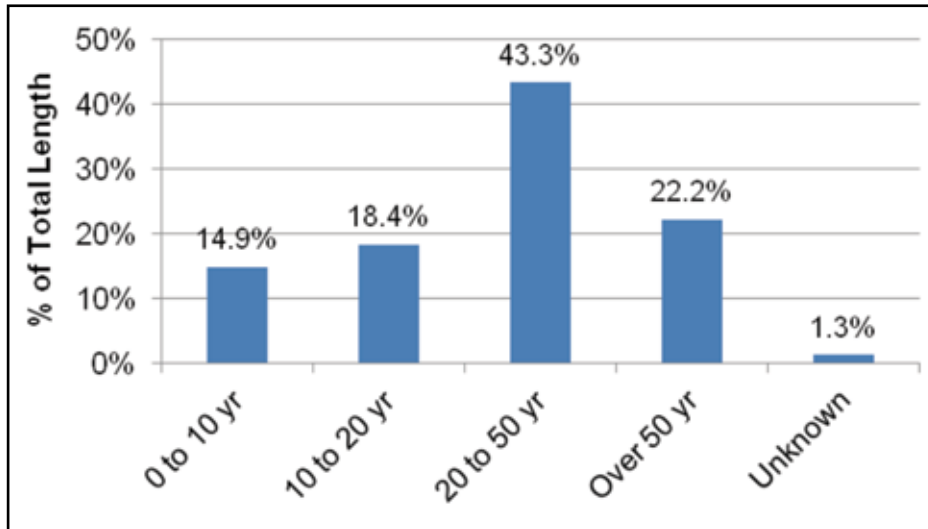
Figure 10. Percent of length of pipe by age from the detailed survey.

The detailed survey asked respondents to provide the distribution of installed pipe by age. Four age groups were provided; zero to 10 years, 10 to 20 years, 20 to 50 years, and over 50 years. Figure 10 lists the percentage of water main length that fits in each age category. Figure 10 indicates that approximately 43% of installed pipe are in the 20 to 50 year age category and 22% are over 50 years of age. This finding is consistent with other industry sources.

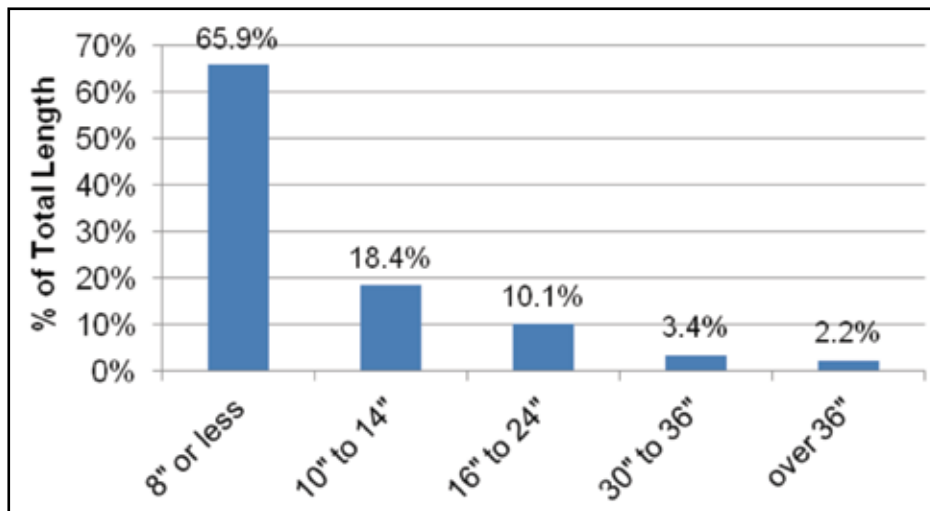
Figure 11. Percent of length of pipe by pipe diameter from the detailed survey.

The respondents were also asked to break down the fraction of total installed pipe length by five pipe diameter categories. Figure 11 illustrates the percentage of water main that fit into each size range. Figure 11 indicates that approximately 66% of the installed pipe is 8 inches or less in diameter.

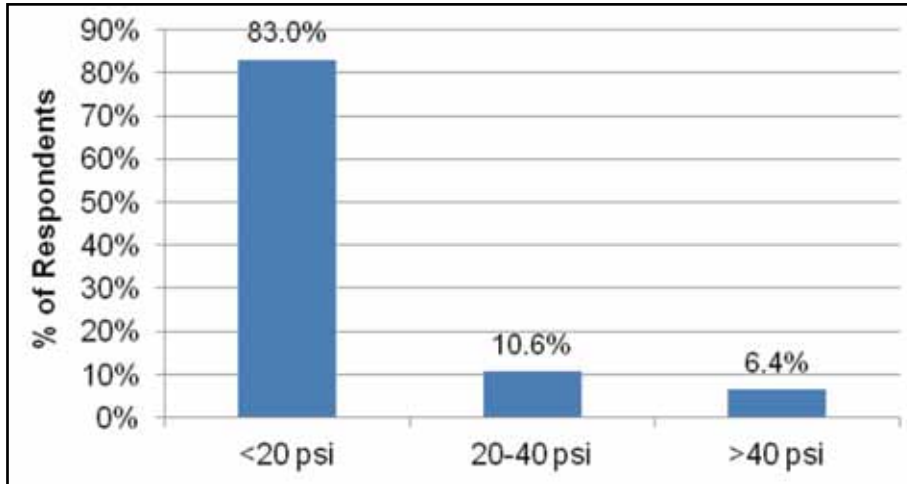
Figure 12. Percentage of respondents with one of three pressure fluctuation ranges.

Based on the detailed survey, the average delivery pressure is 77 psi. The range of values reported for average delivery pressure was 45 to 150 psi. The detailed survey also asked how much does the water pressure fluctuate at any given point in their system during a typical day. The respondents were asked to select one of three ranges. Figure 12 illustrates the percentage of respondents that fit into each pressure range. About 83% are able to limit pressure fluctuations to be less than 20 psi.

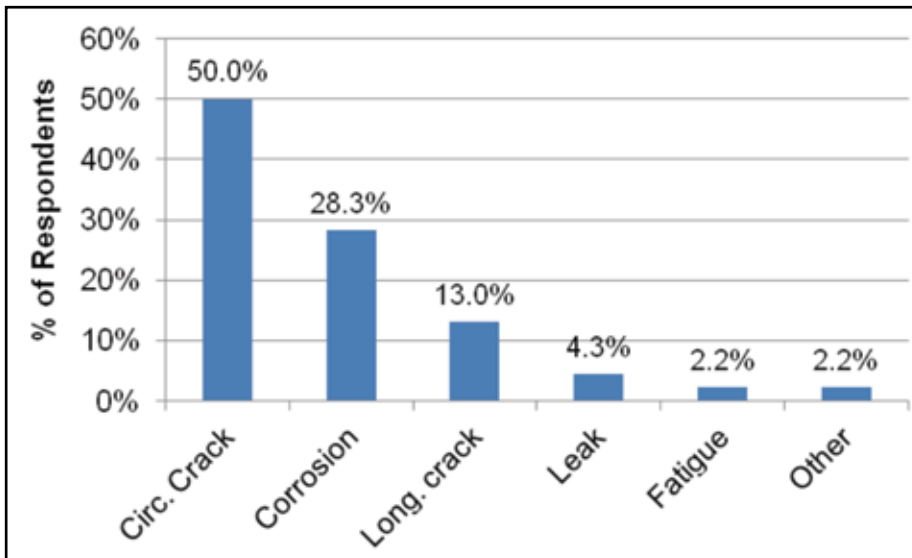
Figure 13. Percent of respondents selecting a most common failure.

The detailed survey asked the respondents to identify the most common failure mode by selecting from one of the following; corrosion, circumferential crack, longitudinal crack, leakage at joints, fatigue, or other. Figure 13 identifies a circumferential crack as the most common failure mode followed by corrosion. The detailed survey also asked respondents to identify the pipe material that was failing most often. Figure 14 shows that 55.3% of respondents identified Cast Iron as the most common failing pipe material followed by Asbestos Cement at 17.0%. The respondents also reported the typical age of a failing water main. The average result was 47 years with a range of values from 20 to 86 years. The survey also asked what the expected life should be when installing new pipe. The average expected life of new pipe was 79 years with a range of responses from 30 to 200 years.

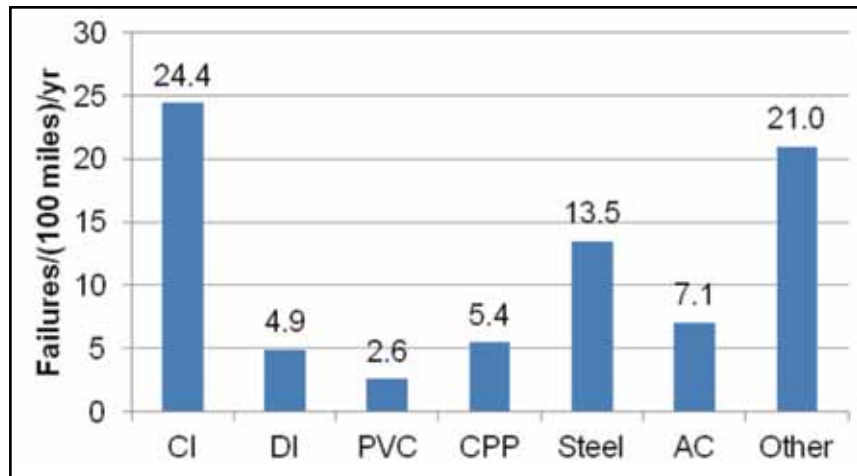
Figure 15. Failure rates of each pipe material from the basic survey.

The survey measured pipe failures over a recent 12 month period, broken down by material type. Table 4 lists the total length of pipe by material type, the number of failures over a recent 12 month period, and the failure rate for each pipe material. Figure 15 illustrates the failure rates as a function of material type. If one assumes a utility had equal lengths of each material installed, then Figure 16 would illustrate the percentage of failures as a function of pipe material. Figure 17 gives the failure rates broken down by material type and by respondents from the USA and Canada.

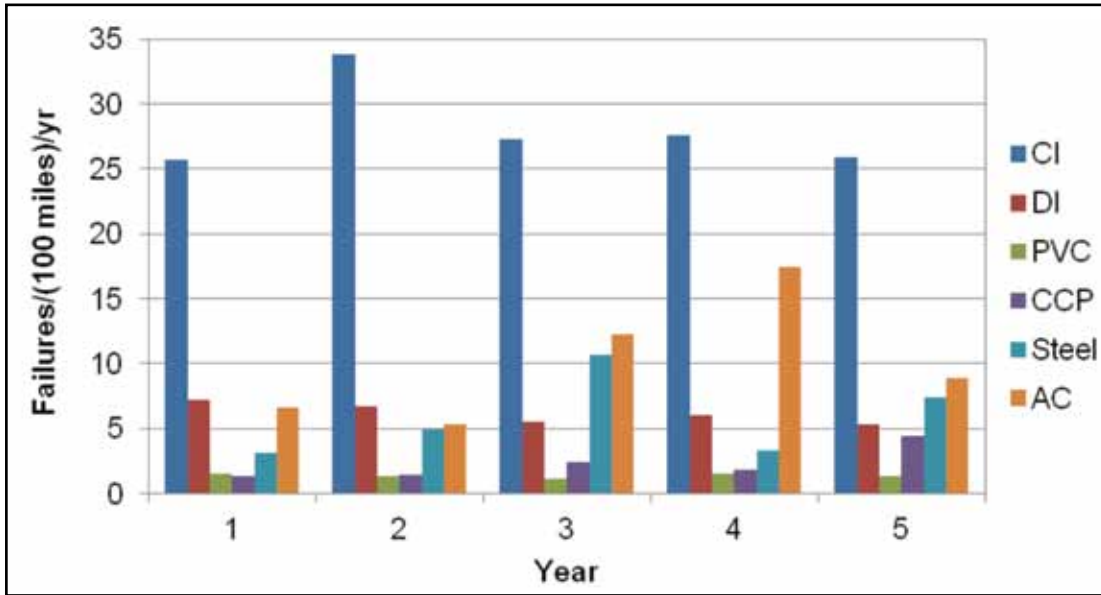
Figure 18. Pipe failure rates over a five year period as a function of pipe material.

The detailed survey requested the respondents to list the number of failures per year for five years, broken down by material type. The desired focus was to examine the year to year variations by pipe material. A single utility might have large year to year variations, but if the number of utilities sampled is sufficient, the year to year variation should be small. Figure 18 shows the failure rates from the detailed survey from each of the five years covered by the survey. Respondents that did not have five years of data were not included in these results.

Table 5 lists the average of the failure rates over the five year period along with the standard deviation and the coefficients of variation (the standard deviation divided by the average). The coefficients of variations for CI, DI, and PVC are similar indicating they have approximately the same variability. The widest variation in rates was associated with CPP, steel and AC pipe. The length of pipe in the detailed survey for these materials was small and more respondents could likely reduce the variability.

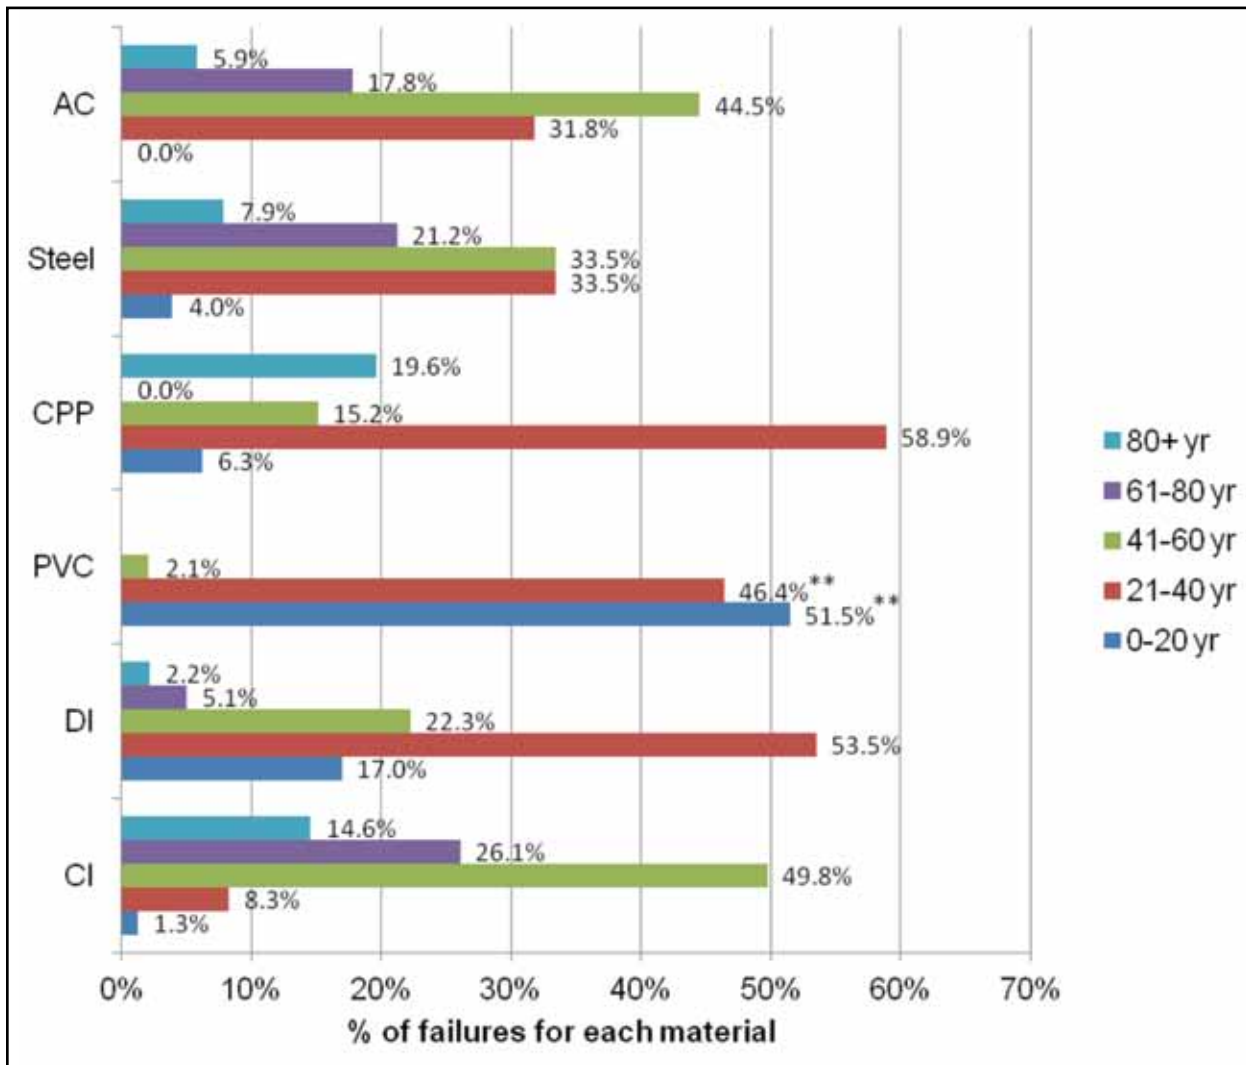
Figure 19. Percent of failures as a function of age and pipe material.

Clearly, pipe age will affect failure rates. The basic survey asked respondents to break down the failures into five different pipe age categories. It is noted that some of the respondents did not know the age of the failed pipes, and they were not included in the results below. For each material type, the fraction of failures in each age group is examined in Figure 19 based on the basic survey results. For example, 49.8% of the reported cast iron failures occurred with a pipe age between 41 and 60 years. Note that the largest percentage of failures is not in the oldest pipes, which has several possible causes. First, the older pipe is being replaced, and, thus, there is less available to fail.

The results in Figure 19 are related to when a pipe material was introduced or removed from the market. Asbestos Cement pipe has not been installed in the USA and Canada in the past 20 years, and, thus, all AC pipe failures exceed 20 years of age. Widespread DI and PVC pipe production in the USA did not start until about 1970, so we should expect to see a small failure percentage for both DI and PVC in the 41 to 60 year age group and none for the 61 to 80 and 80+ age groups. PVC follows that trend in Figure 19. Figure 19 shows the majority of DI pipe failures occur at an age between 21 and 40 years. The DI results in Figure 19 for the 61 to 80 and the 80+ age groups are possibly caused by incorrect records on the age of those failed pipes.

It is of interest that Figure 19 shows a greater percentage of PVC pipes fail in the first 20 years of use than in the next 20 years**. This was investigated in a previous survey funded by AWWARF (Moser, 1994). Figure 20 illustrates the percent of failures as a function of time for AWWA rated PVC pipe. As shown below, over 40% of the reported failures occurred in the first year. Often the cause of these failures in PVC pipe is related to improper installation practices and not a defect in the pipe. The city of Calgary has been able to achieve remarkably small PVC failure rates due to enforced construction standards (Brander, 2004). In addition, Calgary requires new subdivision infrastructure to remain the property of the private developer for a period of two years. During this two year period, most construction related problems will occur. An AWWARF study (Burn, 2006) estimates the design life of PVC to be in excess of 110 years.

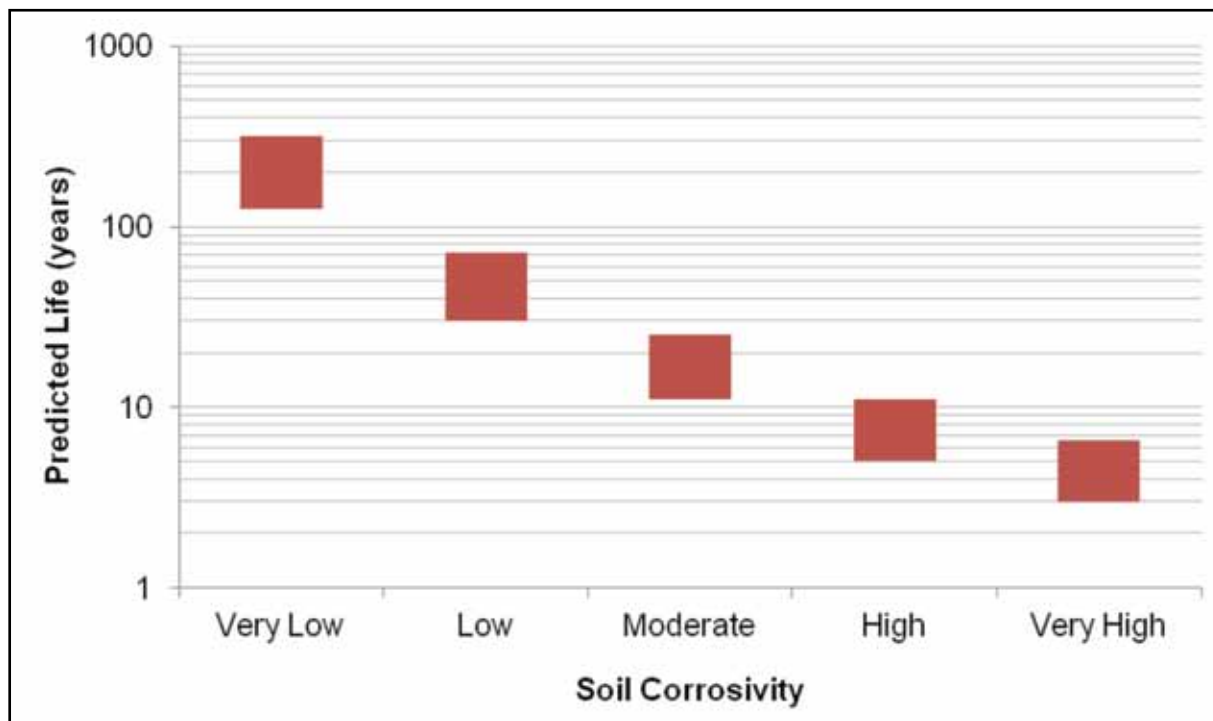
Figure 21. Predicted life of unprotected class 350 DI pipe (from Rajani, 2011).

The expected life in years of an unprotected DI pipe was estimated in a recent Water Research Foundation study (Rajani, 2011). Figure 21 illustrates the published results as a function of a relative scale of soil corrosivity. Figure 19 indicates that the majority of DI pipe failures occur at an age between 21 and 40 years. A 21 to 40 year life in Figure 21 would correspond to a low to moderate soil corrosivity for an unprotected pipe. This would indicate that corrosion is a significant problem in all regions of this study. When a comparison is made between Cast Iron and Ductile Iron, thinner-walled Ductile Iron is experiencing failures more rapidly (21-40 year period) than the thicker-walled cast iron (41-60 year period). Concrete Pressure Pipe also shows failures rates that are impacted by corrosion in the 21-40 year period. The study also notes that “aging or deterioration of ductile iron pipes can vary significantly from one geographical region to another within a city, let alone from city to city.”

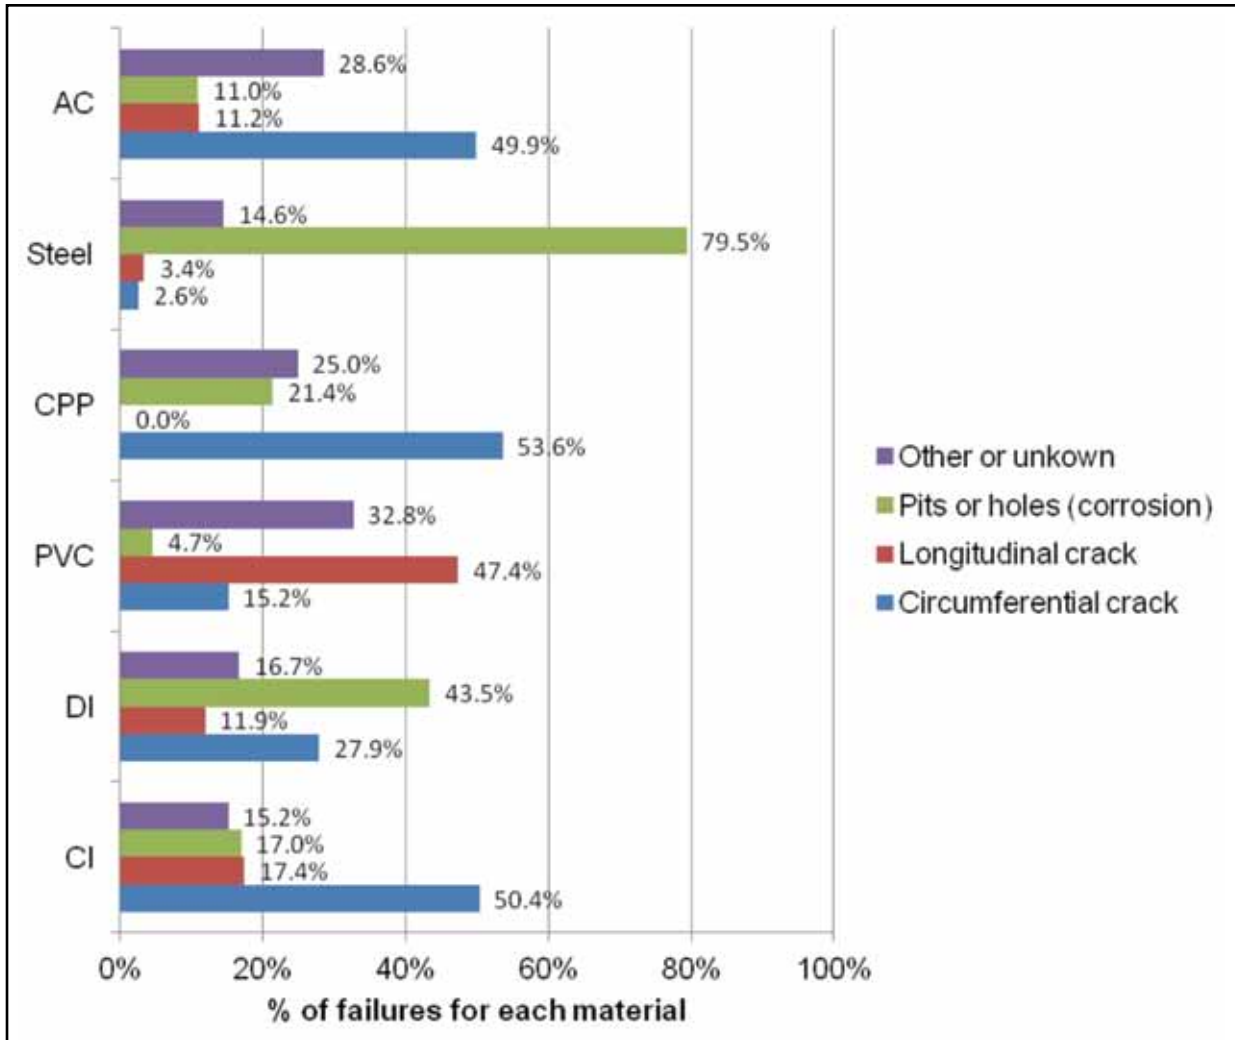
Figure 22. Description of failure for each pipe material.

Figure 22 summarizes the percentage of failures that were reported to fit in each description. A circumferential crack is the primary failure mode for Cast Iron, Concrete and Asbestos Cement pipe. Corrosion is the primary failure mode of Ductile Iron and Steel pipe. A longitudinal crack is the primary failure mode of PVC.

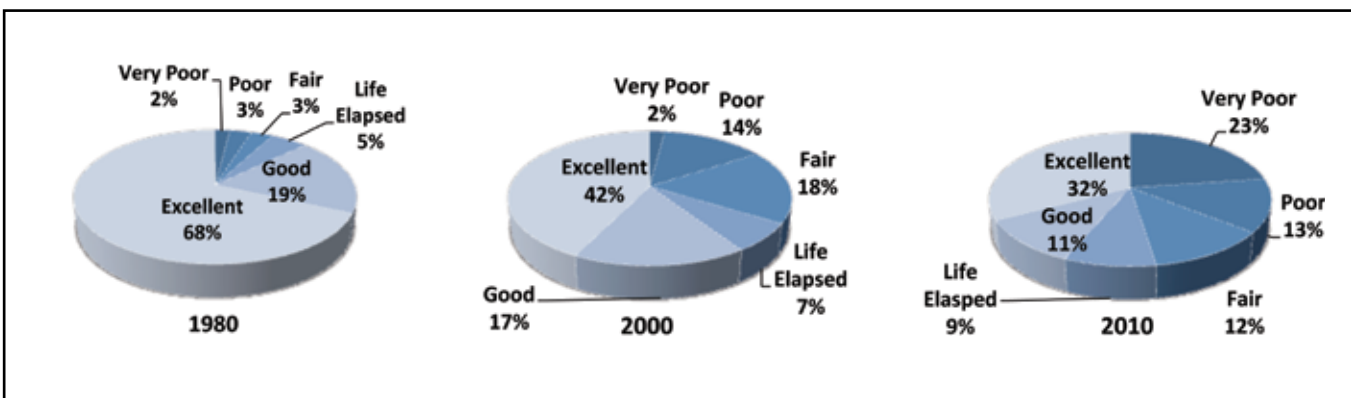
Figure 23. Assessment of pipe condition with time (from EPA, 2002).

It is of interest to compare these results with a study done by the EPA (EPA, 2002). This study classified water main pipe condition into six categories; Excellent, Good, Fair, Poor, Very Poor, and Life Elapsed. The study examined data for years 1980 and 2000 and forecasted data for 2020. Figure 23 below is reproduced from their report and shows that the above mentioned survey average response of 8.4% of pipe are beyond their useful life would correspond well with the “Life Elapsed” category in Figure 23. It is very important to note the projected growth in the “Very Poor” condition category in Figure 23. The rate of growth in that category will make it much more difficult for utilities to get that pipe replaced before it reaches the “Life Elapsed” category. An AWWA study (AWWA, 2012) echoes this trend as illustrated in Table 6. Table 6 shows aggregate costs to cover both replacement and growth in water mains in the USA.

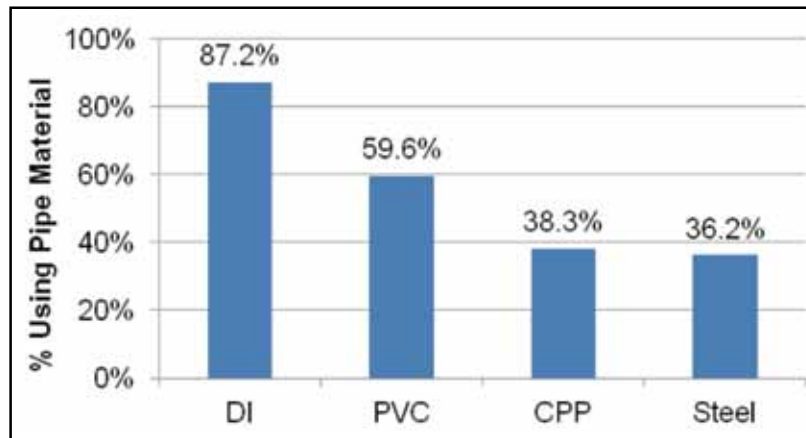
Figure 24. Percent of respondents that will allow installation of these water main pipe materials.

The detailed survey also asked what water main pipe materials are currently excluded from being installed at their utility. Figure 24 illustrates the percentage of respondents that allow a particular pipe material to be installed. The reasons used for excluding a pipe material were also requested in the survey. Table 7 summarizes the most common comments made for exclusion of a pipe material.

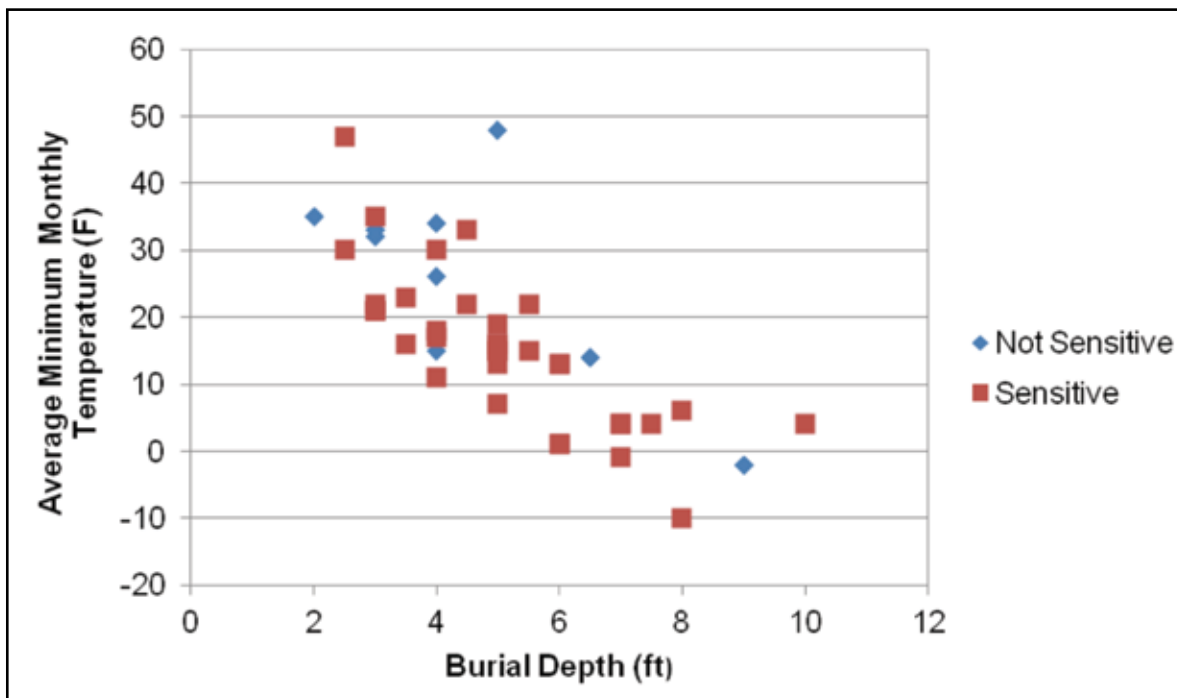
Figure 25. Correlation of the lowest average minimum monthly temperature during the year and burial depth. Red symbols note locations where failures increase with low ambient temperatures.

Figure 25 plots the lowest average minimum monthly temperature during the year for each respondent versus their reported average burial depth. The utilities with the blue symbols indicated they are not sensitive to cold ambient temperatures and the red colored symbols are sensitive. It was thought that with sufficient burial depth, the low temperature sensitivity might be reduced, but the data in Figure 25 does not support that conjecture.

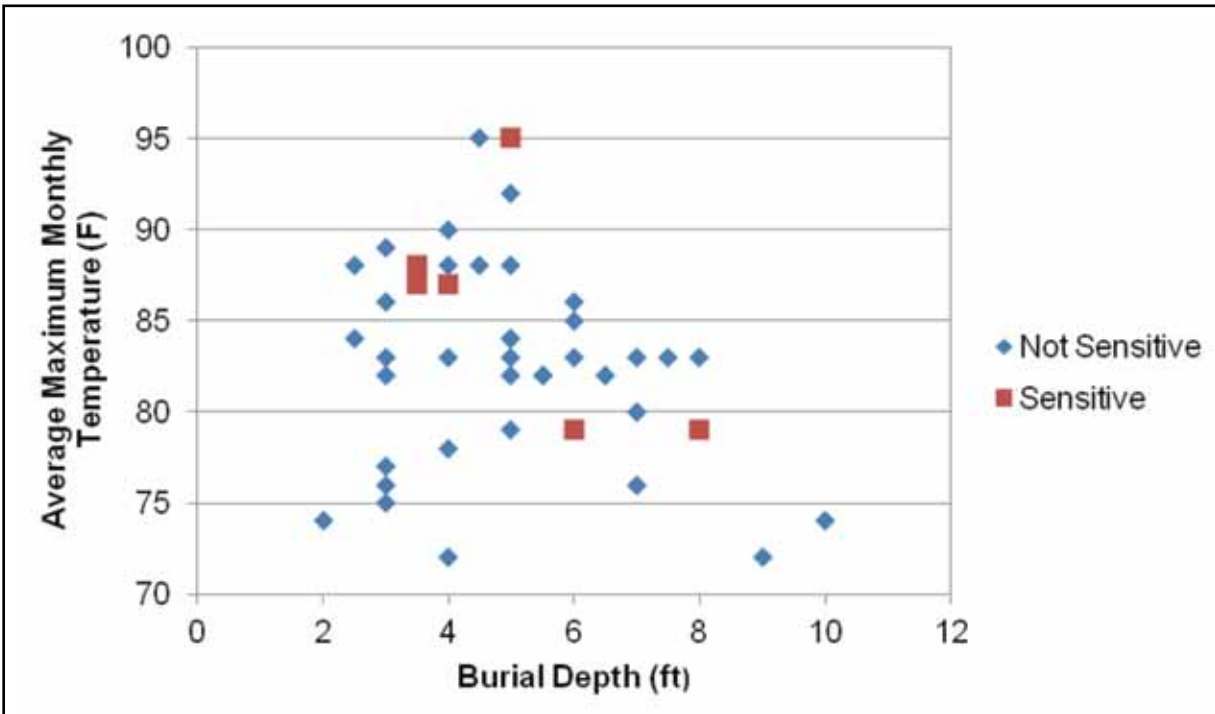
Figure 26. Correlation of the highest average maximum monthly temperature during the year and burial depth. Red symbols note locations where failures increase with high ambient temperatures.

Figure 26 plots the highest average maximum monthly temperature during the year for each respondent versus their reported average burial depth. Again, the color of the symbol indicates whether that utility reported to be sensitive to high ambient temperatures. Again, no correlation was observed.
