PVCNews

Dealing with Disaster

By David Chorley
Manufacturer's Representative,
Diamond Plastics Corporation

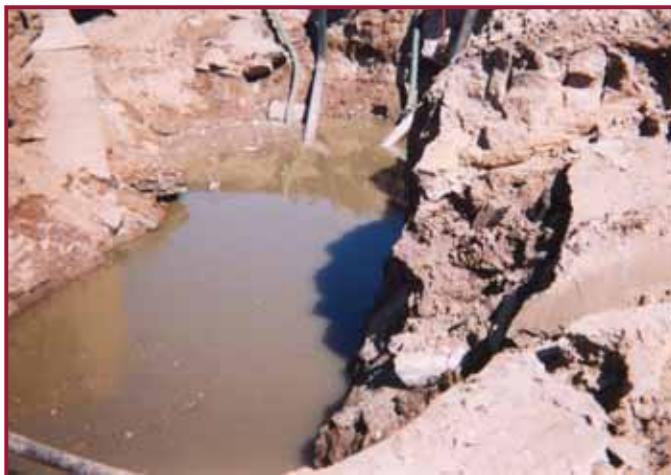
The sink holes were fifteen to twenty feet deep. Pumps were brought in from across the southwest to clean-up the spilled sewage.

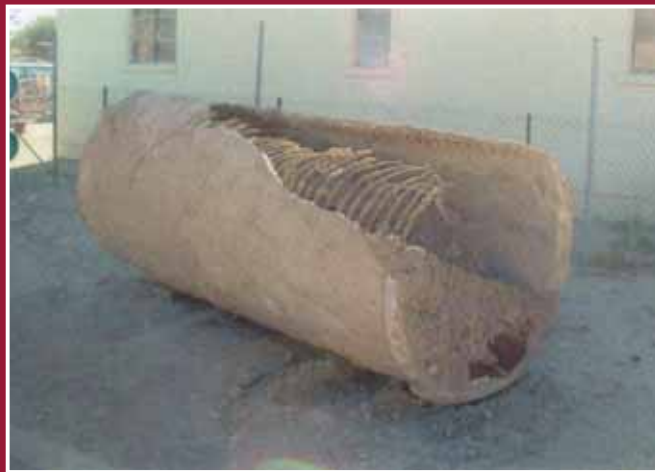
The reason for the sink holes was traced to corrosion at the crown of the concrete sewer interceptor.

ter in the late 1950s, Pima County would not have been faced with the dire consequences from the combination of sulfuric acid and concrete sewer pipe. Regrettably, history is what it is and not what we would like it to be. The current administration has inherited an aging infrastructure vulnerable to sulfuric acid corrosion, and they have to do their best with the resources they have been given. Part of that fiscal responsibility meant using PVC this time instead of concrete. PVC's chemical resistance makes it impervious to sulfuric acid. The missing crown of the collapsed concrete interceptor is a sad reminder of concrete's susceptibility to sulfuric acid attack.

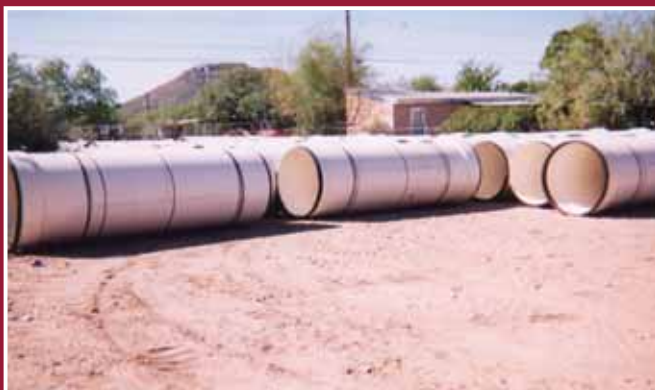
Two loads of 48-inch, F1803, sanitary sewer pipe were delivered three days after it was ordered.

Three days after the order was placed, two loads of PVC pipe were delivered. The order was completed two days after that and two weeks before pipe replacement could begin. Replacement of the line was subcontracted to K. E. & G. Not wanting a novice for this

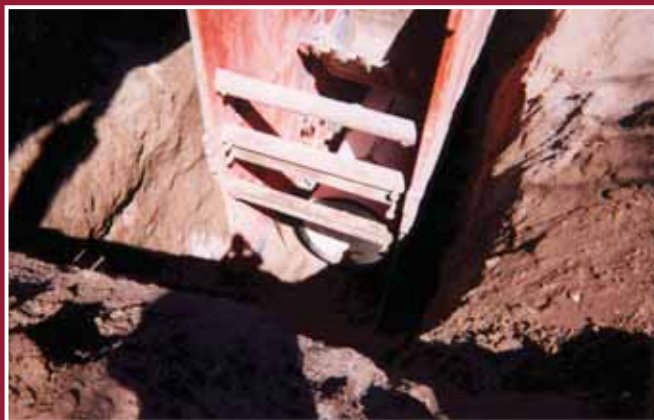
The nylon sling was rigged as a choker around the sewer pipe and connected the backhoe. Tight space necessitated this approach for joint assembly.

high profile project, Pima County and Dar-Hill Construction turned to K. E. & G. because it was a seasoned contractor with a great deal of large diameter pipe installation experience. The soft shifting sands and tight working environment made K. E. & G.'s job difficult. A thirteen-foot trench box was carefully placed between an existing water line and a sewer line. Then the installation of the new PVC sewer pipe began. To assemble the joint, K. E. & G. used a rope-sling to provide the assembly force. Using the backhoe bucket for assembly was not an option due to space limitations. There just was not enough room to maneuver. As an experienced contractor, K. E. & G. made sure the joint was in straight alignment before pulling the joint together with the rope-sling. Due to the harsh conditions, it took approximately three 24-hour days to complete the installation of the replacement pipe. Pima County officials and K. E. & G. were very pleased with the performance — and the relative light weight — of PVC pipe. Both made a difficult installation more manageable.

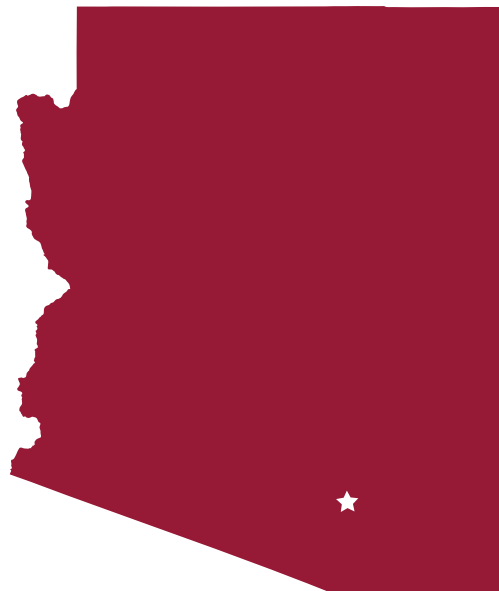
contacted by Ray Morgan, a Pima County Engineer, at the onset of the crisis. He was looking for 42-inch PVC pipe with a pipe stiffness of 46 lb/in-in, and we were pleased to inform him we had it in stock at our plant in Lubbock, Texas. After further in-house consultation in his department, Mr. Morgan called back looking for 48-inch pipe.

Boulevard. After days of around-the-clock bypass pumping, the sites were finally drained and dry enough to begin the delicate work of replacing the collapsed concrete interceptor.

Due to the harsh conditions, it took approximately three 24-hour days to complete the installation of the replacement pipe. Pima County officials and K. E. & G. were very pleased with the performance — and the relative light weight — of PVC pipe. Both made a difficult installation more manageable.

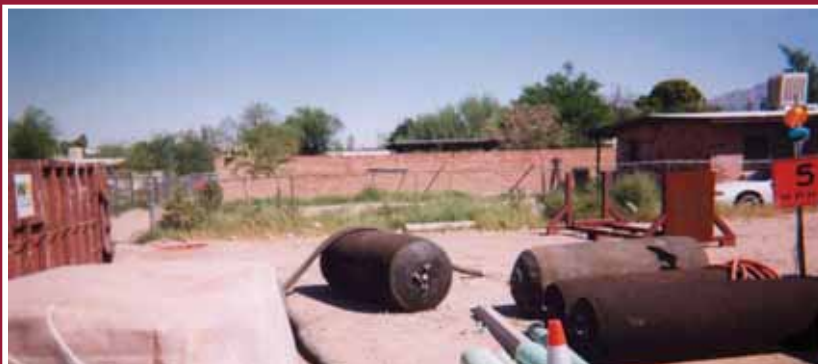
Plugs required for the low-pressure-air test are on-site and available for the acceptance test for system integrity.

After installation was complete, the line was tested. Pima County officials originally were going to perform a hydrostatic-exfiltration test, but they changed their minds because of the time involved and the need to get the new line in service. Instead, they chose to conduct a low-pressure-air test. Having never air tested pipe this large, Pima County went to Uni-Bell for information. Uni-Bell's recommendations state that the test may be successfully concluded after an hour if there is no pressure loss. The first test was conducted on a run of 500 feet of pipe, from manhole to manhole; and the second test was approximately 400 feet, from manhole to manhole. In both cases, the pipe held the pressure without any pressure loss.
