# The Calgary Story

## THE 1970S THE TEMPEST

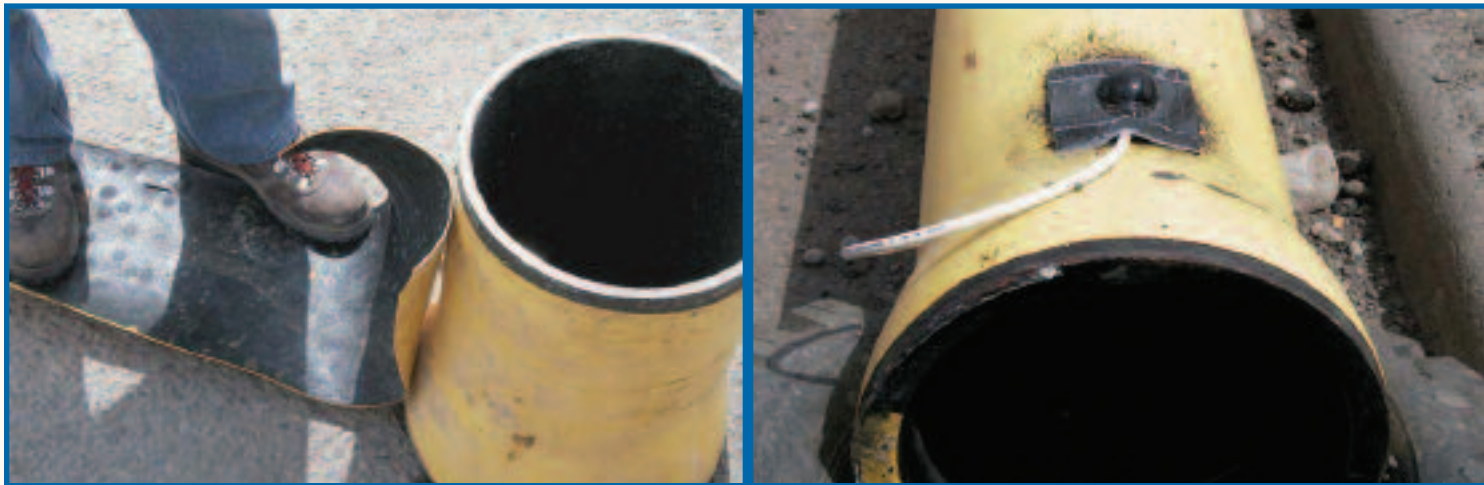
Figure 7: "Yellow-Jacketed" ductile iron (YDI)

Figure 7 has two photos of YDI. The right half pictures the preparation for electrical connectivity at the joint.

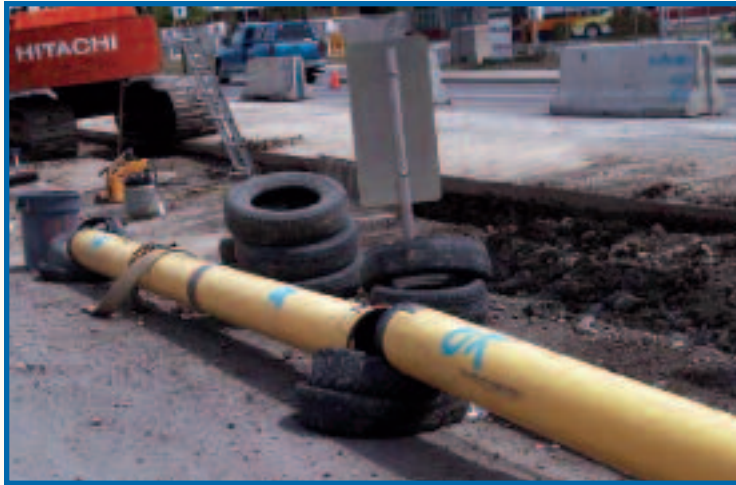
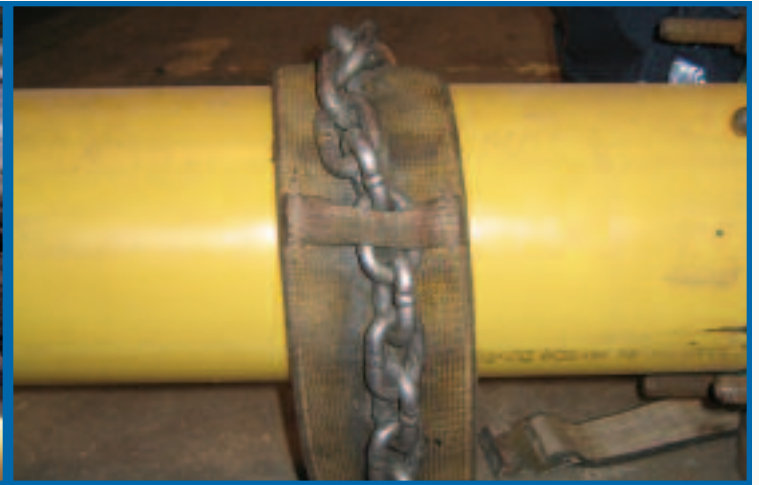
Figure 8: Examples of special construction and handling procedures for YDI

that YDI was stored on tires, not on the ground. (See Figure 8.) YDI was checked for imperfections in the coating by "jeeping" prior to installation. "Jeeping" is checking the coating of the pipe with test equipment. Imperfections are revealed by an arc of electricity from the test equipment to the point of imperfection. Even the chain on the direct tapping machine was modified to protect the YDI coating. (See Figure 8.) Other changes were that embedment for YDI was limited to sand or pea gravel. These changes, and the added cost of the coating, resulted in the doubling of cost as mentioned earlier.
