The Calgary Story

PVC PIPE *news*

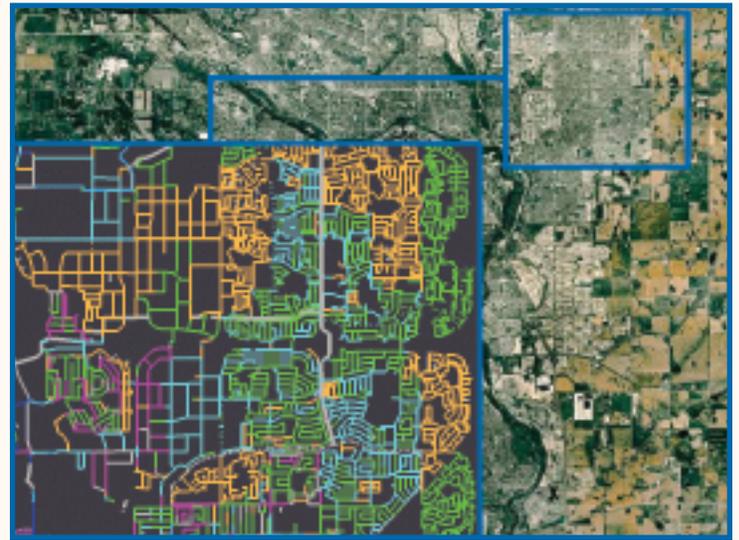
Figure 2: A satellite photograph of Calgary with the northeast section of the City highlighted in blue.

1970s. He states this resulted in a tripling of the budget, and he further stressed that it was not just a budgetary issue. He commented that, "the break pattern was very concentrated in a dozen odd square miles in the northeast corner of the City, where almost all the extra breaks occurred." Figure 2 shows a satellite photo of the City and a close-up of a particular area in the northeast section of the City.

The different colors in the lower left of Figure 2 show the different pipe materials now serving those customers. To understand the situation in the 1970s, Figure 3 zooms in to an area badly affected by corrosion. The red dots shown in the upper right of Figure 3 repre-

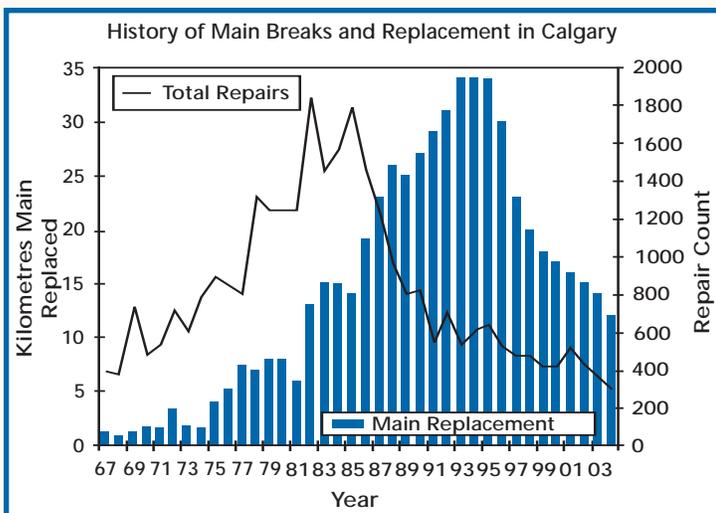
Figure 1: Mr. Brander refers to this figure as "Old Faithful".

He notes that breaks climbed from 500/year in beginning of the 1970s and rose to 1800/year by the end of the

To address this question, Mr. Brander pulls up a figure on his computer screen, which he calls Old Faithful. (See Figure 1.)

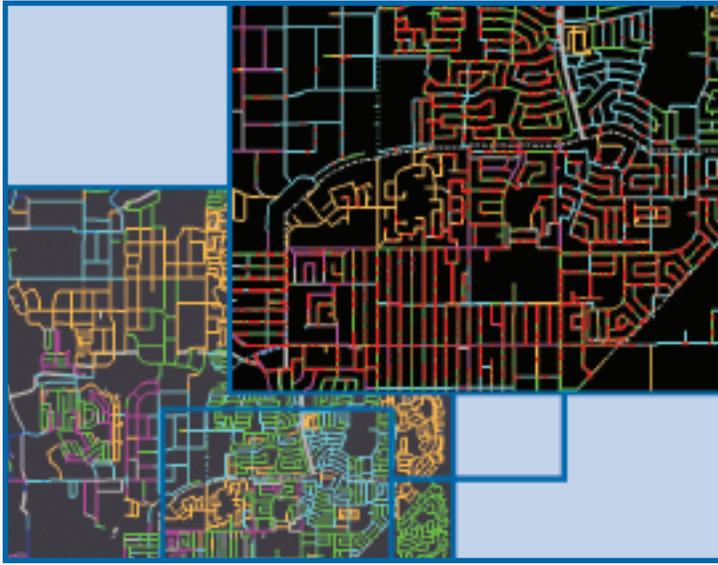
Figure 3: Northeast section of the City (left) and an area in that section with extremely corrosive soils (right)

sent breaks in the water mains between 1960 and 2000.

Mr. Brander explains that this was the City's first encounter with highly corrosive soils. The resistivity of these soils was far lower than the older parts of the City. Mr. Brander comments that the water utility quickly realized that "bare ductile iron in these soils was economically unfeasible. You could not charge enough for the water to pay for

Figure 4 shows the same area as the upper right of Figure 3. Instead of 40 years worth of breaks, just the breaks occurring in the 1970s are pictured. Also, the visual distraction of the pipe system has been removed. The breaks are color coded in two-year intervals. Mr. Brander stated some of the pipe in this area had up to half-a-dozen breaks on the same block and that some sections became uneconomical to continue to repair within seven years after their installation date in the worst case, and in ten to twelve year range in many cases.

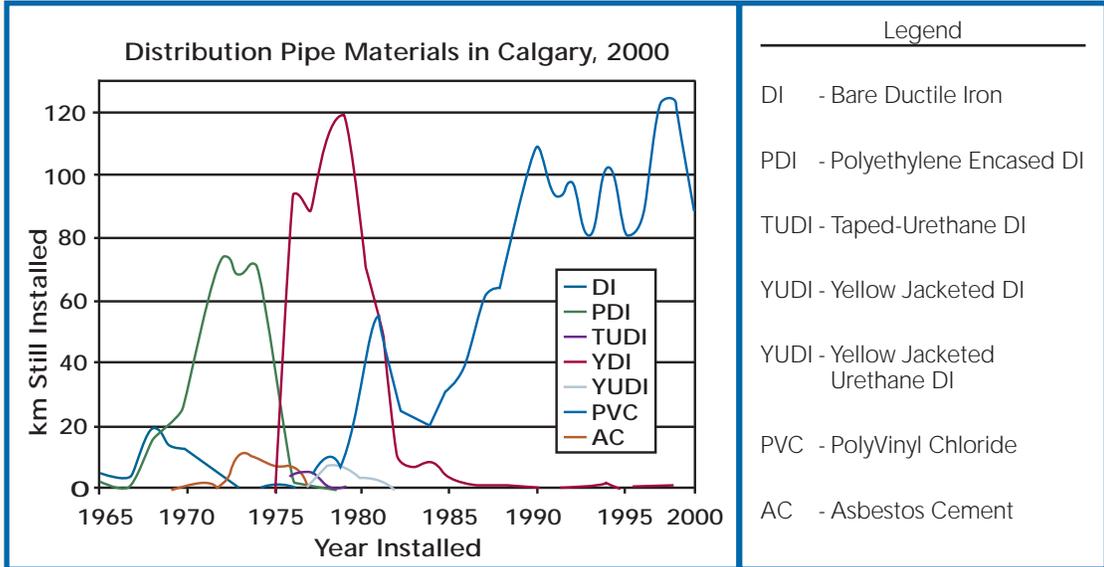
Figure 5: Calgary's pipe preferences by year installed

Figure 5 shows the seven different types of pipe products that the City experimented with in order to solve the corrosion problem they encountered in the 1970s. After bare ductile, Calgary tried polyethylene encased ductile iron (PDI) and then taped-urethane ductile iron (TUDI). They found both options "unsustainable". The life cycle was too short, breaks were too frequent, the pipe needed to be replaced before the utility had accumulated sufficient funds to replace the original pipe and pay for all the maintenance required. At which point, they veered off the traditional water utility path, and they started talking to corrosion engineers and pipeline engineers in the oil industry.

Question One: "Discuss Calgary's openness to change and its willingness to try new pipe materials. Your graph of distribution pipe materials installed by year shows (Figure 5 in this article) seven different types of distribution pipe installed in the 1970s. Why do you suppose Calgary was more willing to experiment than other utilities?"

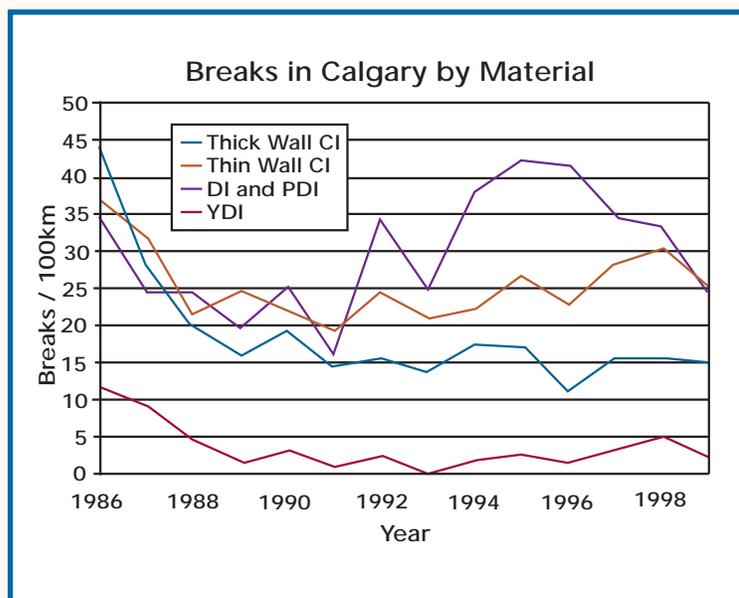
Figure 6: Break rates for all iron products (left) and a comparison of break rates for bare ductile iron (DI) and polyethylene encased ductile iron (PDI) (right)

Our break rates on YDI was about one tenth that of bare ductile iron and PDI. That provided a long enough life cycle

Figure 6 further justifies the use of YDI over PDI and bare DI by comparing their break rates.

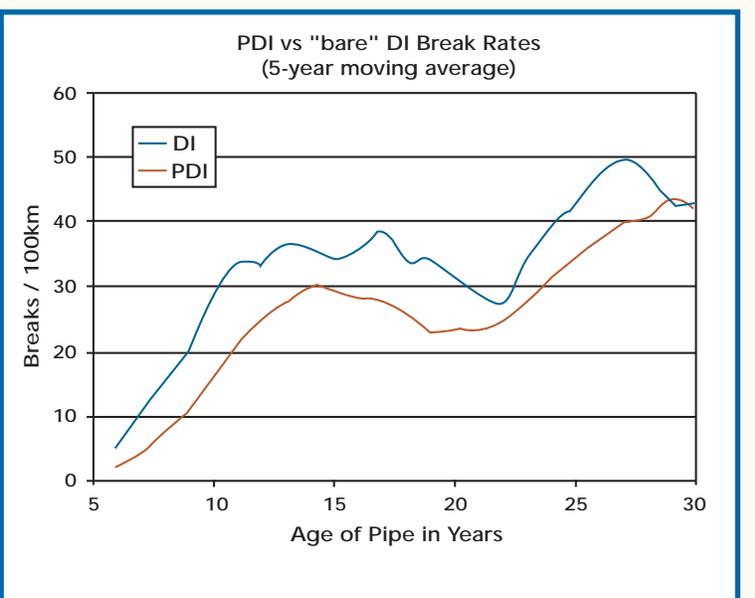
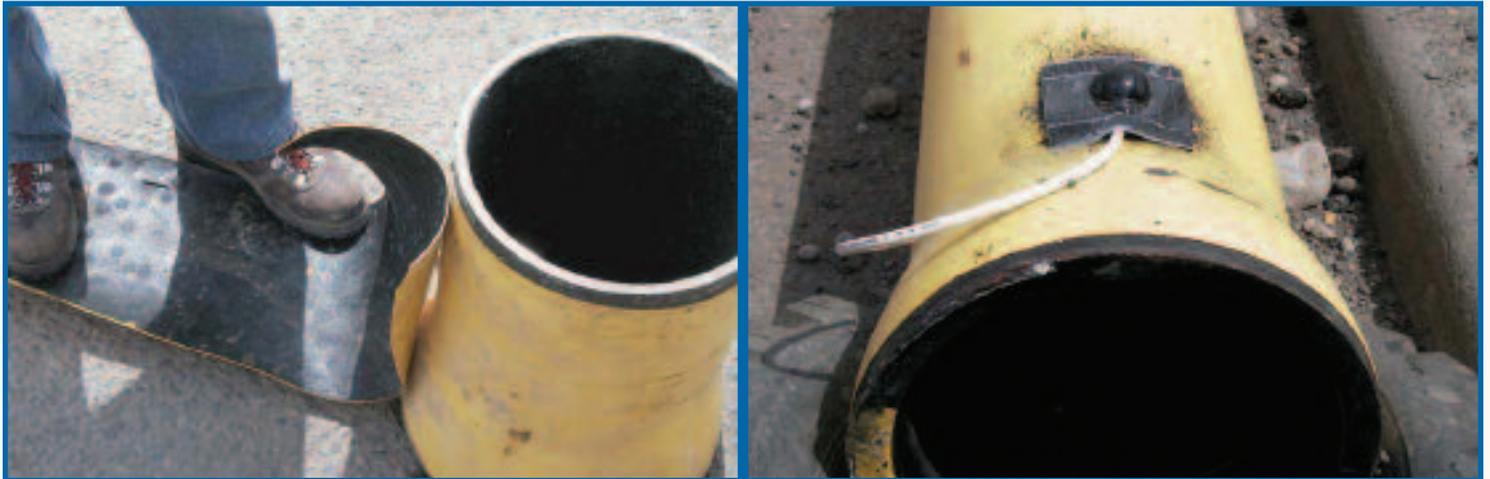
Figure 7: "Yellow-Jacketed" ductile iron (YDI)

Calgary is an oil town. An extremely well known product in the oil industry is YDI or yellow-jacketed ductile iron. It absolutely nailed the corrosion problem for the oil industry forty years ago. As opposed to the PDI, which is loose and only 8 mils, YDI is a 40 mil thick coating bonded to the outside of the ductile iron pipe. (See Figure 7.) The combination of a bonded coating and a cathodic protection system dropped our break rates to an economically sustainable range. (Part of the cost of installing YDI is accounting for the time needed to annually inspect the cathodic protection system and checking whether or not it is time to replace the sacrificial anodes.)

Figure 7 has two photos of YDI. The right half pictures the preparation for electrical connectivity at the joint.

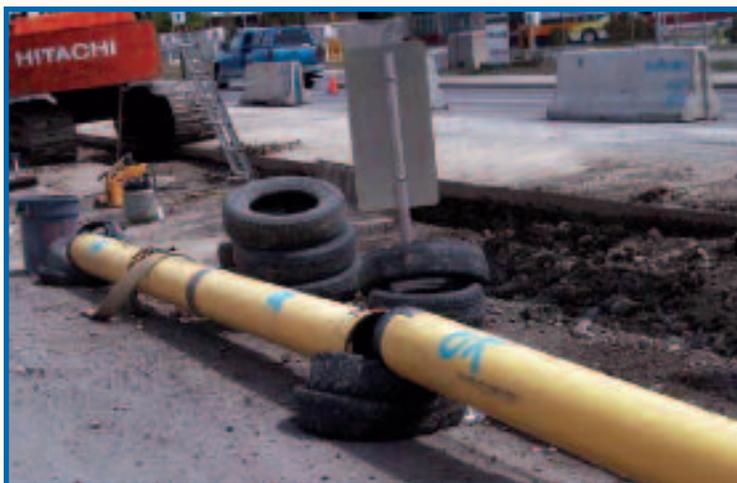
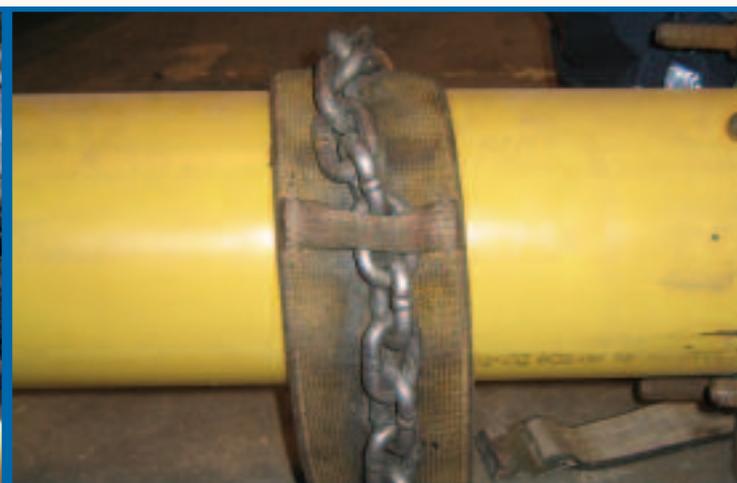
Figure 8: Examples of special construction and handling procedures for YDI

that YDI was stored on tires, not on the ground. (See Figure 8.) YDI was checked for imperfections in the coating by "jeeping" prior to installation. "Jeeping" is checking the coating of the pipe with test equipment. Imperfections are revealed by an arc of electricity from the test equipment to the point of imperfection. Even the chain on the direct tapping machine was modified to protect the YDI coating. (See Figure 8.) Other changes were that embedment for YDI was limited to sand or pea gravel. These changes, and the added cost of the coating, resulted in the doubling of cost as mentioned earlier.
