# THE EFFECTS OF ULTRAVIOLET RADIATION ON PVC PIPE

**UNI-TR-5-03**

**Uni-Bell PVC Pipe Association**

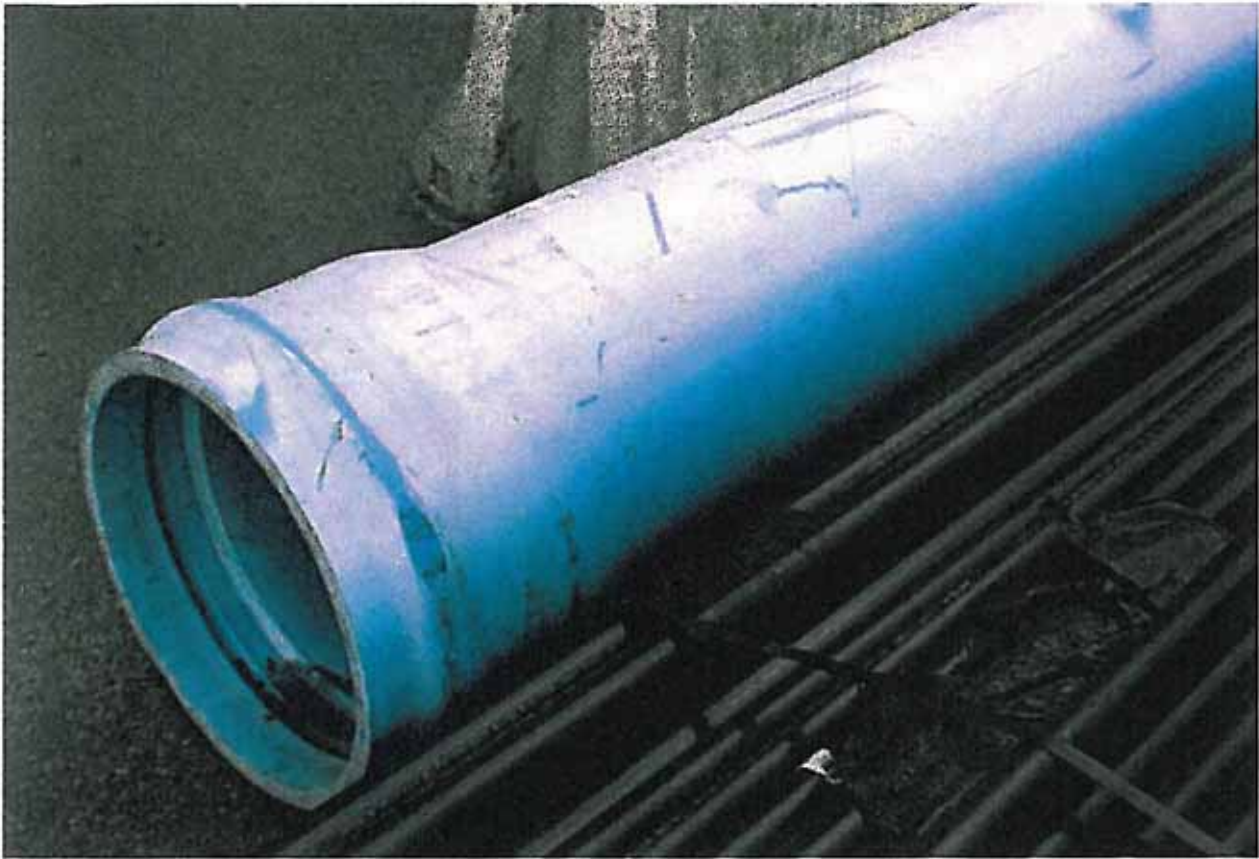
**FIGURE A1**

**THIS LARGE DIAMETER PRESSURE PIPE WAS STORED OUTDOORS, UNPROTECTED FOR 15 YEARS**

The following is a summary of testing conducted on 15-year old PVC pressure pipe that had been continuously exposed to sunlight. The pipe was returned to its plant of origin for testing and evaluation.

<b>PVC Pressure Pipe Specifics</b>	350 mm (14-inch), DR18, PR 235 psi
	Certified to CSA B137.3
	Manufactured on May 23, 1986
	Pipe was severely faded to a maximum depth of 0.002 inches over approximately 180 degrees of its exterior surface.
<b>Storage Location</b>	Outdoors City of Saskatoon Public Works Yard 330 Ontario Avenue Saskatoon, Saskatchewan
<b>Climate</b>	Saskatoon averages 2380 hours of sunshine per year

Even though the PVC pipe endured severe conditions of ultraviolet exposure from 15 years of daytime sunlight, the pipe exhibited no loss of physical strength and should be considered very suitable for ordinary usage.
