PVC PIPE

WINTER 2005 • VOLUME 28 • NUMBER 2

The Mojave River Pipeline Project

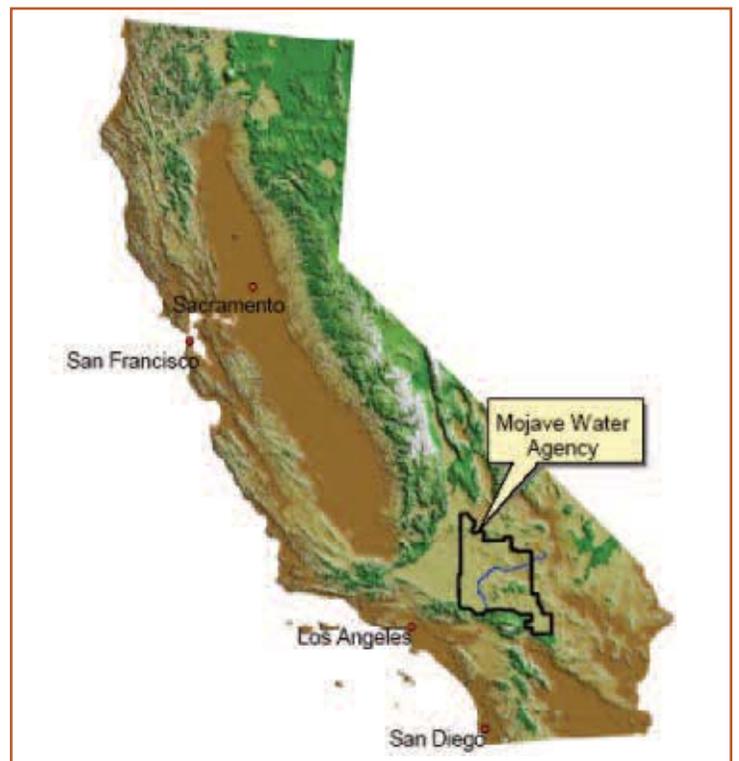
Figure 3. The Mojave Water Agency has more square miles of land area within its boundaries than the entire State of Connecticut.

Background on the Mojave Water Agency (MWA) provides the proper context for introducing the MRPP. In land area, the MWA is a giant. Its boundaries encompass approximately 4,900 square miles. The entire state of Connecticut could fit within its boundaries and there would still be room to spare. The map in Figure 3 shows the location of MWA within the State of California. The MWA's key stakeholders include thirty water agencies and six municipalities.

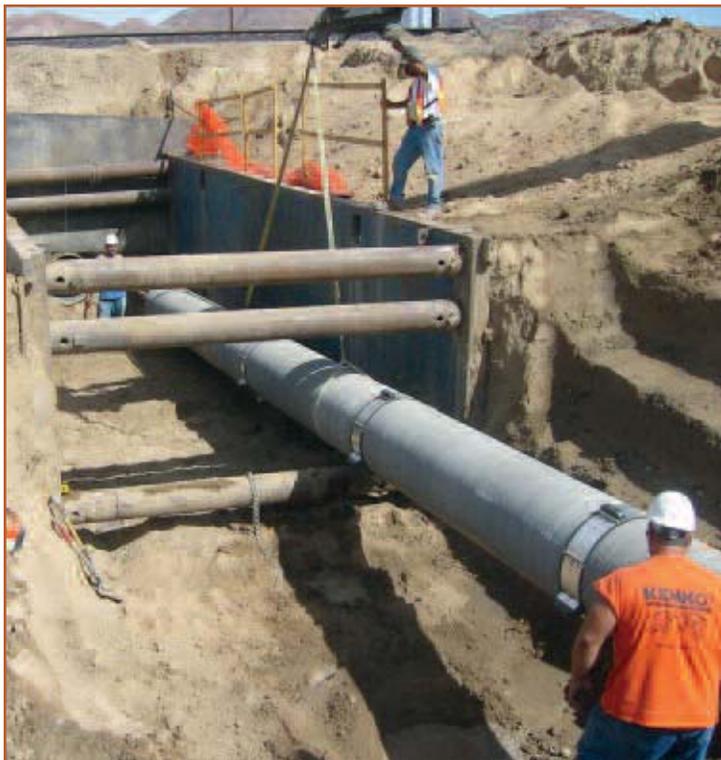
Figure 4. Cement lined and coated steel pipe had been the MWA's pipe material preference. This type of pipe was used for the first three reaches of the MRPP. This photo demonstrates the skill of the backhoe operator, who is threading the steel pipe through the braces of the trench box. Bumping the pipe against the trench box could be disastrous for the internal and external coating. As indicated by the casing skids, the pipe is to be pushed into place inside a casing.

The MWA's product of choice for the first three reaches was cement mortar lined and coated welded steel pipe. (See Figure 4.) However, the MWA was open to discussing alternative materials for the MRPP, and they carefully examined every aspect of PVC before deciding to allow it as an option for Reach 4A of the MRPP.

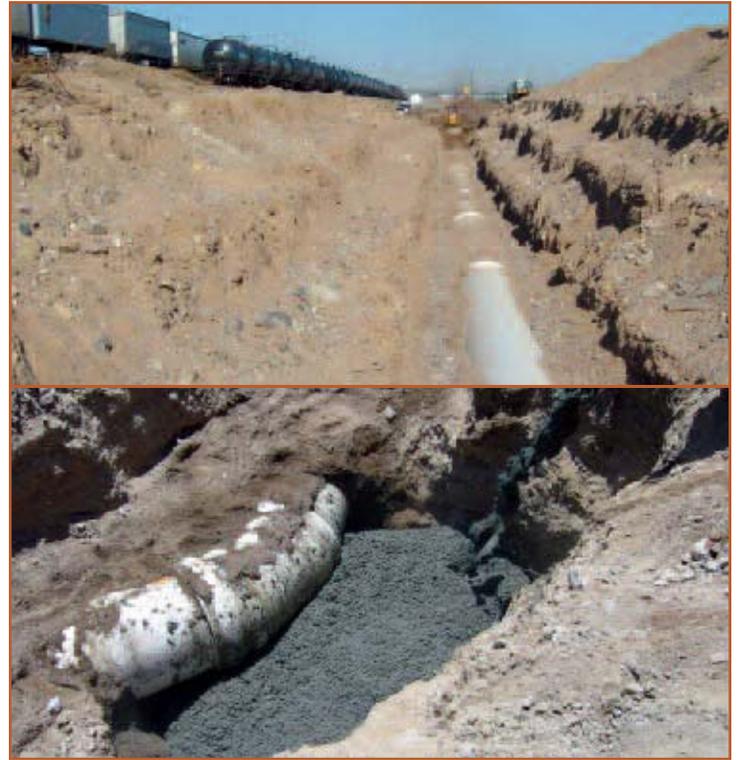
Figure 7. Portions of Reach 4A paralleled active railroad tracks (top). The huge forces generated at changes of direction in a 24-inch pipeline required enormous thrust blocks (bottom).

Figure 7 shows some of the design challenges for this project. Portions of the alignment paralleled railroad tracks, and there were several road crossings. At the maximum test pressure of 140 psi, the resulting unbalanced forces on the 25.8" OD pipe at a 45-degree elbow, as shown in Figure 7, would be almost 20,000 pounds.
