PVCNews

PUBLISHED BY THE UNI-BELL PVC PIPE ASSOCIATION, DALLAS, TEXAS

Dealing with Disaster

By David Chorley
Manufacturer's Representative,
Diamond Plastics Corporation

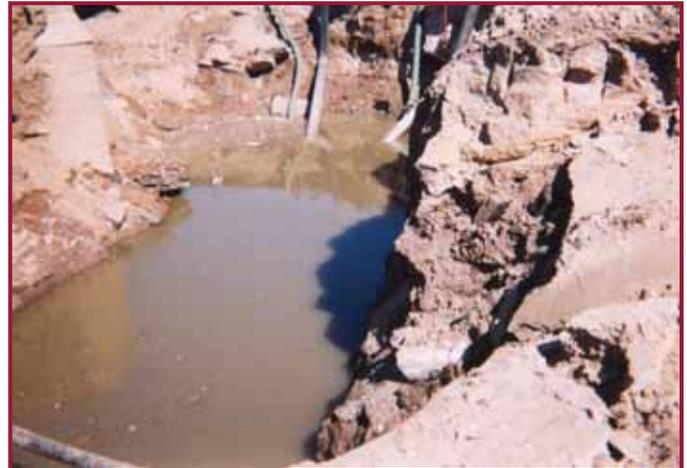
The sink holes were fifteen to twenty feet deep. Pumps were brought in from across the southwest to clean-up the spilled sewage.

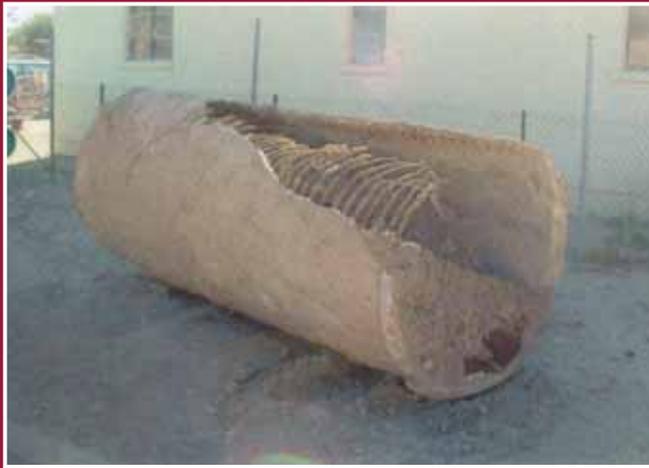
The reason for the sink holes was traced to corrosion at the crown of the concrete sewer interceptor.

ter in the late 1950s, Pima County would not have been faced with the dire consequences from the combination of sulfuric acid and concrete sewer pipe. Regrettably, history is what it is and not what we would like it to be. The current administration has inherited an aging infrastructure vulnerable to sulfuric acid corrosion, and they have to do their best with the resources they have been given. Part of that fiscal responsibility meant using PVC this time instead of concrete. PVC's chemical resistance makes it impervious to sulfuric acid. The missing crown of the collapsed concrete interceptor is a sad reminder of concrete's susceptibility to sulfuric acid attack.

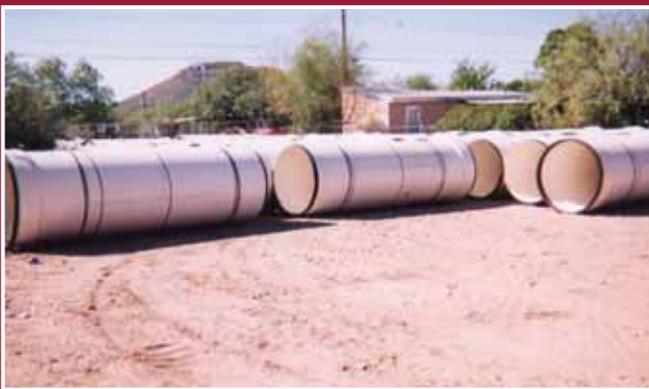
Two loads of 48-inch, F1803, sanitary sewer pipe were delivered three days after it was ordered.

Pima County was interested in maintaining the full 42-inch, inside diameter and in making provisions for future flows. The answer, again, was that the PVC pipe was available in Lubbock. So in 2002, the County was able to do what they could not have done in 1957 when the interceptor was first installed: They placed an order for 910-feet of 48-inch, ASTM F1803, closed-profile, PVC sewer pipe.

Three days after the order was placed, two loads of PVC pipe were delivered. The order was completed two days after that and two weeks before pipe replacement could begin. Replacement of the line was subcontracted to K. E. & G. Not wanting a novice for this

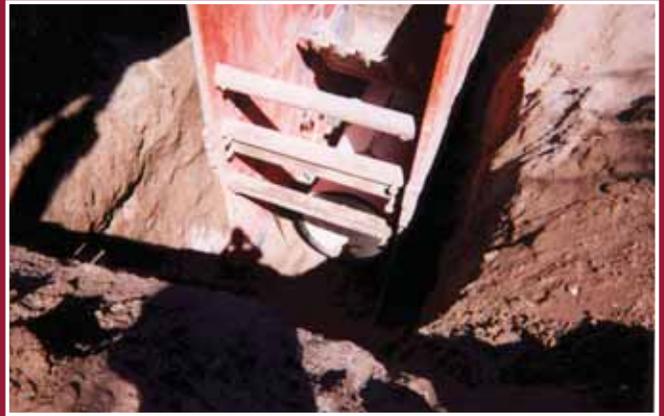
The nylon sling was rigged as a choker around the sewer pipe and connected the backhoe. Tight space necessitated this approach for joint assembly.

high profile project, Pima County and Dar-Hill Construction turned to K. E. & G. because it was a seasoned contractor with a great deal of large diameter pipe installation experience. The soft shifting sands and tight working environment made K. E. & G.'s job difficult. A thirteen-foot trench box was carefully placed between an existing water line and a sewer line. Then the installation of the new PVC sewer pipe began. To assemble the joint, K. E. & G. used a rope-sling to provide the assembly force. Using the backhoe bucket for assembly was not an option due to space limitations. There just was not enough room to maneuver. As an experienced contractor, K. E. & G. made sure the joint was in straight alignment before pulling the joint together with the rope-sling. Due to the harsh conditions, it took approximately three 24-hour days to complete the installation of the replacement pipe. Pima County officials and K. E. & G. were very pleased with the performance — and the relative light weight — of PVC pipe. Both made a difficult installation more manageable.

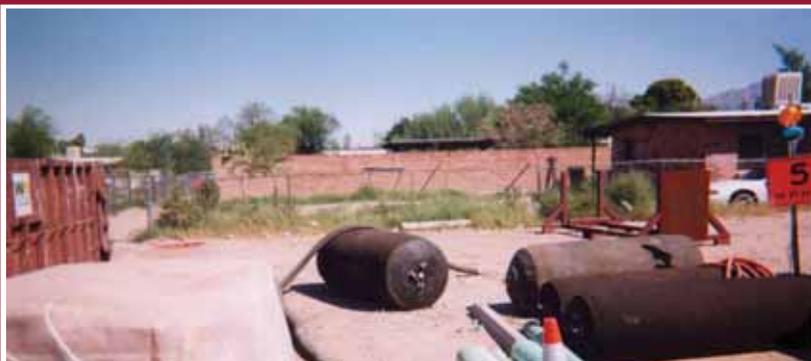
Plugs required for the low-pressure-air test are on-site and available for the acceptance test for system integrity.

After installation was complete, the line was tested. Pima County officials originally were going to perform a hydrostatic-exfiltration test, but they changed their minds because of the time involved and the need to get the new line in service. Instead, they chose to conduct a low-pressure-air test. Having never air tested pipe this large, Pima County went to Uni-Bell for information. Uni-Bell's recommendations state that the test may be successfully concluded after an hour if there is no pressure loss. The first test was conducted on a run of 500 feet of pipe, from manhole to manhole; and the second test was approximately 400 feet, from manhole to manhole. In both cases, the pipe held the pressure without any pressure loss.
