# ***Water Main Break Rates In the USA and Canada: A Comprehensive Study April 2012***

Utah State University  
Buried Structures Laboratory

Steven Folkman, Ph.D., P.E.

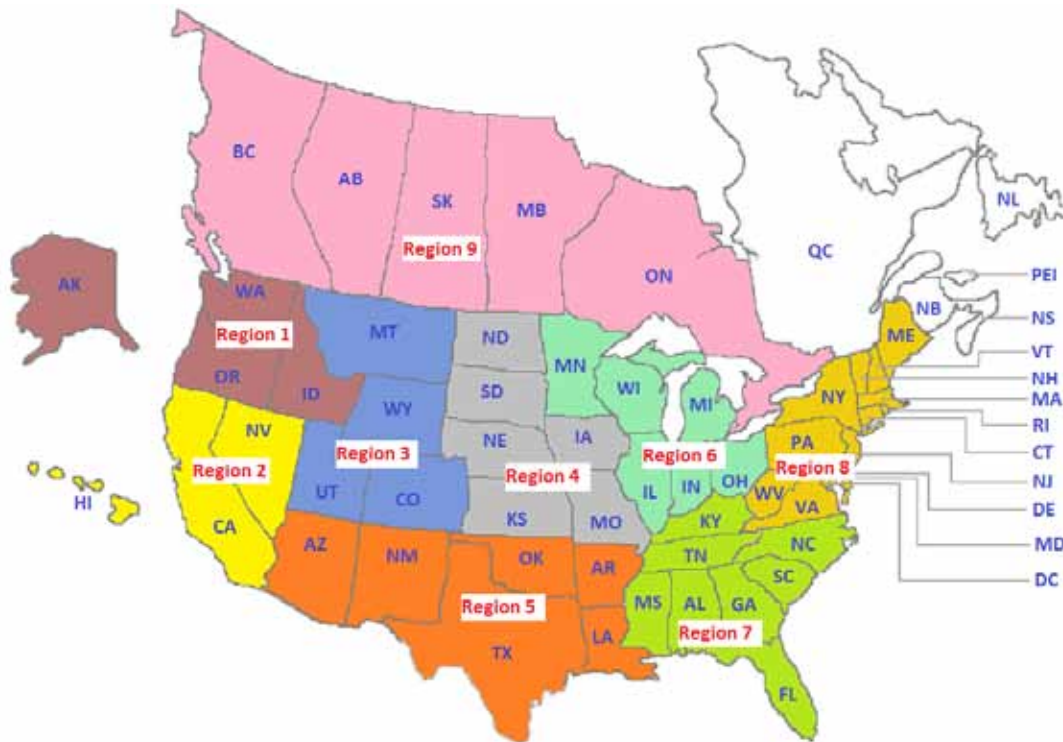
**Figure 1. Regions used to report survey results.**

The regions defined in the study are used here to indicate the wide geographical distribution of the respondents. Table 1 lists the number of respondents in the basic and detailed surveys from each region, and Figure 1 illustrates the locations of the nine different regions used in this report. The provinces in Canada with a white color did not have respondents to the survey. Figure 2 illustrates the miles of water main pipe that were reported in the basic survey on a regional basis. Similarly, Figure 3 illustrates the miles of water main pipe on a regional basis from the detailed survey. A total of 32,130 miles of pipe was reported by respondents in the detailed survey. It is noted that the respondents were distributed across a large survey area, but this study is still more comprehensive than other studies to date.

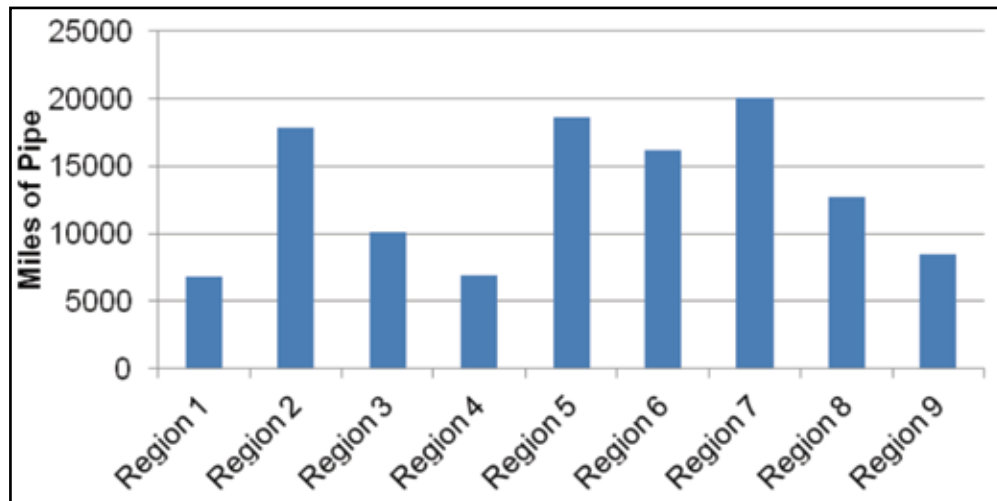
Figure 2. Length of pipe from each region that responded to the basic survey.

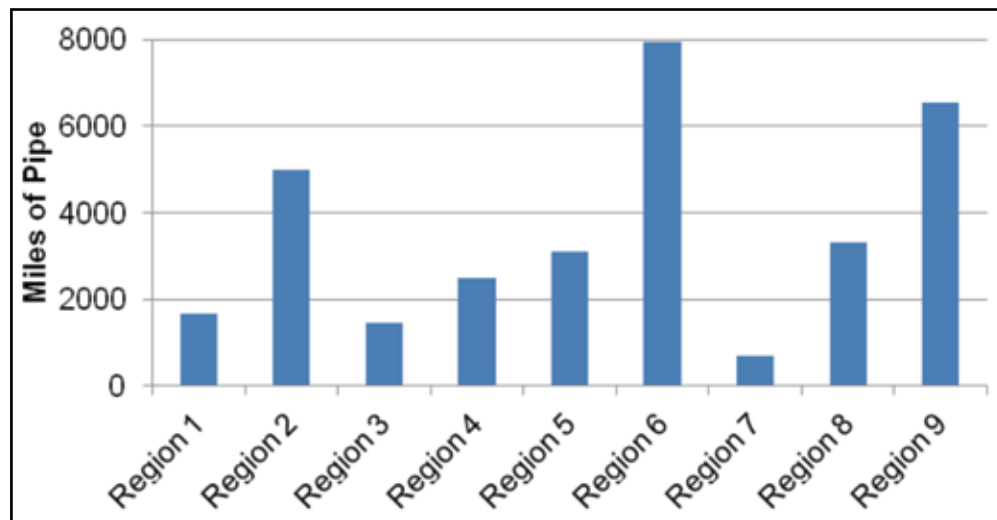
Figure 3. Length of pipe from each region that responded to the detailed survey.

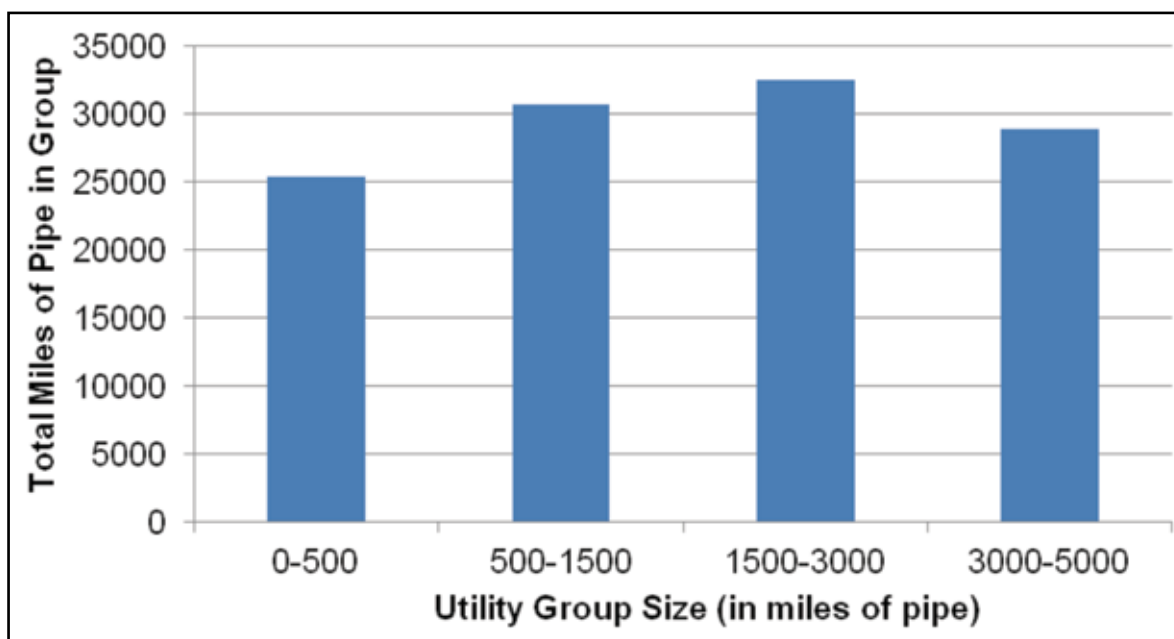
Figure 4. Total miles of pipe in each size group defined in Table 2 based on the basic survey respondents.

Four categories were established as shown in Table 2 and each survey participant was allocated to one of the categories. Figure 4 shows the distribution of total miles from the basic survey based on these categories. Respondents covered the range from very small to very large with each group from Table 2 well represented.

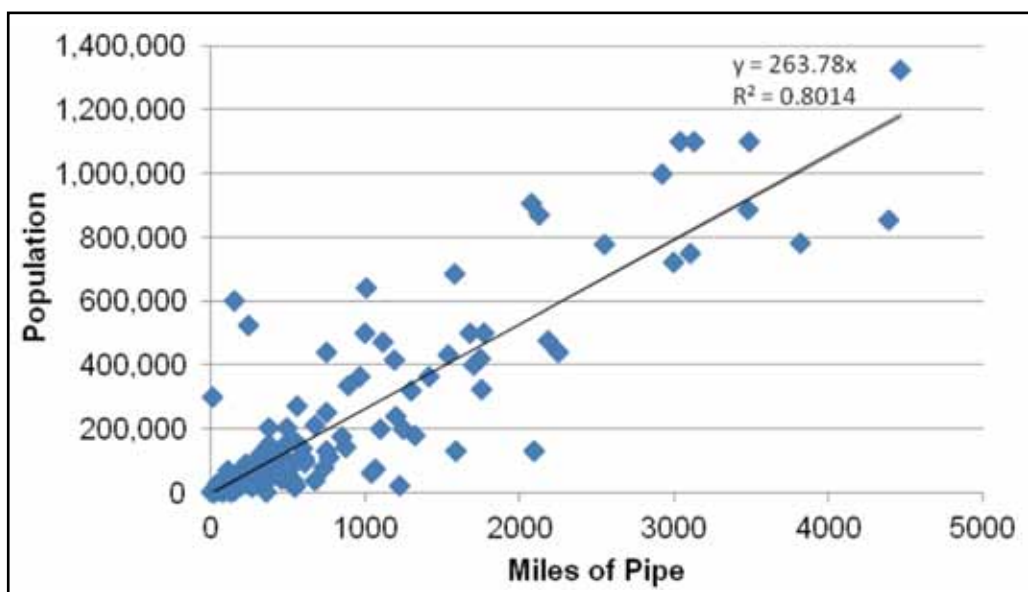
Figure 5 illustrates the relationship between the population served by the utilities participating in the basic survey and the number of miles of water main pipe. The trend line and equation are a best fit to the data. The slope of this line indicates that there are on average 264 people served for each mile of water main installed.

Figure 5. Population served relative to total pipe line miles from the basic survey.

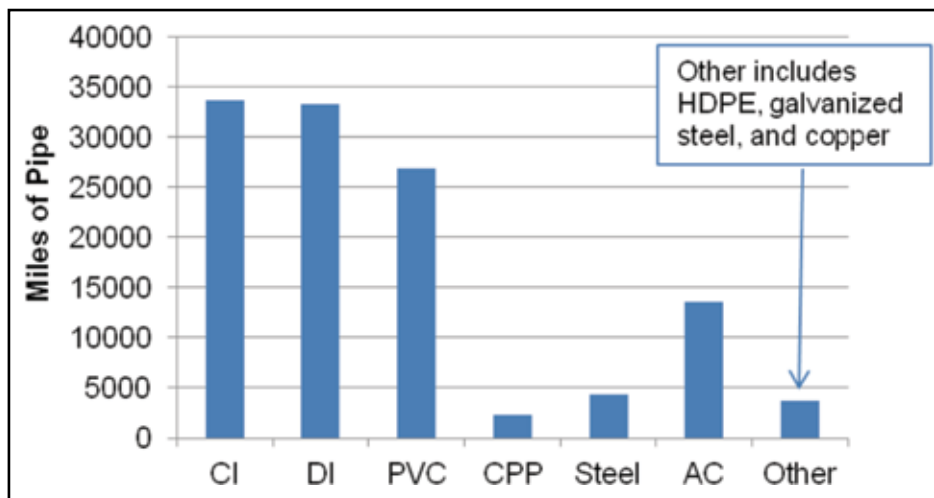
Figure 6 illustrates the length of pipe reported in the basic survey broken down by pipe material. The “Other” category in Figure 6 includes materials such as HDPE, galvanized steel, and copper. Figure 7 illustrates the length of pipe reported in the detailed survey broken down by pipe material. Figure 8 illustrates the pipe material distribution as a percentage of the total length from both the basic and detailed surveys. The distribution of miles of pipe is quite similar in Figure 8 indicating that the detailed survey with a smaller number of respondents still gives similar results.

**Figure 6. Length of pipe broken down by material type from the basic survey.**

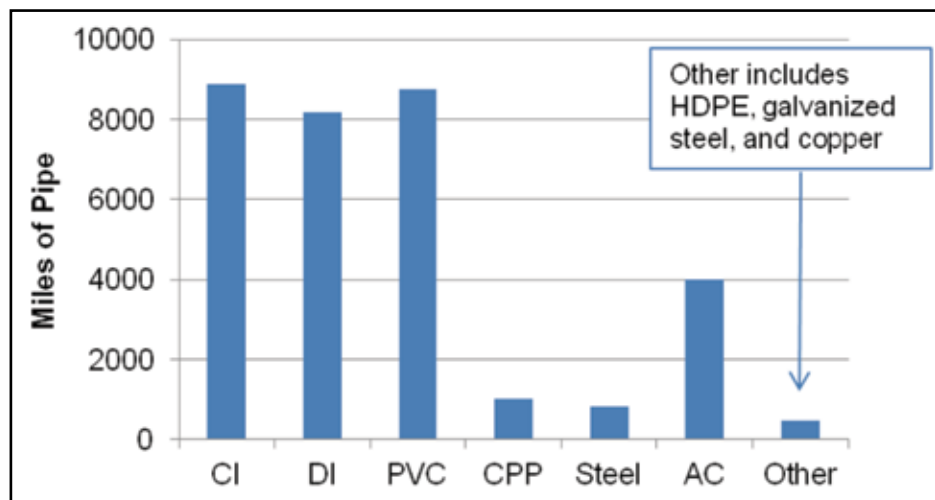
Figure 7. Length of pipe broken down by material type from the detailed survey.

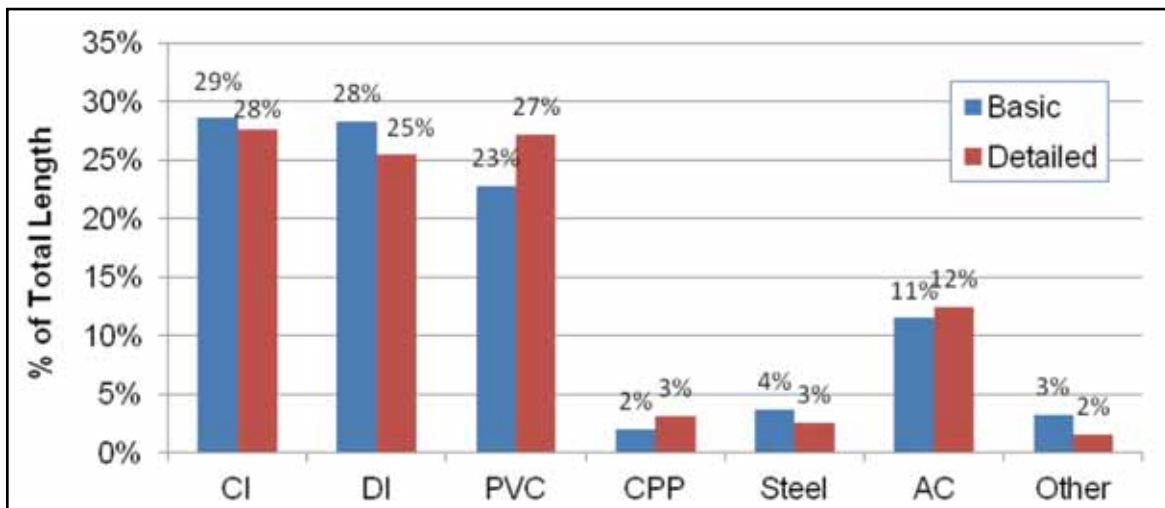
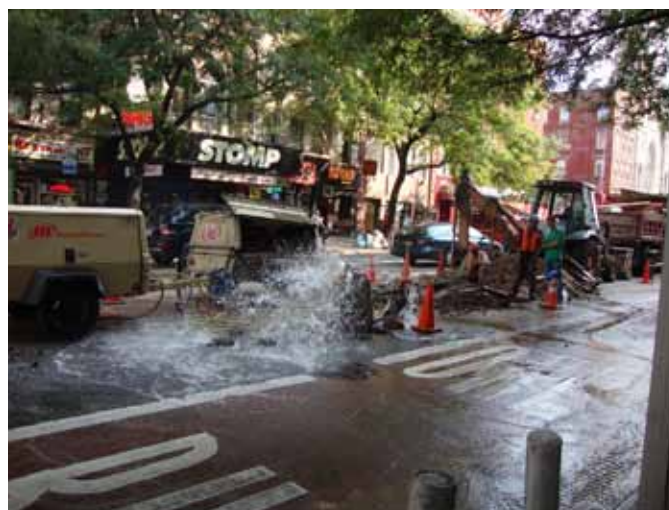
Figure 8. Percentage of total length of pipe by material type from both the basic and detailed surveys.

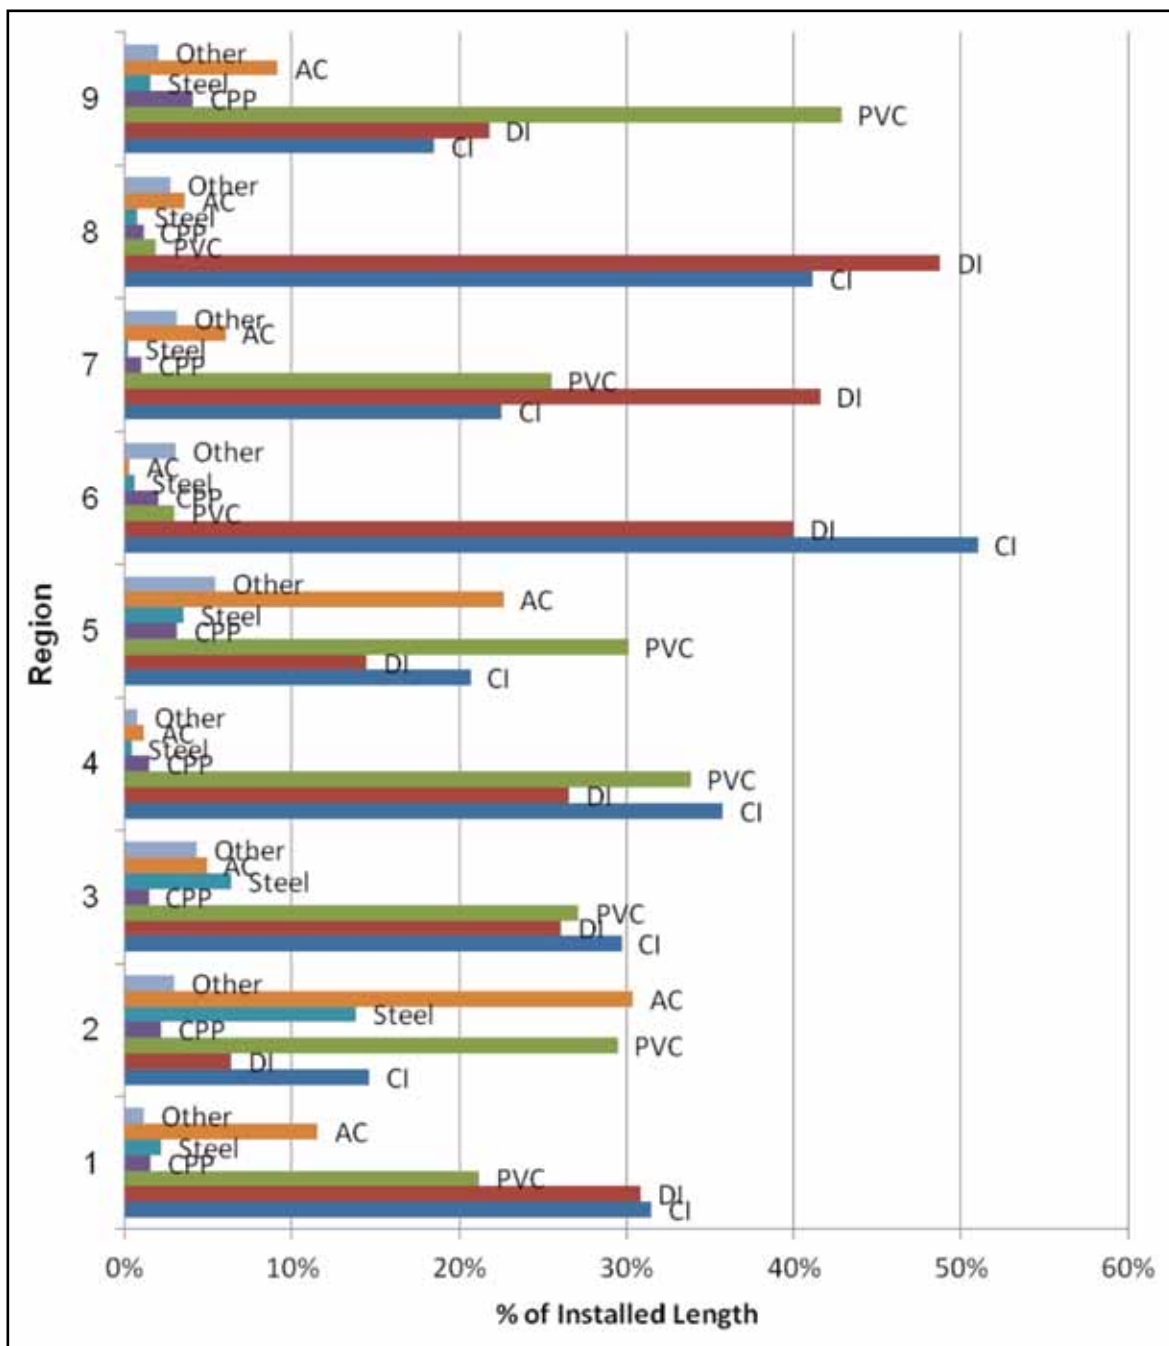
Figure 9 illustrates the regional distribution of pipe material usage as a percentage of the total length in that region. It is interesting to note the significant differences in regional pipe material utilization. Cast and Ductile Iron represent approximately 90% of the pipe in regions 6 and 8. PVC has a dominant role in region 9 and is well established in regions 2, 3, 4, 5, and 7.

**Figure 9. Regional percentage of length of pipe by material type from the basic survey.**

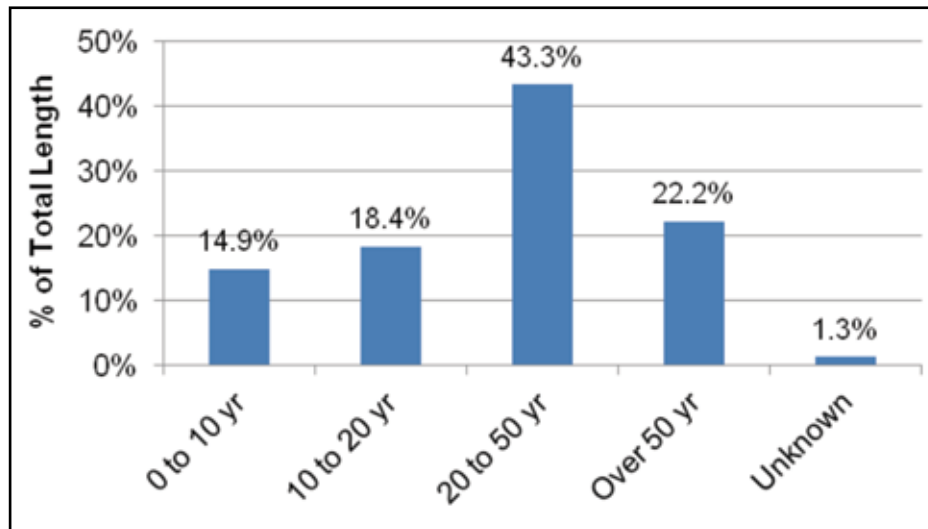
The detailed survey asked respondents to provide the distribution of installed pipe by age. Four age groups were provided; zero to 10 years, 10 to 20 years, 20 to 50 years, and over 50 years. Figure 10 lists the percentage of water main length that fits in each age category. Figure 10 indicates that approximately 43% of installed pipe are in the 20 to 50 year age category and 22% are over 50 years of age. This finding is consistent with other industry sources.

**Figure 10. Percent of length of pipe by age from the detailed survey.**

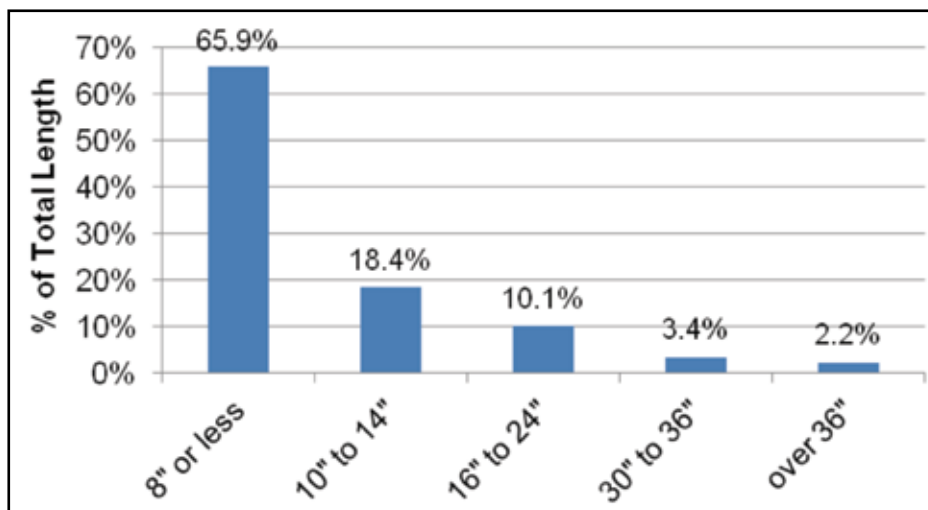
The respondents were also asked to break down the fraction of total installed pipe length by five pipe diameter categories. Figure 11 illustrates the percentage of water main that fit into each size range. Figure 11 indicates that approximately 66% of the installed pipe is 8 inches or less in diameter.

**Figure 11. Percent of length of pipe by pipe diameter from the detailed survey.**

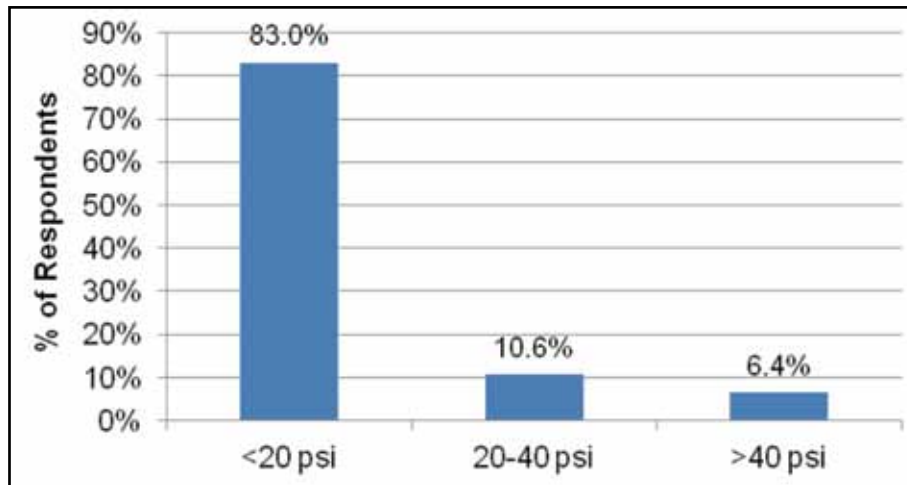
Based on the detailed survey, the average delivery pressure is 77 psi. The range of values reported for average delivery pressure was 45 to 150 psi. The detailed survey also asked how much does the water pressure fluctuate at any given point in their system during a typical day. The respondents were asked to select one of three ranges. Figure 12 illustrates the percentage of respondents that fit into each pressure range. About 83% are able to limit pressure fluctuations to be less than 20 psi.

Figure 12. Percentage of respondents with one of three pressure fluctuation ranges.

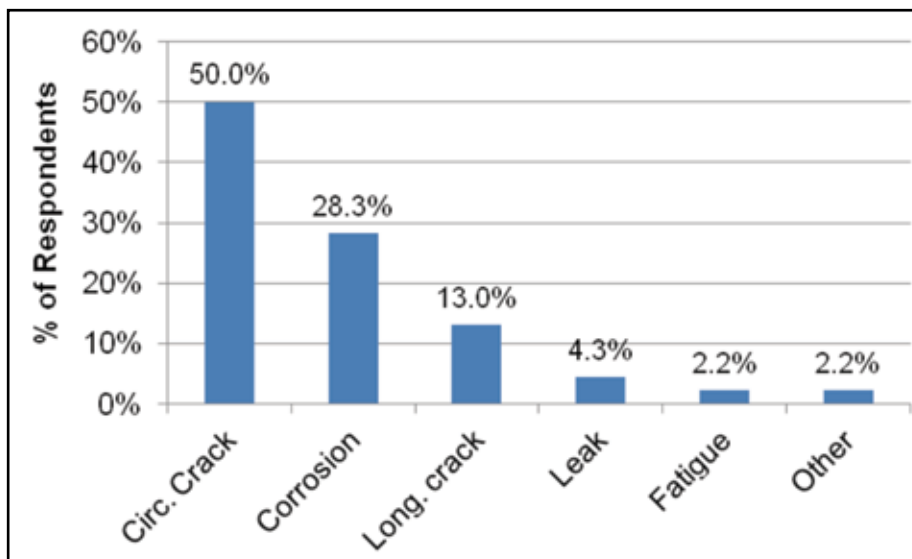
The detailed survey asked the respondents to identify the most common failure mode by selecting from one of the following; corrosion, circumferential crack, longitudinal crack, leakage at joints, fatigue, or other. Figure 13 identifies a circumferential crack as the most common failure mode followed by corrosion. The detailed survey also asked respondents to identify the pipe material that was failing most often. Figure 14 shows that 55.3% of respondents identified Cast Iron as the most common failing pipe material followed by Asbestos Cement at 17.0%. The respondents also reported the typical age of a failing water main. The average result was 47 years with a range of values from 20 to 86 years. The survey also asked what the expected life should be when installing new pipe. The average expected life of new pipe was 79 years with a range of responses from 30 to 200 years.

Figure 13. Percent of respondents selecting a most common failure.

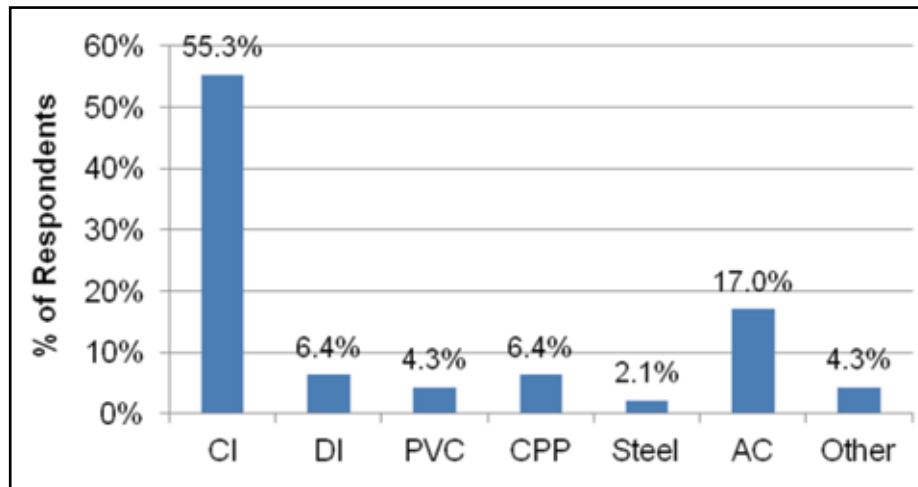
**Figure 14. Percent of respondents selecting a most common failure material.**

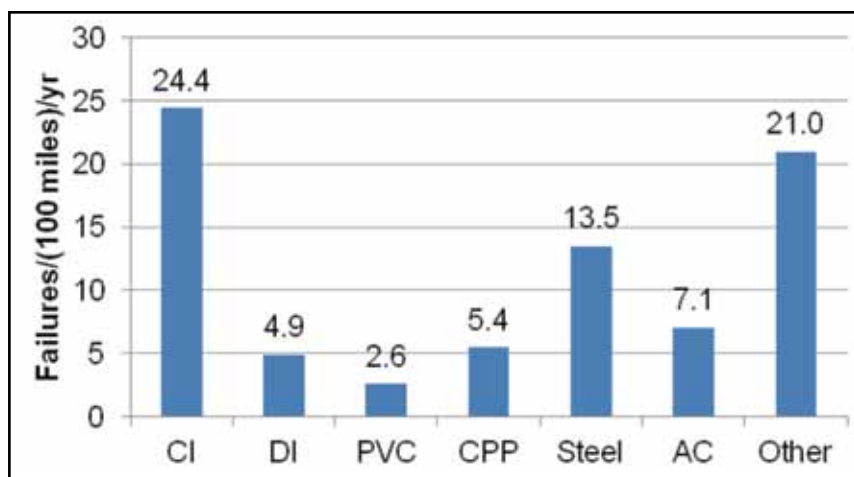
The survey measured pipe failures over a recent 12 month period, broken down by material type. Table 4 lists the total length of pipe by material type, the number of failures over a recent 12 month period, and the failure rate for each pipe material. Figure 15 illustrates the failure rates as a function of material type. If one assumes a utility had equal lengths of each material installed, then Figure 16 would illustrate the percentage of failures as a function of pipe material. Figure 17 gives the failure rates broken down by material type and by respondents from the USA and Canada.

Figure 15. Failure rates of each pipe material from the basic survey.

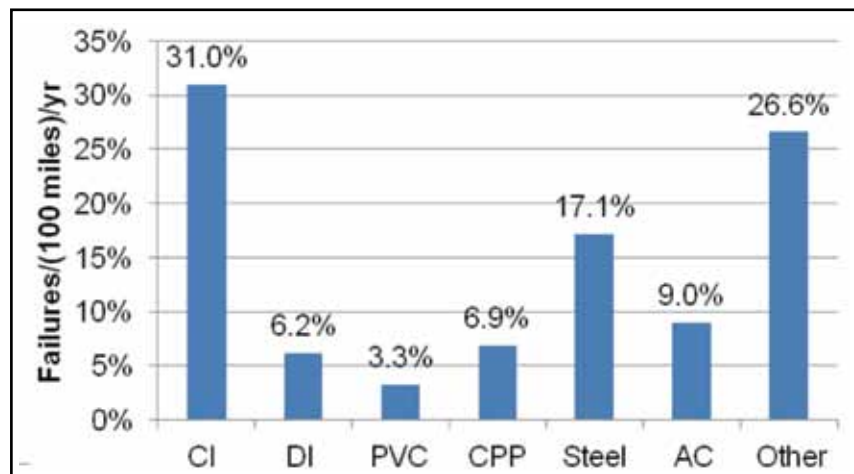
Figure 16. Percentage of failures attributed to each pipe material assuming equal lengths of material were installed.

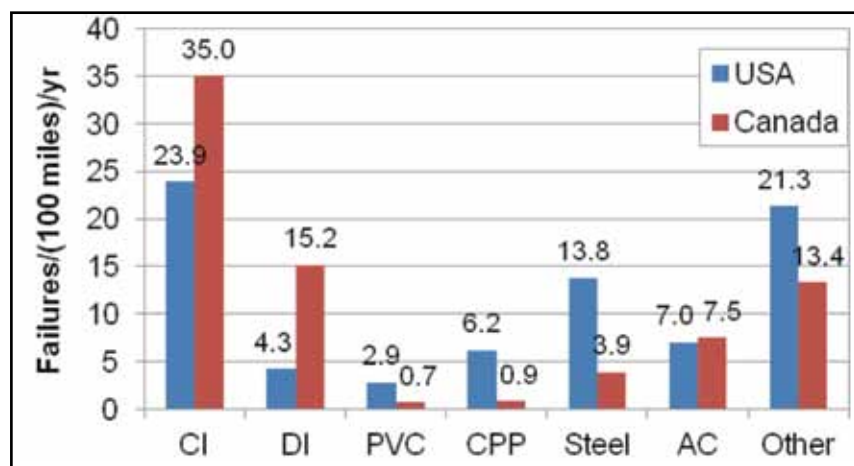
Figure 17. Comparison of failure rates from USA and Canada.

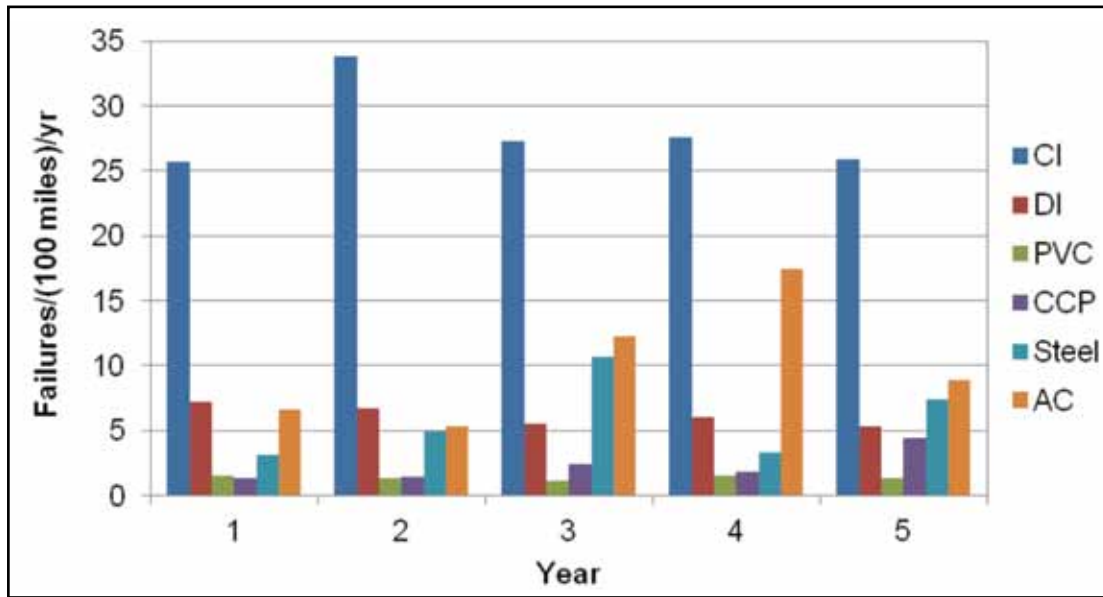
The detailed survey requested the respondents to list the number of failures per year for five years, broken down by material type. The desired focus was to examine the year to year variations by pipe material. A single utility might have large year to year variations, but if the number of utilities sampled is sufficient, the year to year variation should be small. Figure 18 shows the failure rates from the detailed survey from each of the five years covered by the survey. Respondents that did not have five years of data were not included in these results.

**Figure 18. Pipe failure rates over a five year period as a function of pipe material.**

Table 5 lists the average of the failure rates over the five year period along with the standard deviation and the coefficients of variation (the standard deviation divided by the average). The coefficients of variations for CI, DI, and PVC are similar indicating they have approximately the same variability. The widest variation in rates was associated with CPP, steel and AC pipe. The length of pipe in the detailed survey for these materials was small and more respondents could likely reduce the variability.

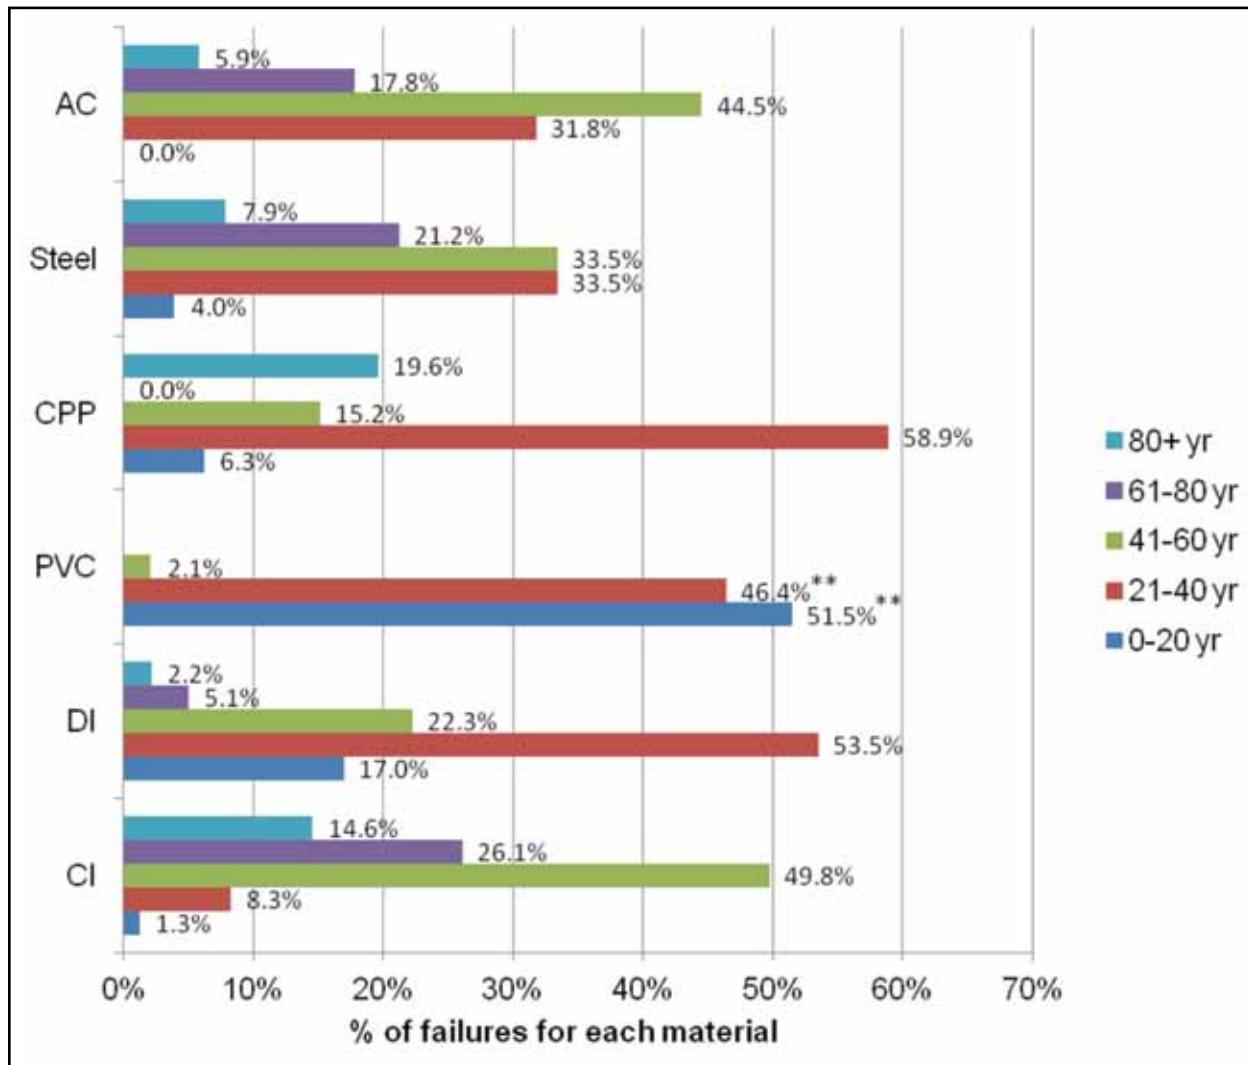
Clearly, pipe age will affect failure rates. The basic survey asked respondents to break down the failures into five different pipe age categories. It is noted that some of the respondents did not know the age of the failed pipes, and they were not included in the results below. For each material type, the fraction of failures in each age group is examined in Figure 19 based on the basic survey results. For example, 49.8% of the reported cast iron failures occurred with a pipe age between 41 and 60 years. Note that the largest percentage of failures is not in the oldest pipes, which has several possible causes. First, the older pipe is being replaced, and, thus, there is less available to fail.

**Figure 19. Percent of failures as a function of age and pipe material.**

The results in Figure 19 are related to when a pipe material was introduced or removed from the market. Asbestos Cement pipe has not been installed in the USA and Canada in the past 20 years, and, thus, all AC pipe failures exceed 20 years of age. Widespread DI and PVC pipe production in the USA did not start until about 1970, so we should expect to see a small failure percentage for both DI and PVC in the 41 to 60 year age group and none for the 61 to 80 and 80+ age groups. PVC follows that trend in Figure 19. Figure 19 shows the majority of DI pipe failures occur at an age between 21 and 40 years. The DI results in Figure 19 for the 61 to 80 and the 80+ age groups are possibly caused by incorrect records on the age of those failed pipes.

It is of interest that Figure 19 shows a greater percentage of PVC pipes fail in the first 20 years of use than in the next 20 years\*\*. This was investigated in a previous survey funded by AWWARF (Moser, 1994). Figure 20 illustrates the percent of failures as a function of time for AWWA rated PVC pipe. As shown below, over 40% of the reported failures occurred in the first year. Often the cause of these failures in PVC pipe is related to improper installation practices and not a defect in the pipe. The city of Calgary has been able to achieve remarkably small PVC failure rates due to enforced construction standards (Brander, 2004). In addition, Calgary requires new subdivision infrastructure to remain the property of the private developer for a period of two years. During this two year period, most construction related problems will occur. An AWWARF study (Burn, 2006) estimates the design life of PVC to be in excess of 110 years.

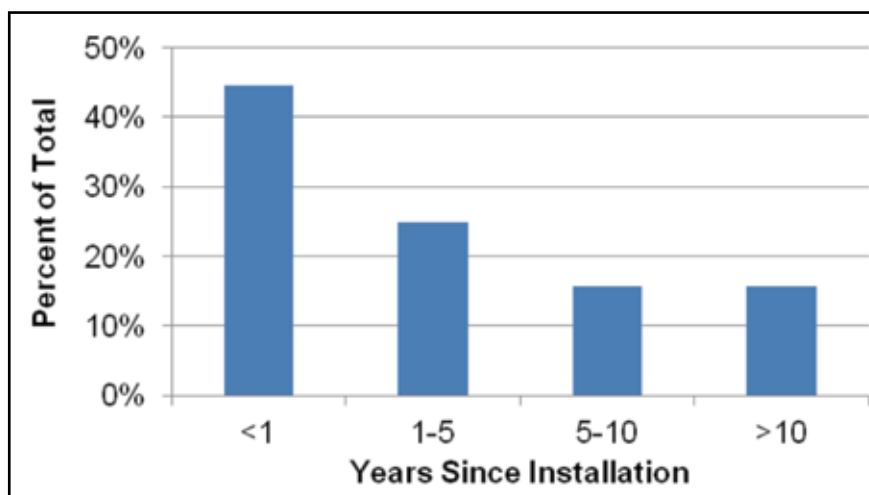
**Figure 20. PVC failures as a function of time (adapted from Moser, 1994).**

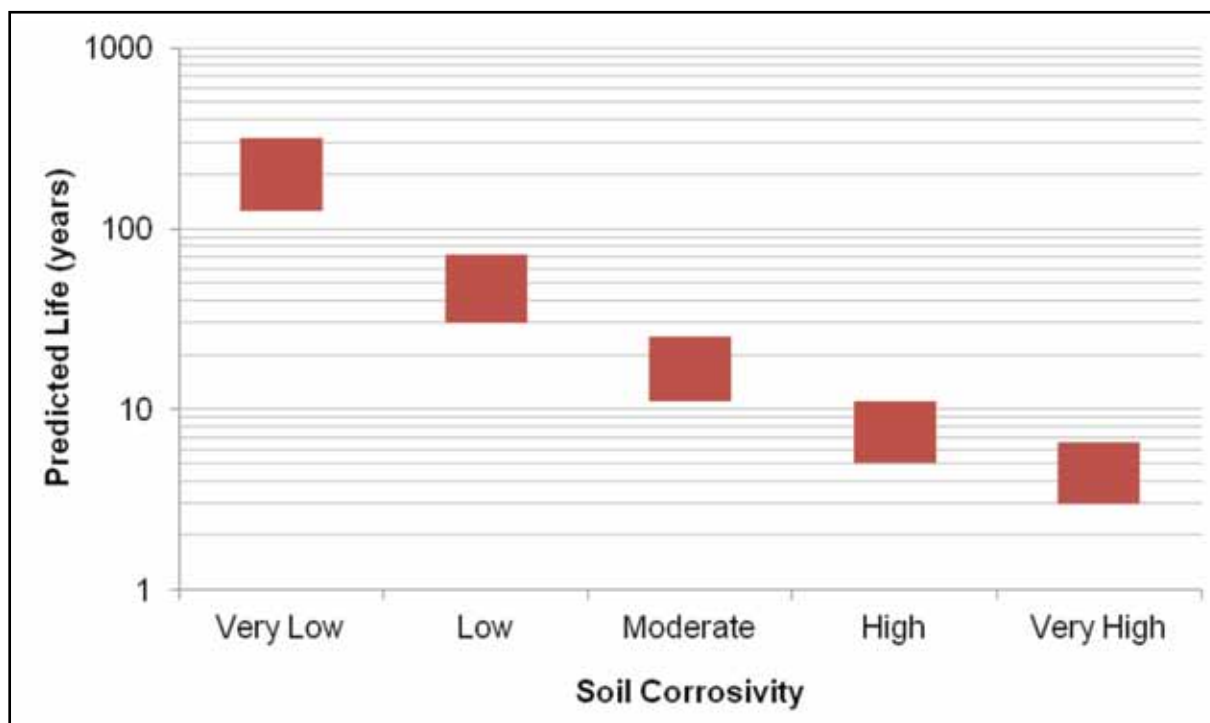
The expected life in years of an unprotected DI pipe was estimated in a recent Water Research Foundation study (Rajani, 2011). Figure 21 illustrates the published results as a function of a relative scale of soil corrosivity. Figure 19 indicates that the majority of DI pipe failures occur at an age between 21 and 40 years. A 21 to 40 year life in Figure 21 would correspond to a low to moderate soil corrosivity for an unprotected pipe. This would indicate that corrosion is a significant problem in all regions of this study. When a comparison is made between Cast Iron and Ductile Iron, thinner-walled Ductile Iron is experiencing failures more rapidly (21-40 year period) than the thicker-walled cast iron (41-60 year period). Concrete Pressure Pipe also shows failures rates that are impacted by corrosion in the 21-40 year period. The study also notes that “aging or deterioration of ductile iron pipes can vary significantly from one geographical region to another within a city, let alone from city to city.”

**Figure 21. Predicted life of unprotected class 350 DI pipe (from Rajani, 2011).**

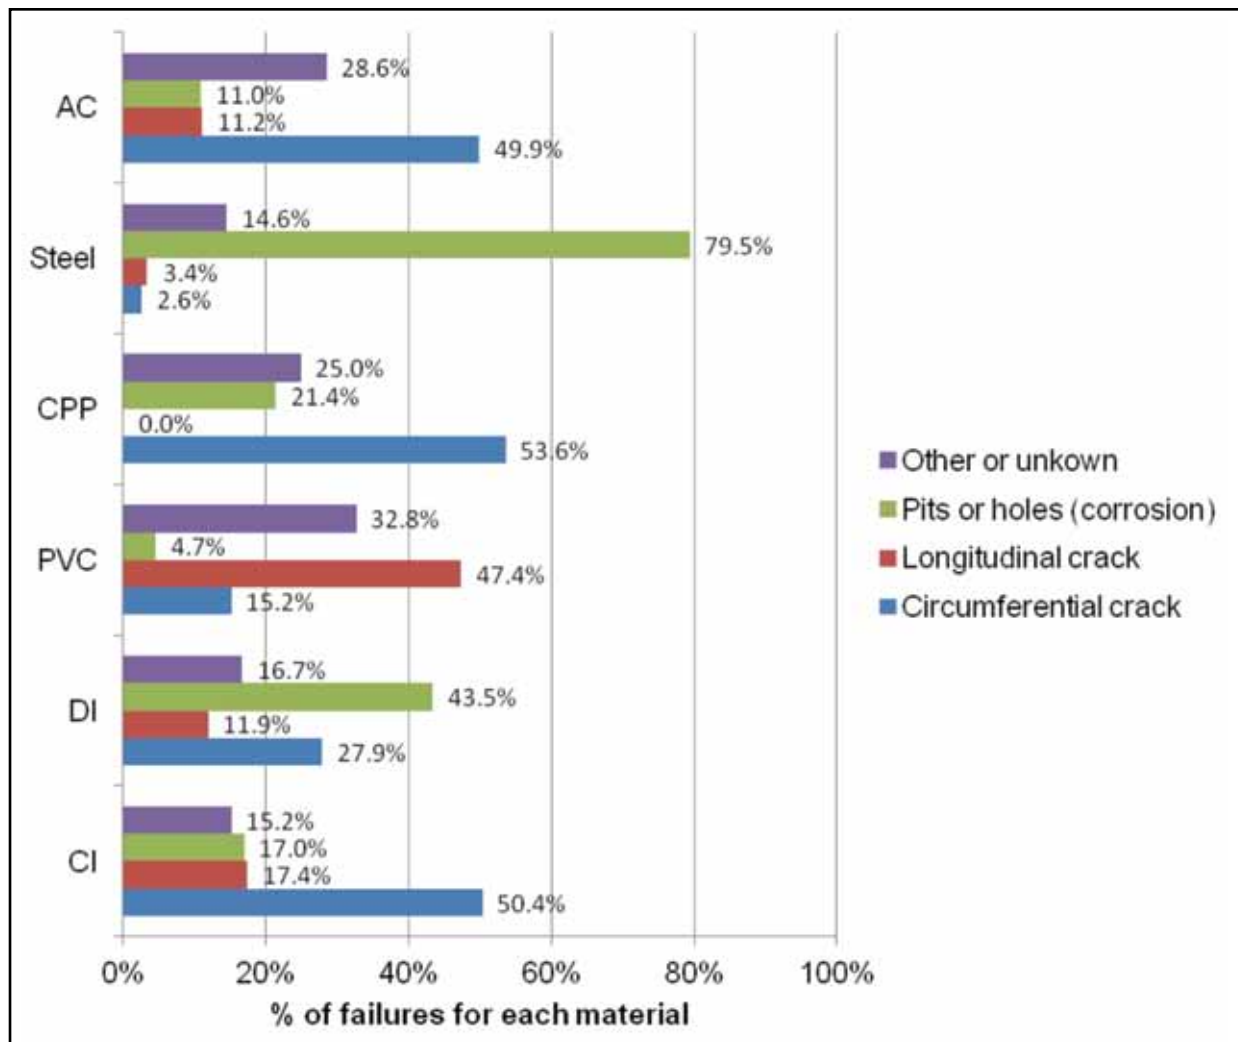
Figure 22 summarizes the percentage of failures that were reported to fit in each description. A circumferential crack is the primary failure mode for Cast Iron, Concrete and Asbestos Cement pipe. Corrosion is the primary failure mode of Ductile Iron and Steel pipe. A longitudinal crack is the primary failure mode of PVC.

**Figure 22. Description of failure for each pipe material.**

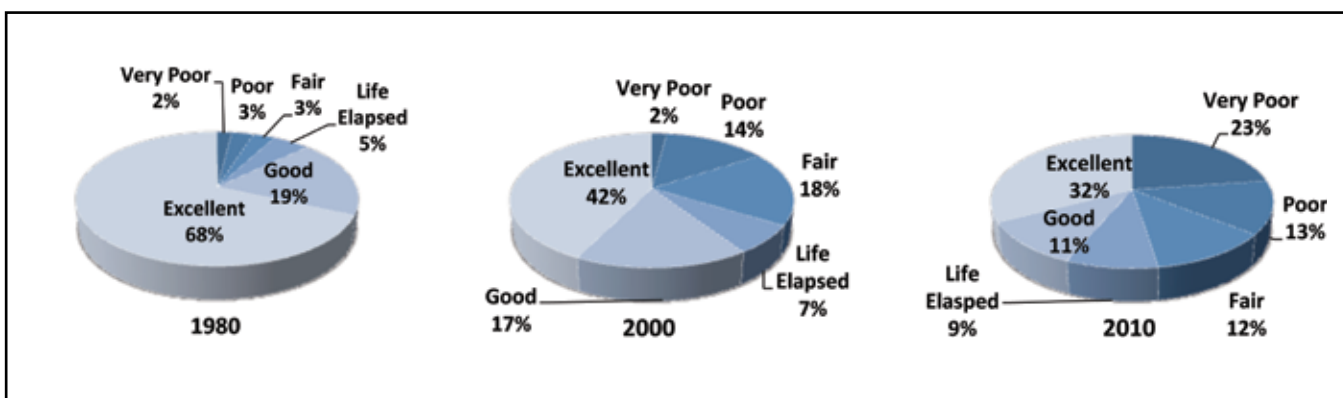
It is of interest to compare these results with a study done by the EPA (EPA, 2002). This study classified water main pipe condition into six categories; Excellent, Good, Fair, Poor, Very Poor, and Life Elapsed. The study examined data for years 1980 and 2000 and forecasted data for 2010. Figure 23 below is reproduced from their report and shows that the above mentioned survey average response of 8.4% of pipe are beyond their useful life would correspond well with the “Life Elapsed” category in Figure 23. It is very important to note the projected growth in the “Very Poor” condition category in Figure 23. The rate of growth in that category will make it much more difficult for utilities to get that pipe replaced before it reaches the “Life Elapsed” category. An AWWA study (AWWA, 2012) echoes this trend as illustrated in Table 6. Table 6 shows aggregate costs to cover both replacement and growth in water mains in the USA.

Figure 23. Assessment of pipe condition with time (from EPA, 2002).

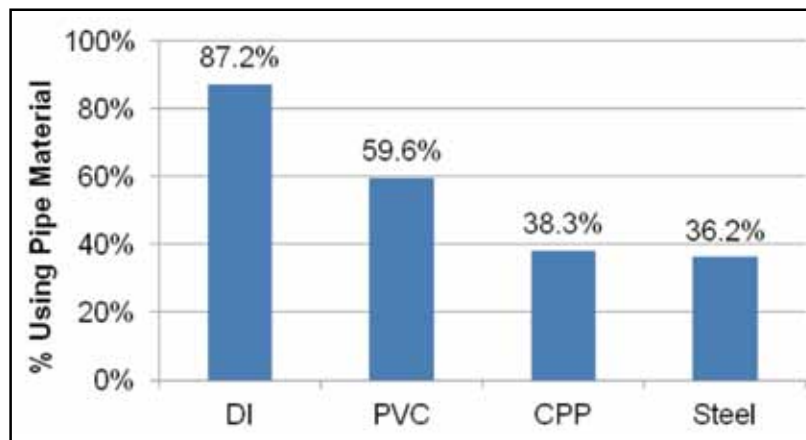
The detailed survey also asked what water main pipe materials are currently excluded from being installed at their utility. Figure 24 illustrates the percentage of respondents that allow a particular pipe material to be installed. The reasons used for excluding a pipe material were also requested in the survey. Table 7 summarizes the most common comments made for exclusion of a pipe material.

**Figure 24. Percent of respondents that will allow installation of these water main pipe materials.**

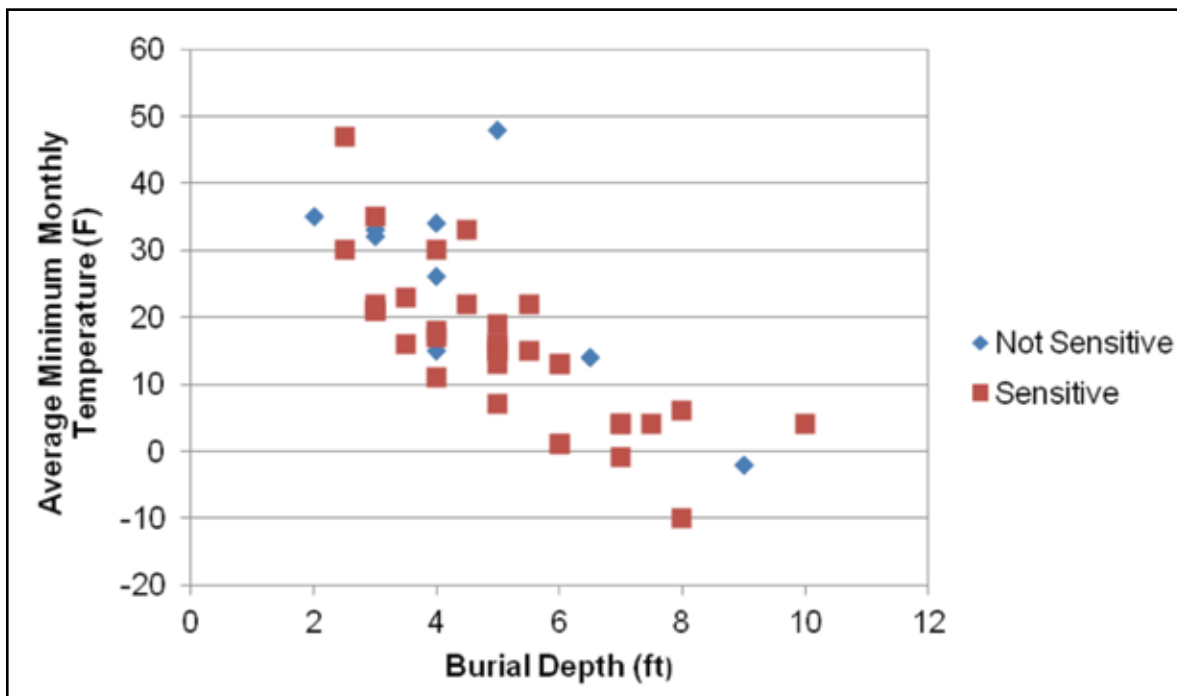
Figure 25 plots the lowest average minimum monthly temperature during the year for each respondent versus their reported average burial depth. The utilities with the blue symbols indicated they are not sensitive to cold ambient temperatures and the red colored symbols are sensitive. It was thought that with sufficient burial depth, the low temperature sensitivity might be reduced, but the data in Figure 25 does not support that conjecture.

**Figure 25. Correlation of the lowest average minimum monthly temperature during the year and burial depth. Red symbols note locations where failures increase with low ambient temperatures.**

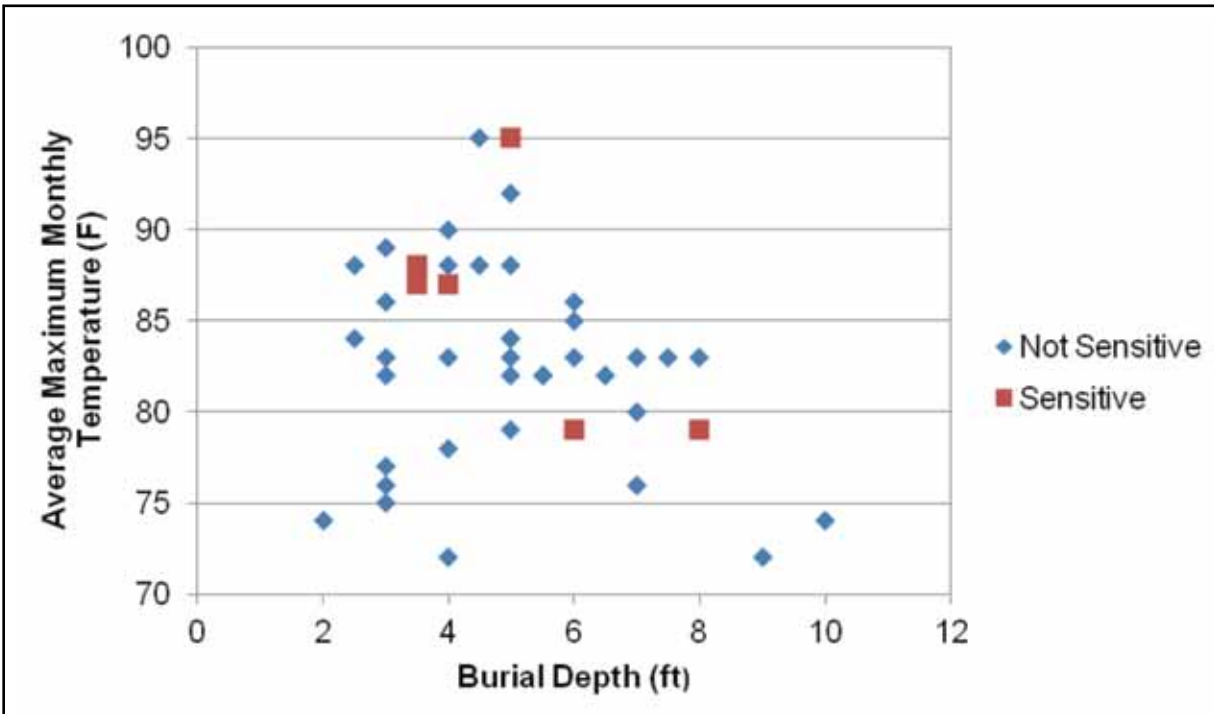
Figure 26 plots the highest average maximum monthly temperature during the year for each respondent versus their reported average burial depth. Again, the color of the symbol indicates whether that utility reported to be sensitive to high ambient temperatures. Again, no correlation was observed.

**Figure 26. Correlation of the highest average maximum monthly temperature during the year and burial depth. Red symbols note locations where failures increase with high ambient temperatures.**
