Water Main Break Rates In the USA and Canada: A Comprehensive Study

An Asset Management Planning Tool for Water Utilities

Utah State University
Buried Structures Laboratory
Steven Folkman, Ph.D., P.E.

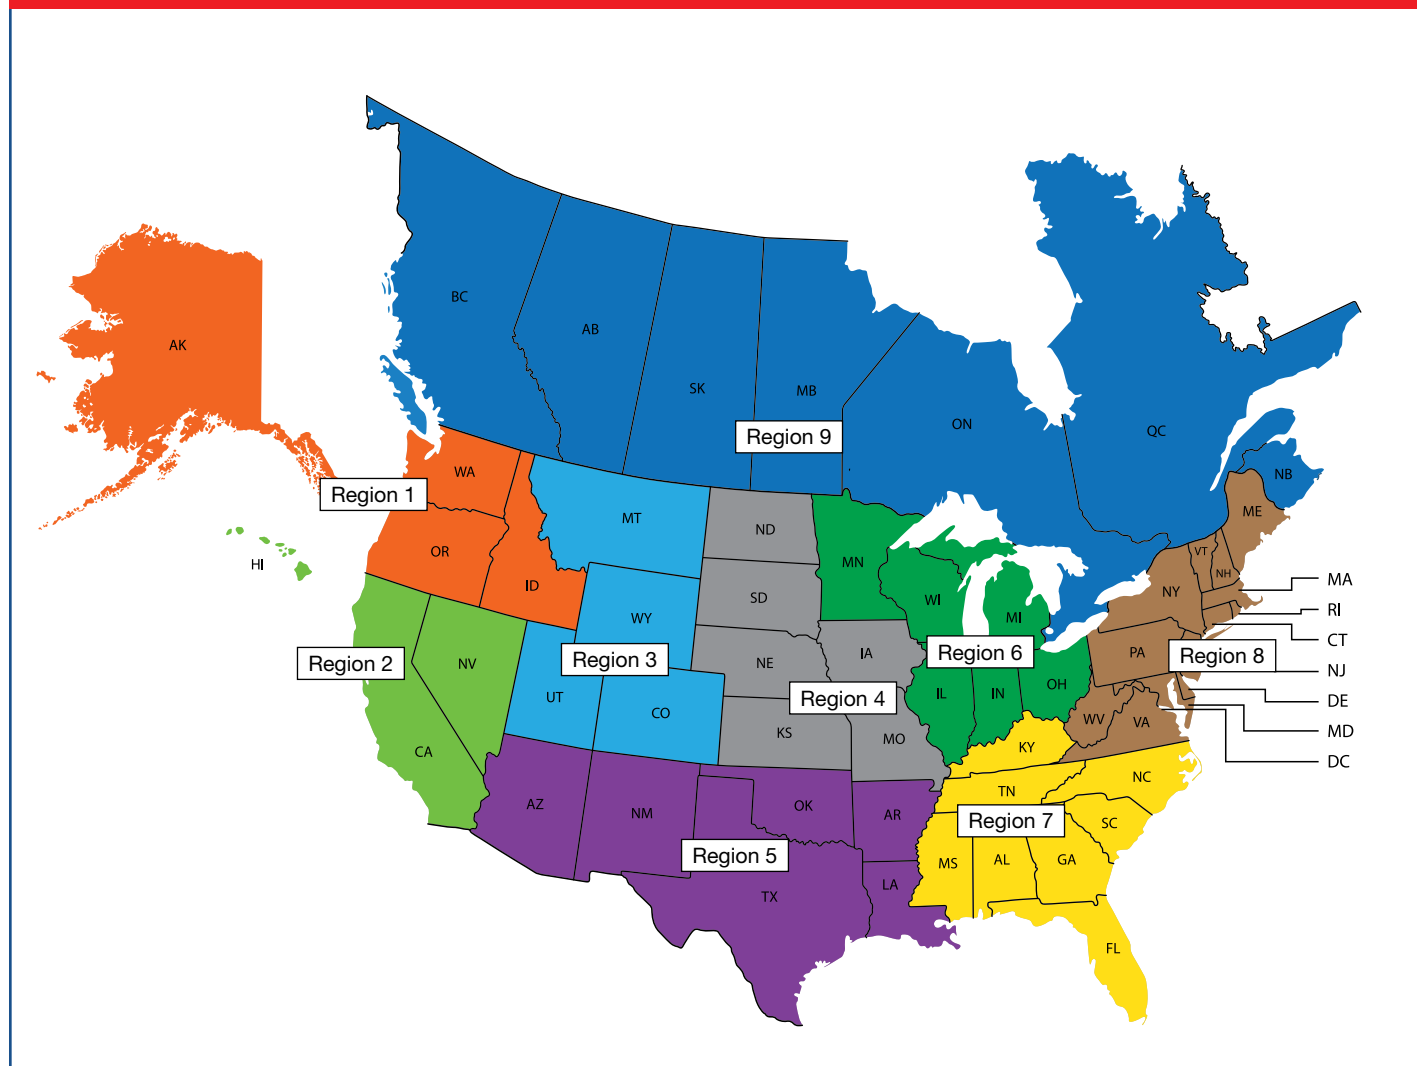
FIGURE 1: REGIONS USED TO REPORT SURVEY RESULTS

In total, 281 utilities participated in the surveys and provided failure data. To examine regional variations, nine survey regions in the United States and Canada were selected. The regions defined in the study are used here to indicate the wide geographical distribution of the respondents. Table 1 lists the number of respondents with failure data, the miles of pipe, and the population served in the basic and detailed surveys from each region. Figure 1 illustrates the locations of the nine different regions used in this report. Respondents were asked to report the length of water supply mains in their system but not to include sewer or force mains or lines with a diameter less than 3 inches. Figure 2 illustrates the miles of water main pipe that were reported in the basic and detailed surveys on a regional basis. A total of 170,569 miles and 98,097 miles of pipe was reported by respondents in the basic and detailed surveys, respectively. Figure 3 illustrates the number of respondents from each region. There were 26 additional respondents to the basic survey that could not provide failure data and these are not included in the miles of pipe or populations served in Table 1. The respondents are distributed across a large survey area. The basic survey

Figure 5 shows the average population served per utility for each region in Figure 1. The average population served per utility for the entire basic survey was 186,752.

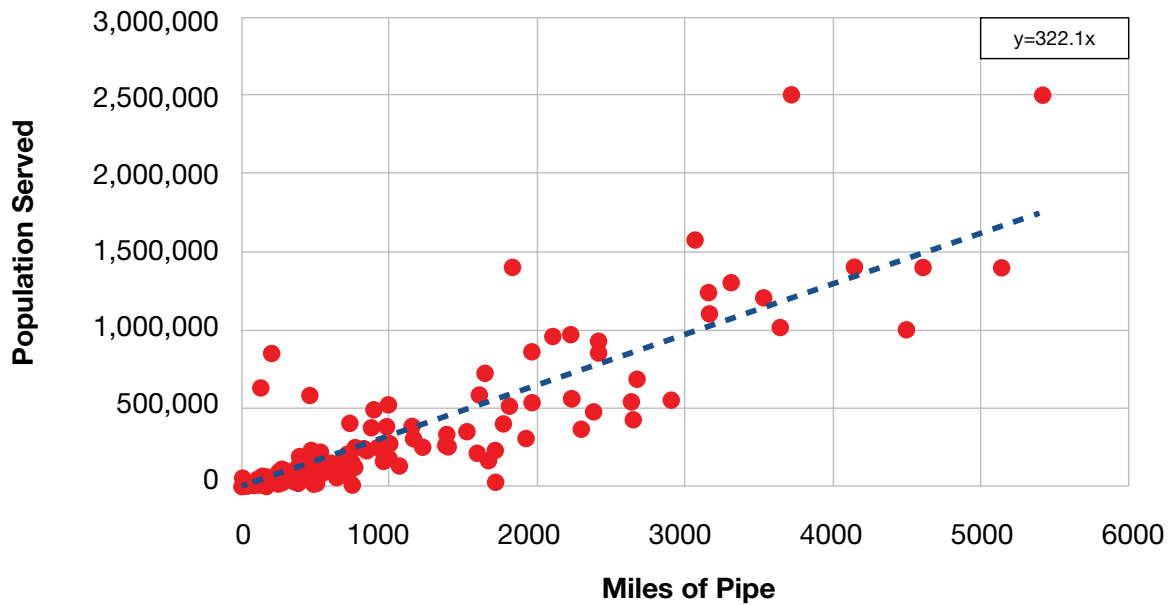
FIGURE 7: POPULATION SERVED RELATIVE TO TOTAL MILES OF PIPE FROM THE BASIC SURVEY

Figure 7 illustrates the relationship between the population served by the utilities participating in the basic survey and the number of miles of water main pipe. The trend line and equation are a best fit to the data. The slope of this line indicates that there are on average 322 people served for each mile of water main installed. Figure 7 tends to be biased by the points most distant from the origin. Figure 8 utilizes the data in Table 1 to compute average population served per mile of pipe for each region. We see that this produces an overall average of 308 people served per mile. More rural areas such as Regions 3, 4, and 5 have lower population to miles of pipe ratios as expected. Utilities that were exclusively transmission systems were excluded. This compares with a commonly used estimate of 325 people per mile (Eidinger, 2001). The 2012 survey reported this value as 264 people served per mile. Pipe breaks in utilities with a higher count of people per mile would have a greater impact on the community.

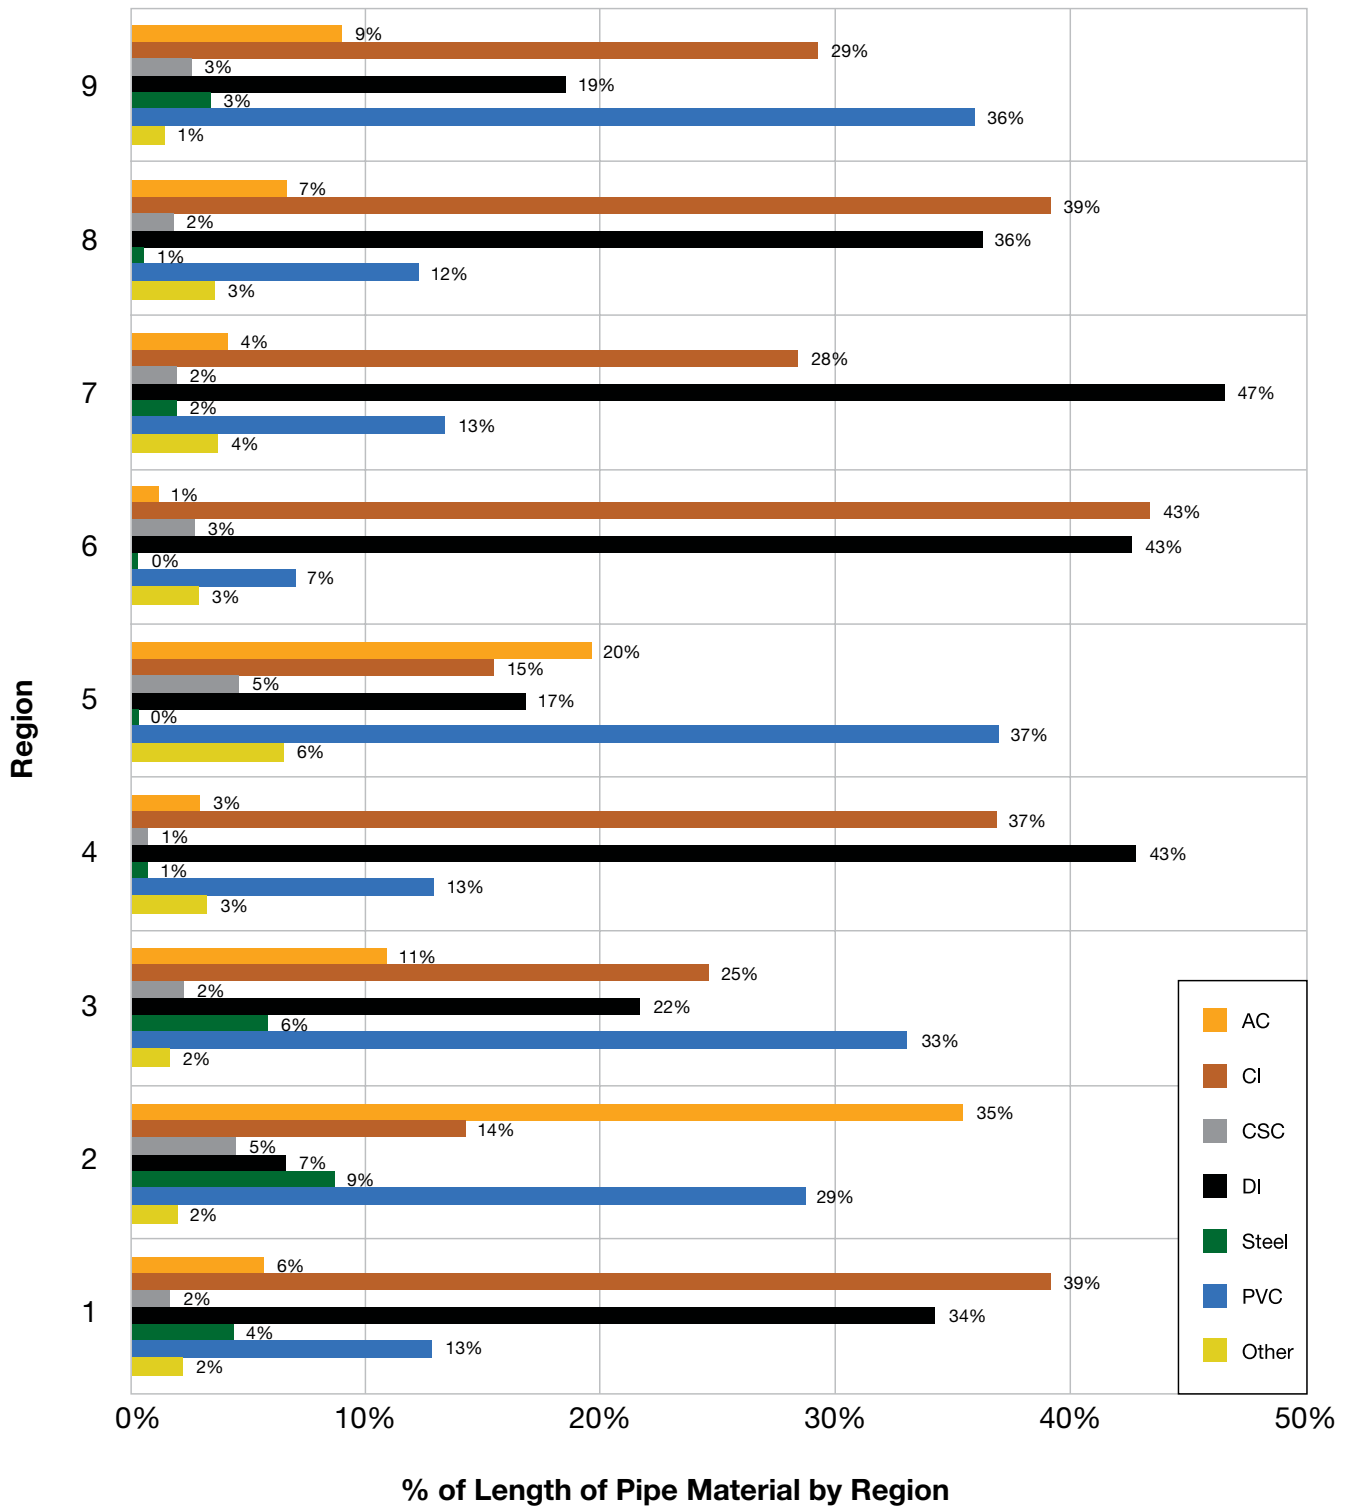
FIGURE 11: REGIONAL PERCENTAGE OF LENGTH OF PIPE BY MATERIAL TYPE (BASIC SURVEY)

Figure 11 illustrates the regional distribution of pipe material usage as a percentage of the total length in that region. It is interesting to note the significant differences in regional pipe material utilization. Cast iron (CI) and ductile iron (DI) pipe represent approximately 86% of the water mains in Region 6 and over 75% in Regions 4, 7, and 8. PVC has a leading role in Regions 3, 5 and 9 and is slightly behind asbestos cement (AC) pipe in Region 2. AC pipe has a significant presence in Regions 2 and 5. Region 2 is unique in that it is the only region where AC pipe is the most common material. This suggests that the selection and use of pipe materials are based on historical preference versus comparative cost analysis or environmental conditions. Since CI and AC pipes are no longer manufactured in the US and Canada, the use of these materials in water systems should be decreasing with time as they are replaced. By applying asset management best practices, life cycle cost analysis should be used to do a comparative total cost of ownership evaluation of what pipe material should replace the CI and AC pipes.

Water main pipe material usage varies significantly over geographic regions (see Figure 11). This suggests that the selection and use of pipe materials are based on historical preference versus comparative cost analysis or environmental conditions. The upper northwest and eastern half of the USA (Regions 1, 4, 6, 7, and 8 as illustrated in Figure 1) have either cast iron or ductile iron pipe for much of the installed pipe length. Regions 3, 5, and 9 have more PVC pipe than any other material. The most common pipe material in Region 2 is asbestos cement and it is unique in that respect.

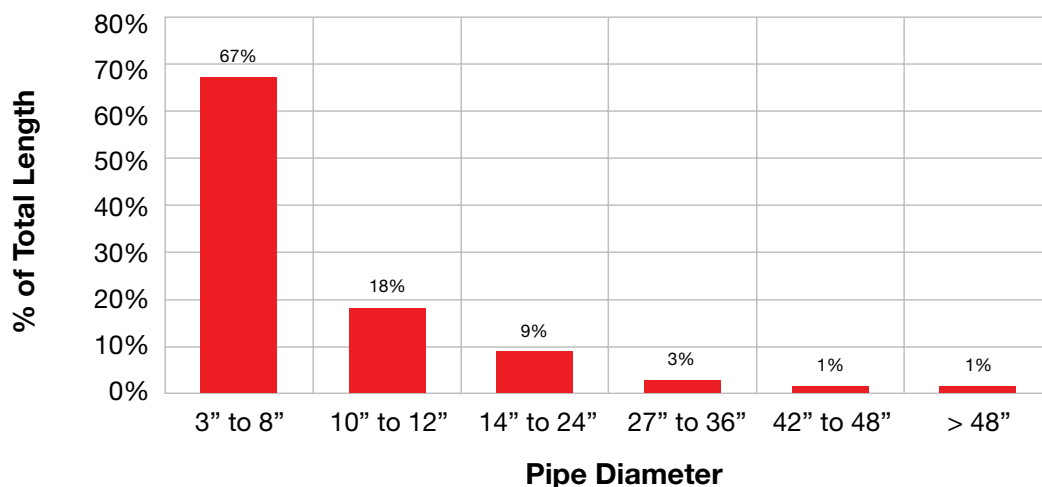
FIGURE 15: PERCENT OF TOTAL LENGTH OF PIPE BY SIZE FROM THE DETAILED SURVEY

The detailed survey respondents were also asked to break down the fraction of total installed pipe length by six pipe diameter categories. Figure 15 illustrates the percentage of water main that fit into each size range. Figure 15 indicates that approximately 67% of the installed pipe is 8 inches or less in diameter. The 2012 survey found that 66% of the pipe was 8 inches or less in diameter showing good agreement. Earlier studies assumed 73% of water pipes were 10 inches or less in diameter (Stone et al., 2002). Figure 16 illustrates the diameter distribution for each material type. Figure 16 shows that large diameter transmission pipes are dominated by steel and concrete pipe materials with 18% of all concrete pipe and 14% of all steel pipe having a diameter greater than 48-inches. Figure 17 illustrates the percent of total length of all pipe materials broken down by material type and diameter. Figure 17 illustrates that cast iron pipe from 3 to 8 inches in diameter represents over 19% of the installed pipe.

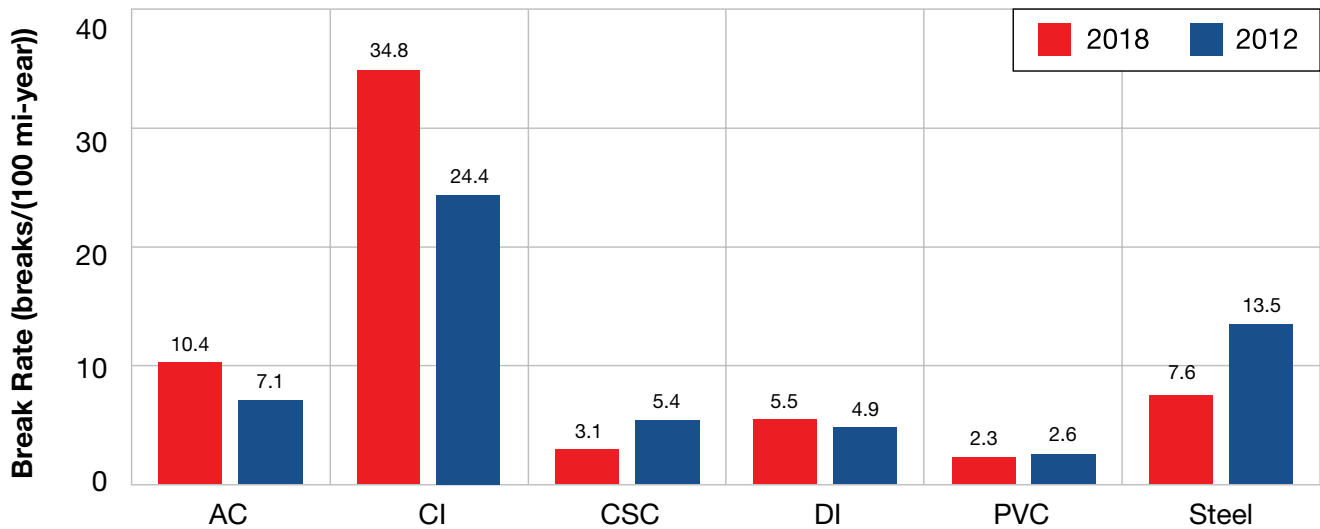
FIGURE 22: COMPARISON OF BREAK RATES OF THE 2018 AND 2012 SURVEYS

Figure 22 compares the break rates of the 2012 and 2018 surveys. Since over 90% of installed pipe consists of AC, CI, DI, and PVC, the break rates for those material types will be most accurate. From 2012 to 2018, Figure 22 shows a small decrease in break rates for PVC and a small increase for DI pipe. The overall consistency of those values demonstrates they are accurate. Again, the increase in break rates for AC and CI pipes is a very significant observation.

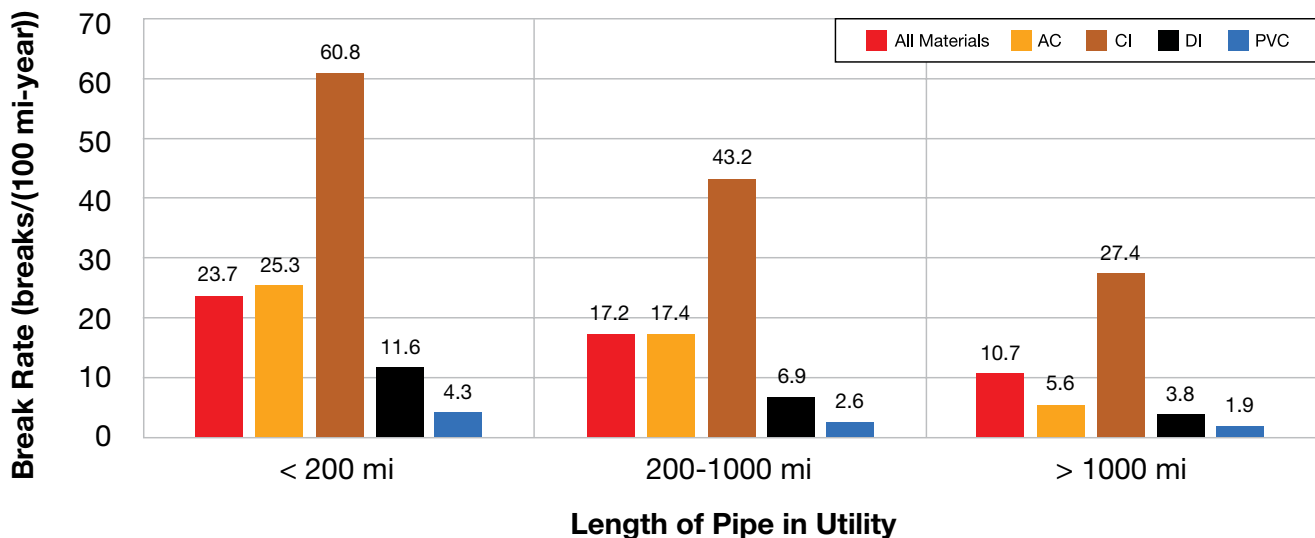
FIGURE 23: BREAK RATES BY UTILITY SIZE FROM THE BASIC SURVEY

The size of a utility can affect break rates. Three sizes of utilities are considered here based on the length of pipe; small with less than 200 miles, intermediate with 200 to 1000 miles, and large with over 1000 miles. Figure 23 illustrates the overall break rate (for all pipe materials) and then separated by the four most common pipe materials in these three utility sizes. The large utilities consistently had lower break rates than intermediate and smaller utilities. This is likely due to better funding and larger staffs for engineering design, monitoring and information gathering, installation oversight, and repair of water mains. It is very significant that small utilities consistently have break rates at least double that of a large utility.

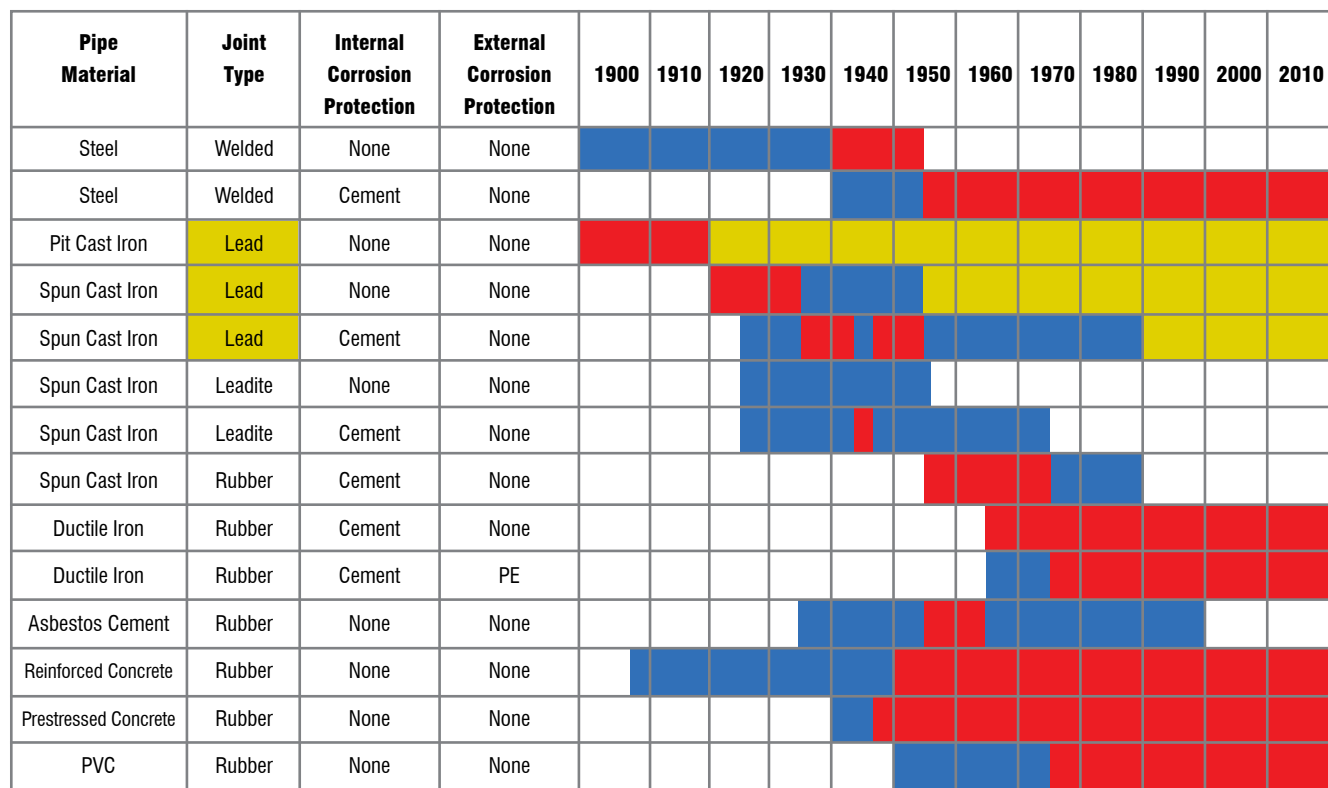
FIGURE 29: TIMELINE OF PIPE TECHNOLOGY IN THE US IN THE 20TH CENTURY

As mentioned in section 3.0, the survey did not track the many subclasses of pipe that have been installed because many utilities do not have that information. Individual utilities should try to add to their database as much as they can about what is referred to as a pipe cohort and other details about their installation. Copeland, et al. (2015) provides a good example of data to record. A pipe cohort is a group of pipes with similar characteristics. This concept is useful in pipe management because defining different pipe cohorts can be helpful in identifying pipes that have different risk characteristics (see Figure 29).

- Pipe Material Availability
- Periods of Active Installation and Widespread Use
- Extended Potential Lead Joint Leaching Periods in Iron Pipes

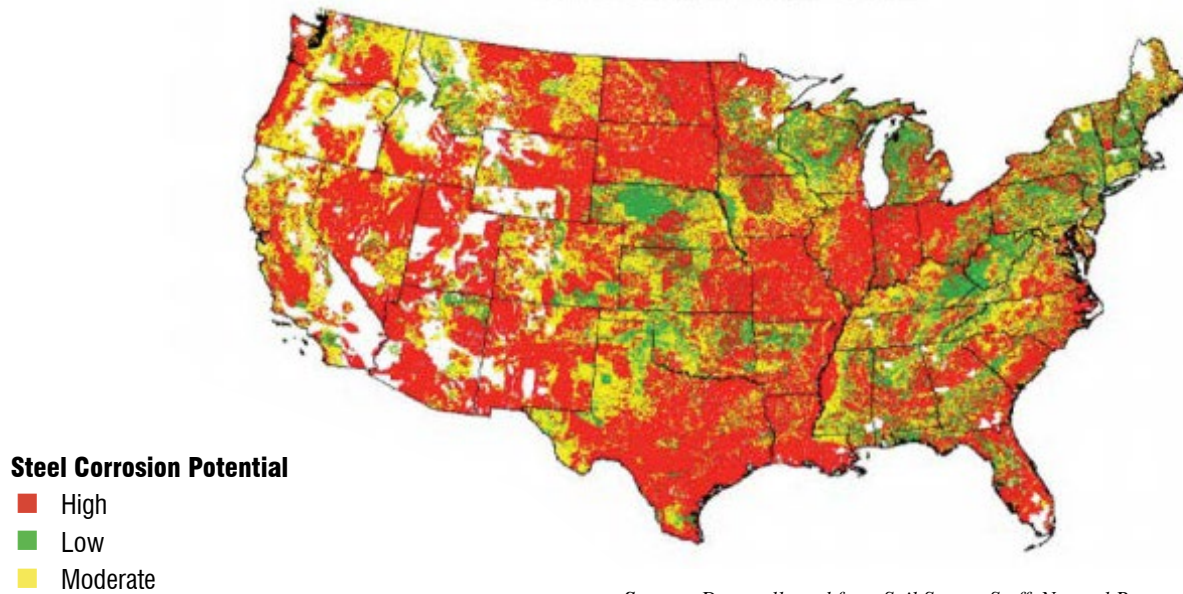
FIGURE 30: US CORROSIVE SOILS MAP (CONUS POTENTIAL FOR STEEL CORROSION)

Source: Data collected from Soil Survey Staff, Natural Resources Conservation Service, U.S. Department of Agriculture Soil Survey Geographic Database.

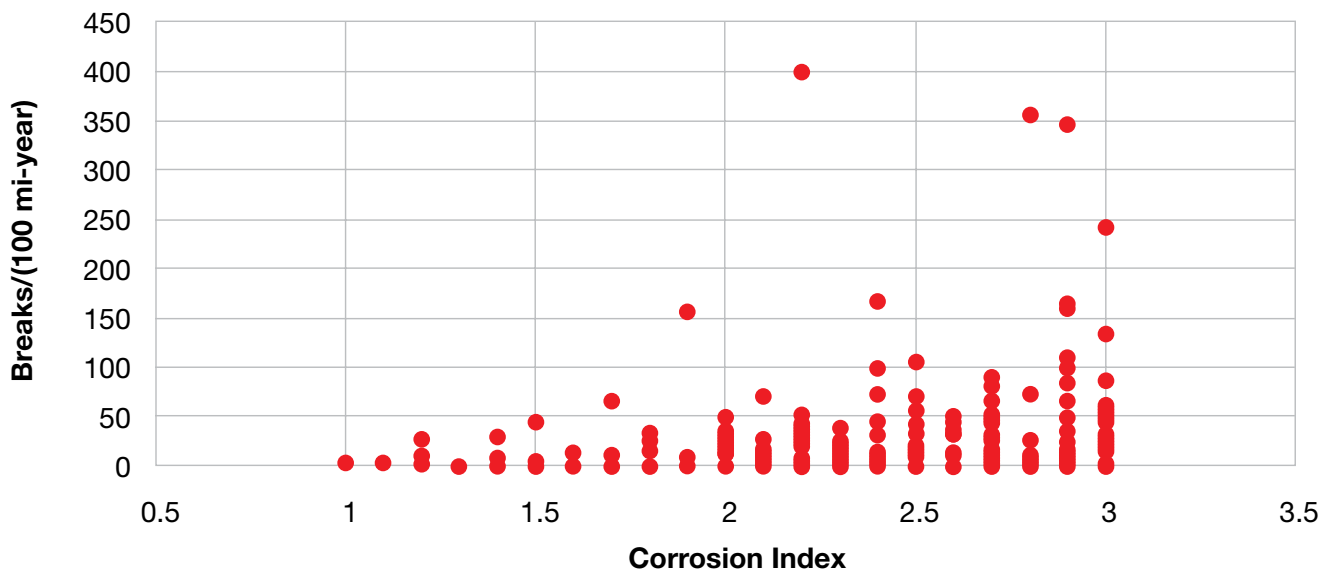
FIGURE 33: INDIVIDUAL UTILITY BREAK RATES FOR CAST IRON PIPE VERSUS THEIR CORROSION INDEX

It is reasonable to expect break rates would increase when pipe is installed in corrosive soils. To examine this, plots were made of a utility's corrosion index versus break rate. Figure 33 illustrates this for cast iron pipe. There is a trend of higher break rates with increasing corrosion index, but the wide scatter in the data makes analysis difficult. The high break rates in Figure 33 are associated with small utilities that have a small amount of pipe. Consider a utility with 1 mile of cast iron pipe with 2 breaks during the past year. That would translate to a break rate of 200 breaks/(100 miles)/year. If that utility had no breaks the following year, the break rates drop to zero.

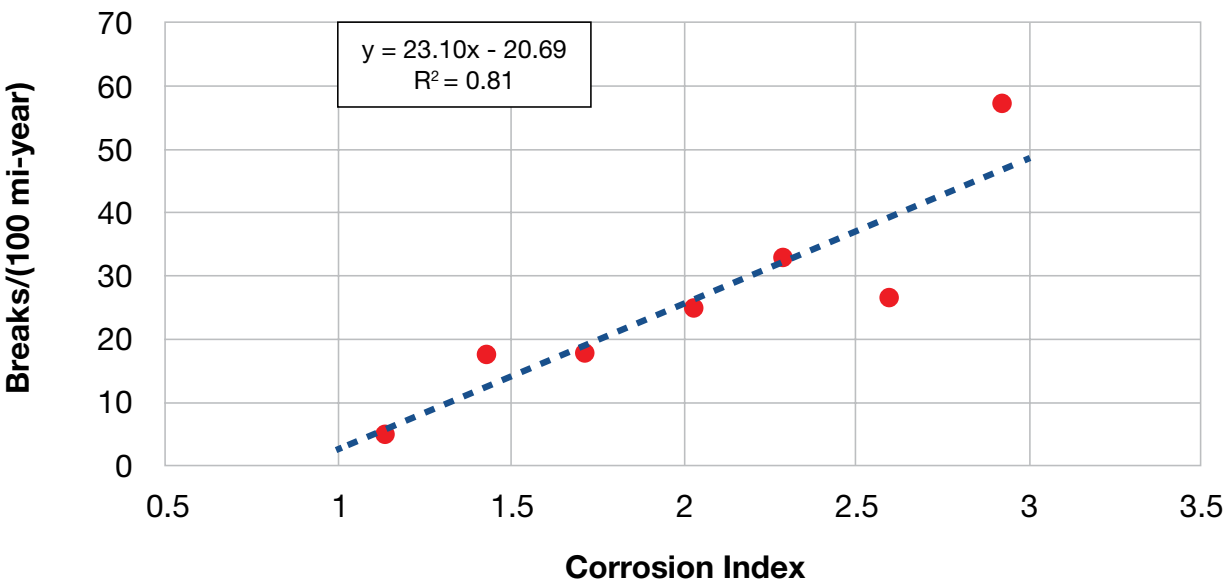
FIGURE 34: CAST IRON PIPE BREAK RATE VERSUS CORROSION INDEX

To get a realistic estimate of break rates, we need to add the number of breaks of a pipe type from several utilities and divide by the sum of the length of that pipe type to compute break rates. The corrosion index data was broken down into the same seven categories used in Figure 32. The results are listed in Table 7. The break rates versus corrosion index data are plotted in Figure 34 for cast iron pipe and Figure 35 for ductile iron pipe. The figures also contain a regression equation fit and a correlation coefficient. Correlation coefficients close to 1.0 indicates an excellent correlation and zero indicate no correlation. Both cast and ductile iron results in reasonably good fits to the data.

Using the equations in Figure 34 with $x=1$ for a low corrosion risk and $x=3$ for a high corrosion risk, one can show that a cast iron pipe in a high corrosion soil is expected to have over 20 times the break rate of one in a low corrosion soil. Similarly, ductile iron pipe in a high corrosion soil has over 10 times the break rate than one in a low corrosion soil. Very poor correlations were found for the other material types in this survey.

Analyses of soil corrosivity completed in this study shows that a cast iron (CI) pipe in highly corrosive soil is expected to have over 20 times the break rate of a CI pipe in low corrosive soil. Traditionally, the thickness of the iron pipe wall provided the additional corrosion protection. CI pipes manufactured after World War II have significantly higher failure rates due to thinner walls. The resulting higher main

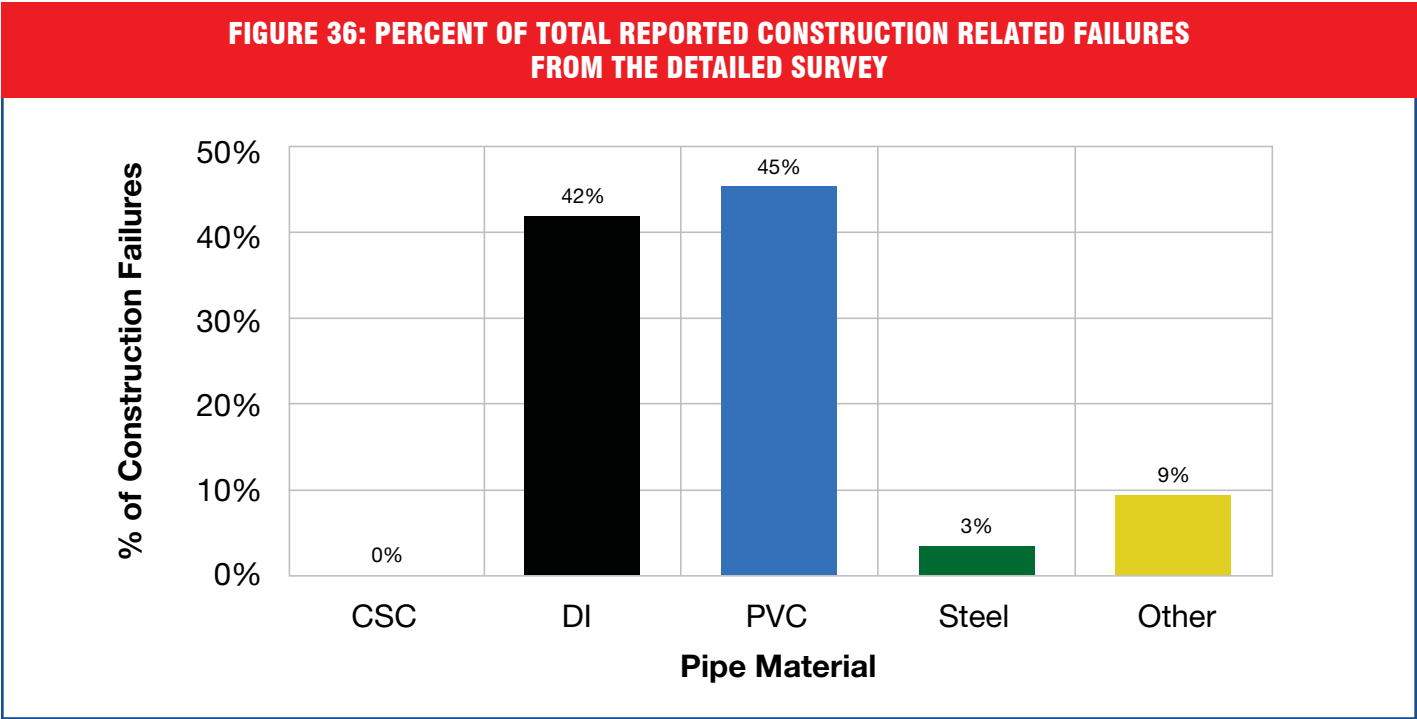
The detailed survey asked respondents to report failures related to construction activities. Figure 36 illustrates the percentage of total construction failure related to a particular pipe material. Ductile iron and PVC pipes have the majority of construction related failures at a nearly equal frequency. Figure 14 shows that DI and PVC are the two pipe materials that are also most commonly being installed today. This points to the need to improve construction practices for underground infrastructure regarding installation, location services and inspection.

The detailed survey asked utilities to report the number of failures related to construction activities and identify the pipe material that failed. The vast majority of construction related failures involved either ductile iron (DI) or PVC pipe and the number of failures for each material was essentially identical. Therefore, DI and PVC pipe have an equivalent rate of construction related failures. This points to the need to improve construction practices for underground infrastructure regarding installation, location services and inspection.

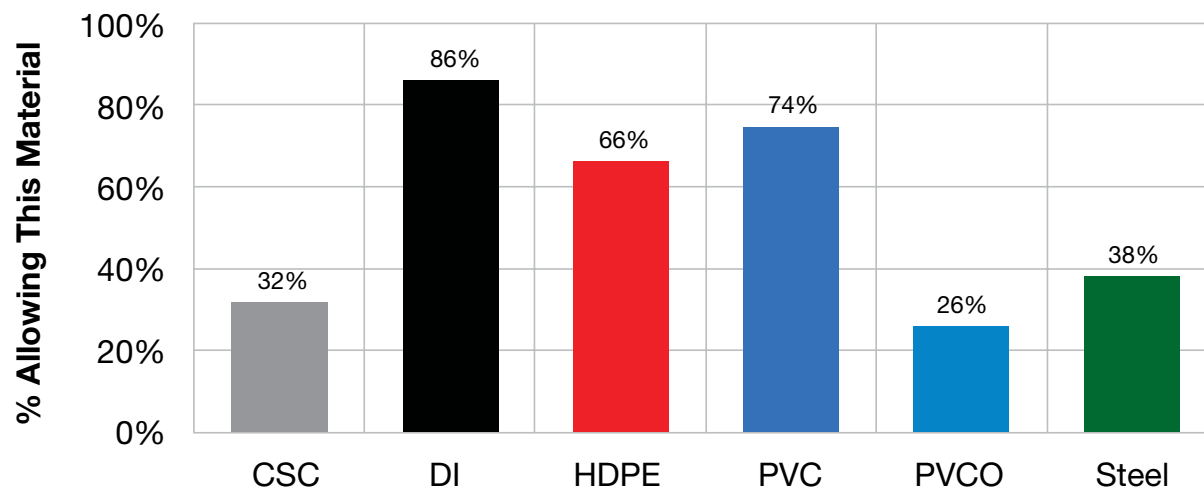
FIGURE 39: RESPONDENTS ALLOWING INSTALLATION OF THESE WATER MAIN MATERIALS

The detailed survey also asked respondents what water main pipe materials are currently approved for use at their utility. Figure 39 illustrates the percentage of respondents that allow a particular pipe material to be installed. HDPE pipe at 66% allowance for use in water systems represents a high degree of acceptance for trenchless applications such as pipe bursting and directional drilling, whereas for open cut installations PVC and ductile iron pipe are the predominantly accepted materials (see Table 10). Figure 40 compares the pipe materials approved for use by utilities in the 2018 survey with the data obtained in the 2012 survey. Figure 40 shows a 23% increase in the acceptance of PVC water pipe by North American utilities since 2012. Specifically, PVC pipe approval among survey respondents increased from 60% of water utilities allowing its use in 2012 to 74% of utilities allowing its use in 2018. The number of utilities approving of ductile iron, concrete steel cylinder, and steel pipes for use in water systems remains essentially the same.
