Louisville Water Company The PVC Pipe Experience

by Bret Russell
Planning Engineer
Louisville Water Company

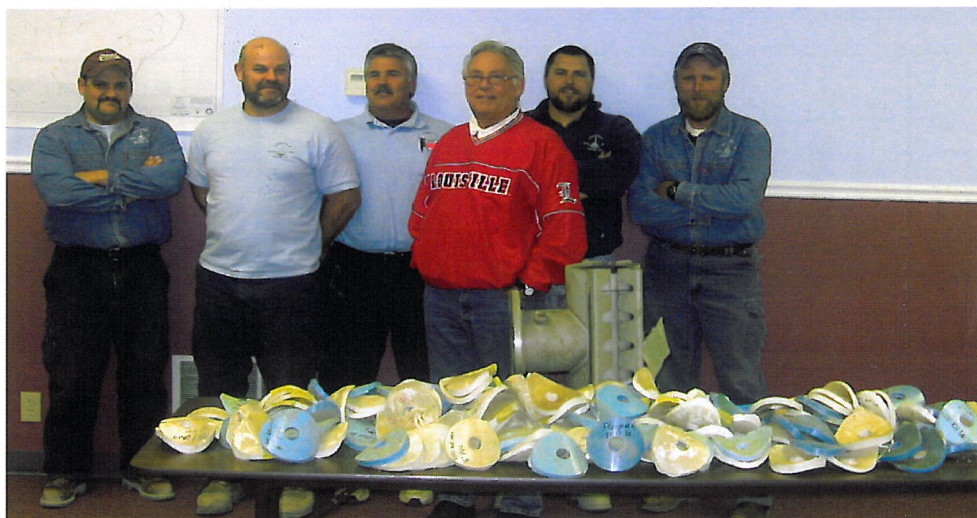
Figure 8. PVC coupons from tapping in tees for installing fire hydrants.

In 2000, LWC acquired an existing water district in neighboring Bullitt County. This water system has extensive installations of PVC SDR 21 pipe over the last 30 years. In order to bring the system up to a more urban design standard, approximately 360 fire hydrants have been installed using a tapping sleeve arrangement with 200 of those being tapped on the SDR21 PVC pipe. The photo in Figure 8 shows the field crew and the PVC coupons removed. The success rate for these large diameter taps was 99.5%. After more than 30 years of service, this is quite a testimonial for PVC.
