Louisville Water Company The PVC Pipe Experience

by **Bret Russell**
Planning Engineer
Louisville Water Company

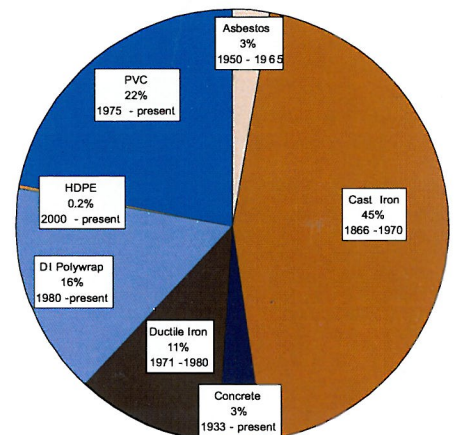
Figure 1. LWC Pipe Materials, 2005

Located in Louisville, Kentucky, LWC is supplied from the Ohio River and is a regional provider for 800,000 people through 285,000 service connections and 3,800 miles of pipe. LWC first began operation in 1860 and is now one of the largest water utilities (both in the miles of water mains and in number of customers served) in the US, delivering an average of 130 MGD of water and generating \$105 million in annual revenue. LWC's system is comprised of cast iron, PVC, ductile iron, concrete, asbestos cement, and HDPE piping materials. Figure 1 shows the percentage of each pipe material and the time period it was installed.

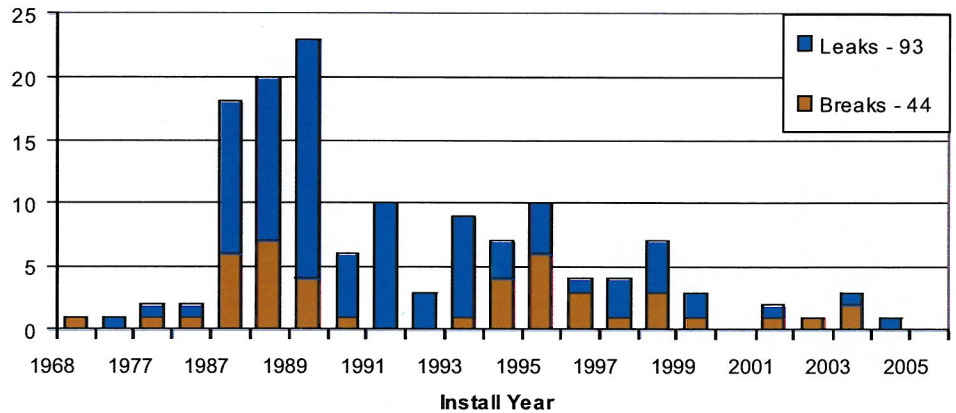
Figure 5. PVC Pipe Failures by Installation Year

A review of failures by installation years revealed a unique factor. Figure 5 depicts how early installation attempts have influenced the failures of PVC pipe, clearly indicating a reduction in recent years.

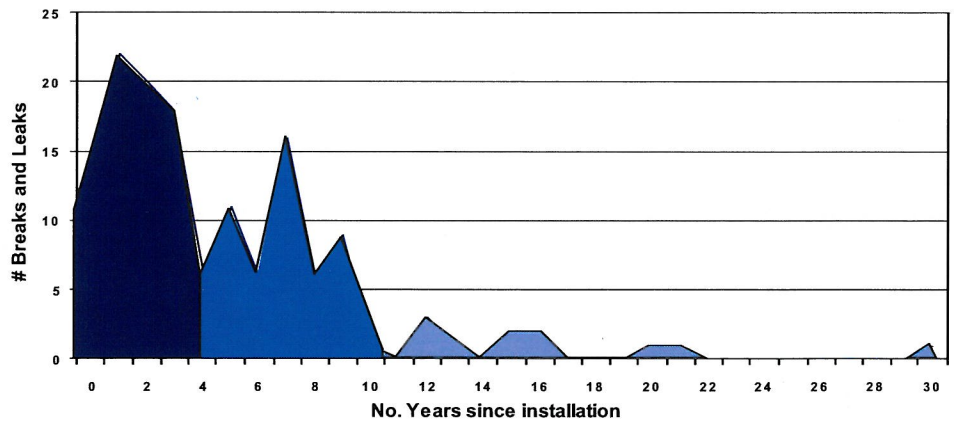
Figure 6. PVC Pipe Failures by Installation Year

Looking at the time of failure more closely, Figure 6 shows the break patterns based on age of pipe. Fifty percent (50%) of PVC breaks have occurred within the first three years of installation, indicating a connection with construction practices. Additionally, almost all remaining breaks occur within 10 years of installation, signifying there is no trend towards long-term failure problems.

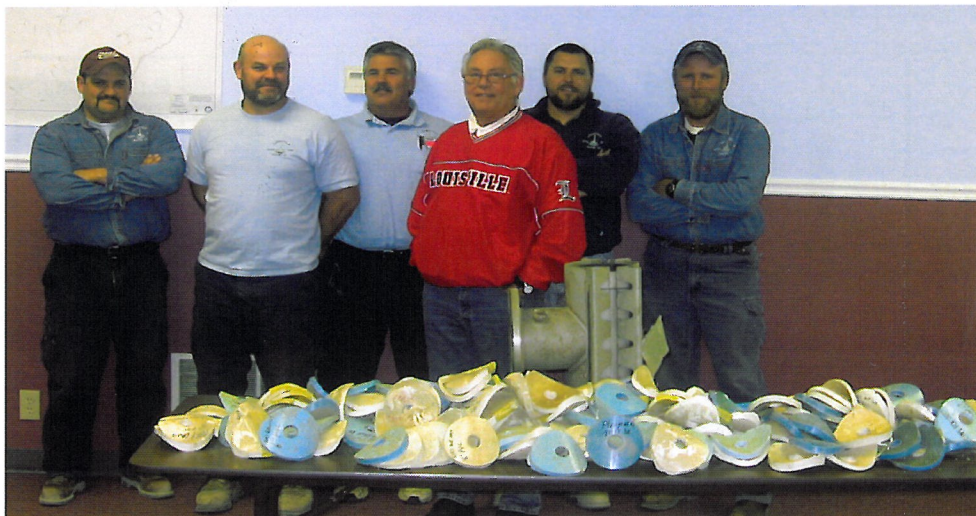
Figure 8. PVC coupons from tapping in tees for installing fire hydrants.

In 2000, LWC acquired an existing water district in neighboring Bullitt County. This water system has extensive installations of PVC SDR 21 pipe over the last 30 years. In order to bring the system up to a more urban design standard, approximately 360 fire hydrants have been installed using a tapping sleeve arrangement with 200 of those being tapped on the SDR21 PVC pipe. The photo in Figure 8 shows the field crew and the PVC coupons removed. The success rate for these large diameter taps was 99.5%. After more than 30 years of service, this is quite a testimonial for PVC.
