# PVC PIPE *news*

SPRING 2008 • Volume 31 • Number 1

## THE EDMONTON STORY

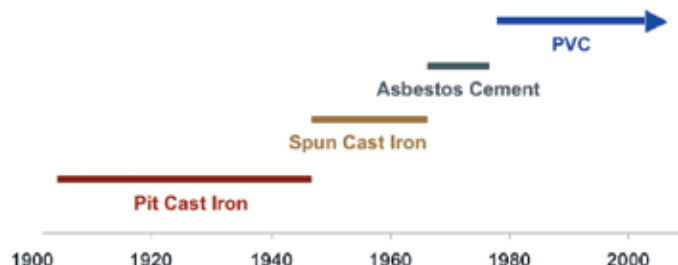
Figure 3, Pipe Material Timeline

### Timeline of the Evolution of Edmonton's Preferred Water Pipe Material

As Edmonton grew, and as other pipe materials and manufacturing processes became available, the utility's preferred pipe material changed. Figure 3 tracks that preference over time.

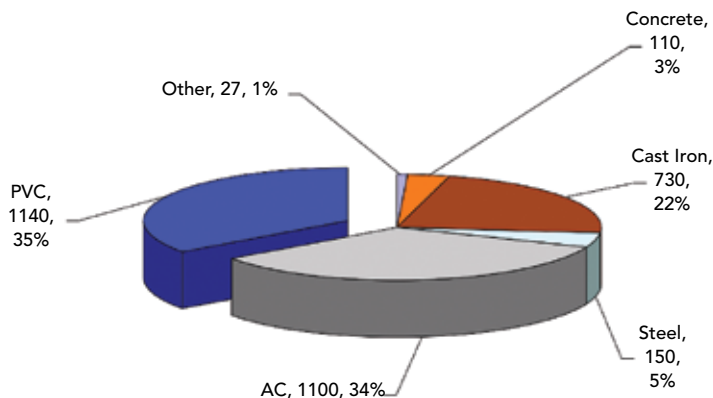
Figure 6, Pipe Materials Used In Edmonton's Water System

### Edmonton's Pipe Materials (km and percent)

**PVC:** The switch to PVC manufactured to AWWA C900 occurred in 1977. Corrosion potential was a key factor considered throughout the decision making process. Figure 4 shows why. The break rates of the cast iron pipe kept increasing during the late 1960's through the 1970's, peaking in 1985. Figure 5 has two photos demonstrating the effects of Edmonton's corrosive soils on the unprotected iron pipe. PVC continues to be the preferred pipe material in Edmonton to this day. At the end of 2006, Edmonton's inventory of buried water pipe totaled 3,250 km (2,023 miles). The net effect of pipe preferences and an aggressive main replacement program commencing in 1986 is shown in Figure 6, which breaks down the inventory of buried pipe by material.

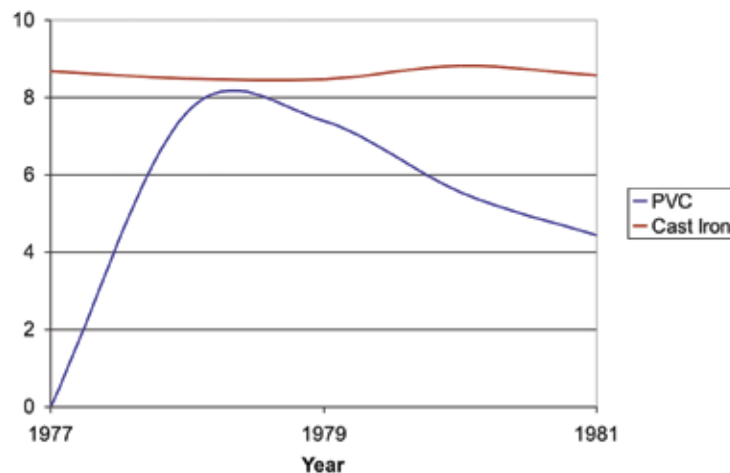
Figure 8, Cumulative Average Water Main Break Rates per 100 km

*Historical data for the period from 1952 to 1965 for the cast iron portion of the water system.*

*Length Increased from 650 km to 1,220 km*

*Breaks Increased from 50/yr to 500/yr*

If Figure 7 were the only figure presented, one may come away with the impression that implementing the switch to PVC was problem-free. EPCOR did experience a few minor bumps at the outset. In the first five years, it had a total of five breaks. However, with the small amount of PVC installed, that resulted in some worrisome initial trends. Refer to Figure 8 and Table 1.

Table 1, Data for Figure 8

Year	Cumulative Length of PVC Installed (km)	Breaks	Annual Breaks Per 100 km	Cumulative Avg. Breaks Per 100 km
1977	3.49	0	0.00	0.00
1978	13.14	2	15.22	7.61
1979	43.20	3	6.94	7.39
1980	59.90	0	0.00	5.54
1981	84.89	0	0.00	4.43
