PVC PIPE *news*

SPRING 2008 • Volume 31 • Number 1

THE EDMONTON STORY

BY CRAIG FISHER, P.E.

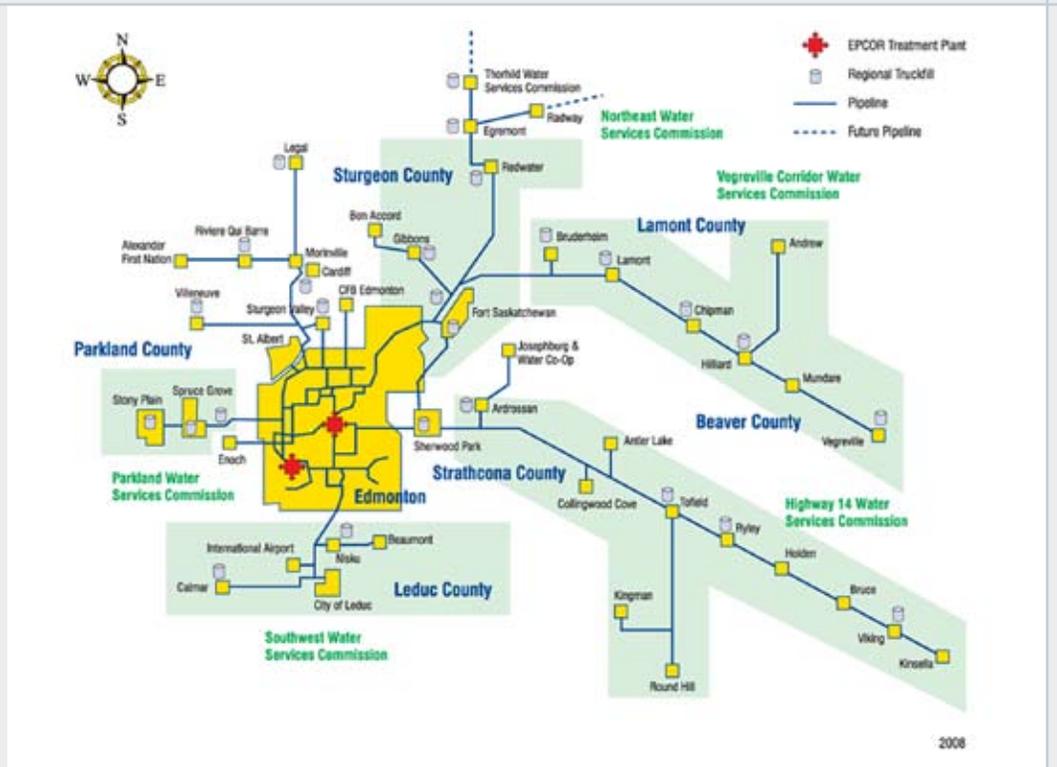
Figure 2, EPCOR Regional Map for Greater Edmonton

Epcor Water Services, Inc. (EPCOR) is the water utility that serves the one million people that live in Edmonton and 40 surrounding communities. Figure 2 maps the major components in the EPCOR water system.

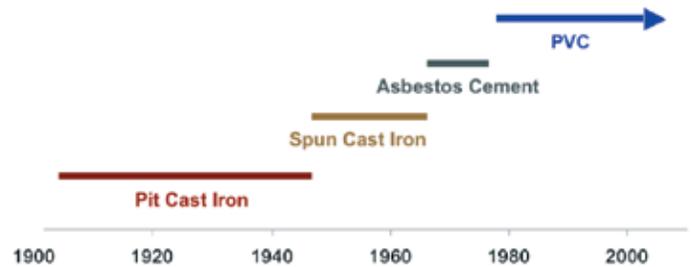
Figure 3, Pipe Material Timeline

As Edmonton grew, and as other pipe materials and manufacturing processes became available, the utility's preferred pipe material changed. Figure 3 tracks that preference over time.

Timeline of the Evolution of Edmonton's Preferred Water Pipe Material

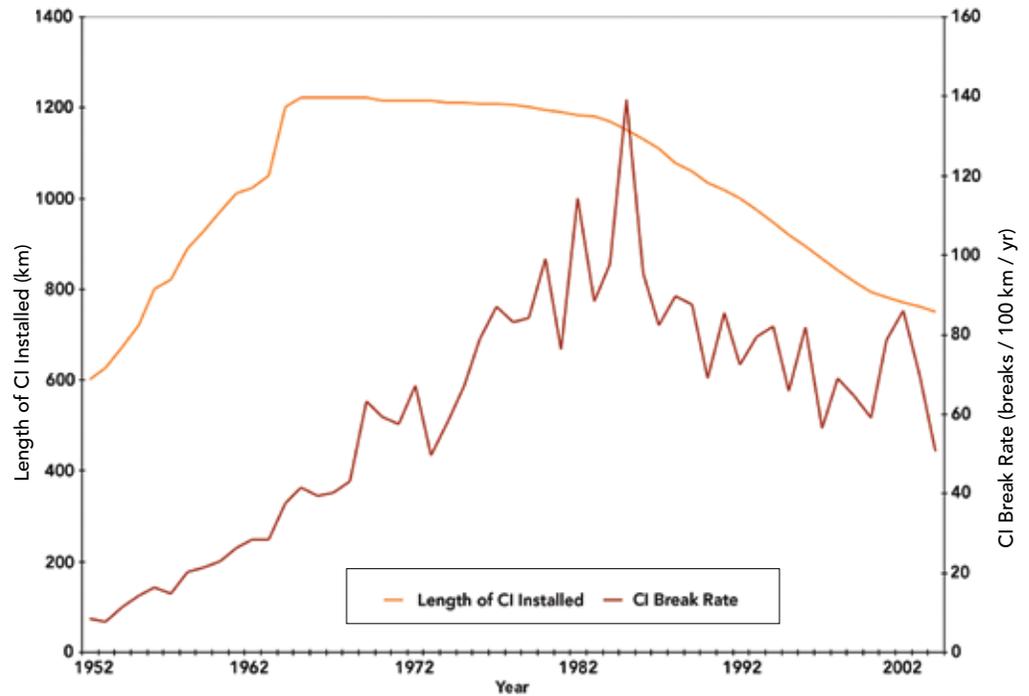
Figure 4, Cast Iron Pipe Performance

Edmonton's predominant soil type is clay with soil resistivities ranging from 400 to 10,000 Ohm-cm. These corrosive soils took their toll on the thinner walls of the spun cast iron pipe. As shown in Figure 4, the break rates of the cast iron pipe continued to climb throughout the 1950's and the early 1960's. Most of the breaks were occurring on the younger spun cast iron pipe.

PVC: The switch to PVC manufactured to AWWA C900 occurred in 1977. Corrosion potential was a key factor considered throughout the decision making process. Figure 4 shows why. The break rates of the cast iron pipe kept increasing during the late 1960's through the 1970's, peaking in 1985. Figure 5 has two photos demonstrating the effects of Edmonton's corrosive soils on the unprotected iron pipe. PVC continues to be the preferred pipe material in Edmonton to this day. At the end of 2006, Edmonton's inventory of buried water pipe totaled 3,250 km (2,023 miles). The net effect of pipe preferences and an aggressive main replacement program commencing in 1986 is shown in Figure 6, which breaks down the inventory of buried pipe by material.

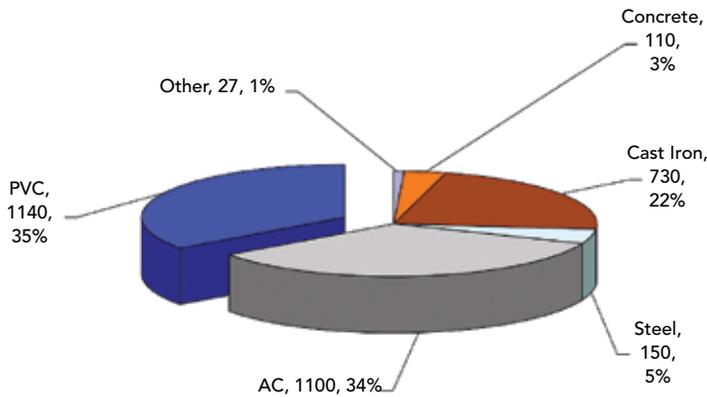
Figure 6, Pipe Materials Used In Edmonton's Water System

Edmonton's Pipe Materials (km and percent)

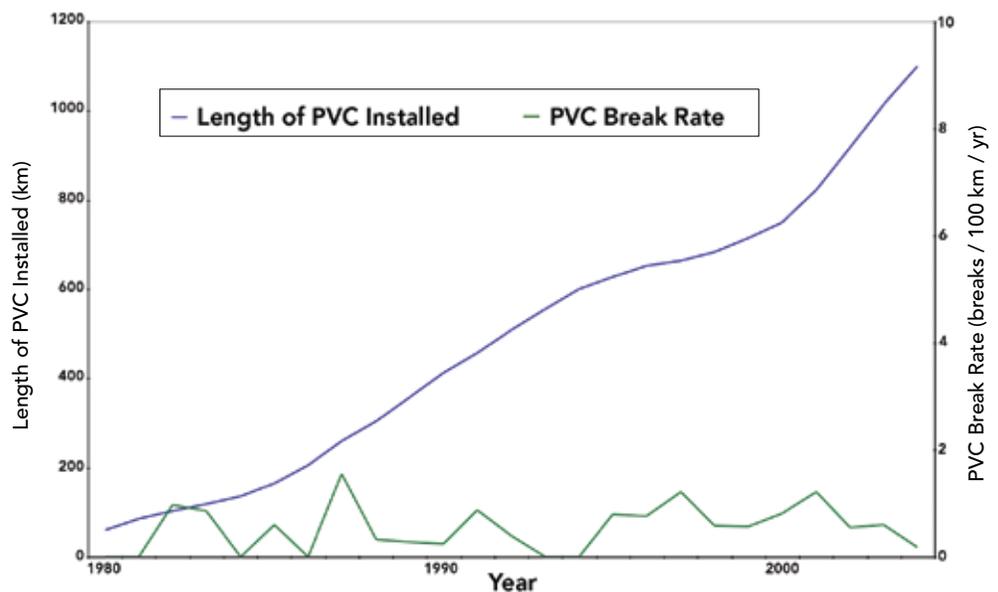
Figure 7, PVC Pipe Performance

(80°F), while winter temperatures can be as low as -40°C (-40°F). Raw water temperatures fluctuate between 0.5°C (33°F) and 20°C (68°F). Do frost heave, thermal stresses, and expansion and contraction issues wreak havoc with the PVC portion of the Edmonton water system? Figure 7 indicates that these climatic challenges have not impaired the PVC pipe's ability to deliver superior service. The PVC break rates are two orders of magnitude less than the iron pipe's. (The article, "Hard Data on Cold Weather," on page 8 gives details on PVC's performance in freezing conditions.)

Figure 7 also addresses all the other alternative explanations: design, installation, inspection, maintenance. If any of those issues were EPCOR's tragic

If Figure 7 were the only figure presented, one may come away with the impression that implementing the switch to PVC was problem-free. EPCOR did experience a few minor bumps at the outset. In the first five years, it had a total of five breaks. However, with the small amount of PVC installed, that resulted in some worrisome initial trends. Refer to Figure 8 and Table 1.

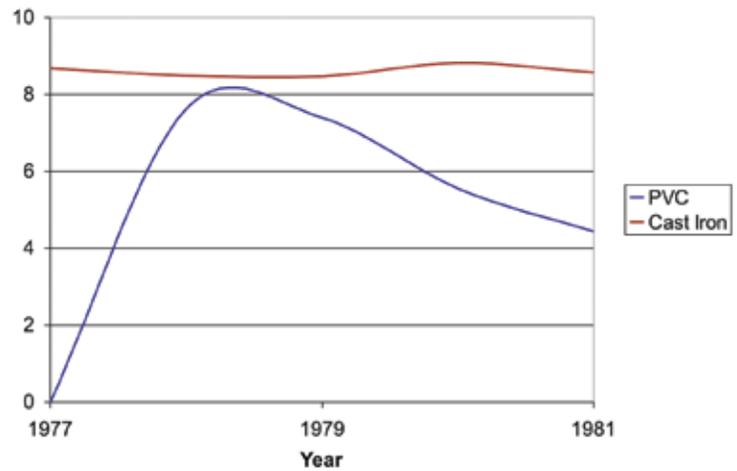
Figure 8, Cumulative Average Water Main Break Rates per 100 km

Table 1, Data for Figure 8

Year	Cumulative Length of PVC Installed (km)	Breaks	Annual Breaks Per 100 km	Cumulative Avg. Breaks Per 100 km
1977	3.49	0	0.00	0.00
1978	13.14	2	15.22	7.61
1979	43.20	3	6.94	7.39
1980	59.90	0	0.00	5.54
1981	84.89	0	0.00	4.43

EPCOR was convinced the product had merit and was determined to give it a fair test. In Doug's words, "You have to expect a few surprises when you are getting to know a new pipe material. Of course, you look at what caused the problem and address it." The downward trend of the cumulative average break rate from 1978 until this day demonstrates that EPCOR conviction of the pipe's potential was well founded.

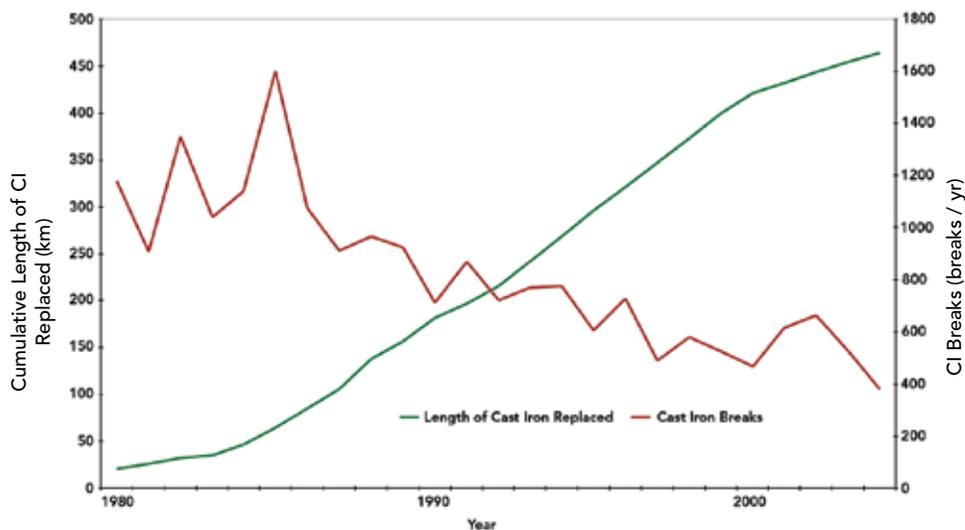
Figure 9, EPCOR's Main Replacement Program

While the break rates for PVC trended downward after 1978, the direction of the cast iron break rates did not. Instead of re-plotting the break-rate, Figure 9 shows the total number of cast iron pipe breaks per year (dark red line). As the number of breaks grew, the greater Edmonton community became more vocal with expressing its desire to have the problem fixed, and the City Council heard the message. Doug said "with 1600 breaks in 1985, the problem was approaching a crisis." As a result, City Council asked the water utility to come up with a plan. The response was a proposal to add a 13.5% surcharge on the water bill that would be dedicated to the replacement of cast iron water pipe. The plan was approved and the program began in 1986. Since the inception of the replacement program, EPCOR has replaced about a third of its cast iron pipe inventory. Breaks in the cast iron system have fallen to below a quarter of the peak experienced in 1985.
