## APRIL 2017

# LIFE CYCLE ASSESSMENT OF PVC WATER AND SEWER PIPE AND COMPARATIVE SUSTAINABILITY ANALYSIS OF PIPE MATERIALS

This study evaluates underground pipe infrastructure in the context of providing sustainable water and sewer service over a 100-year period: (1) with minimal risk of degrading water quality; (2) while reducing the costs of operations, maintenance and repair; and (3) by taking into consideration the variables which can influence pipe performance and service-level expectations. The report also provides relevant data which can assist utility officials with their asset management plans and life cycle cost assessments for different pipe materials.

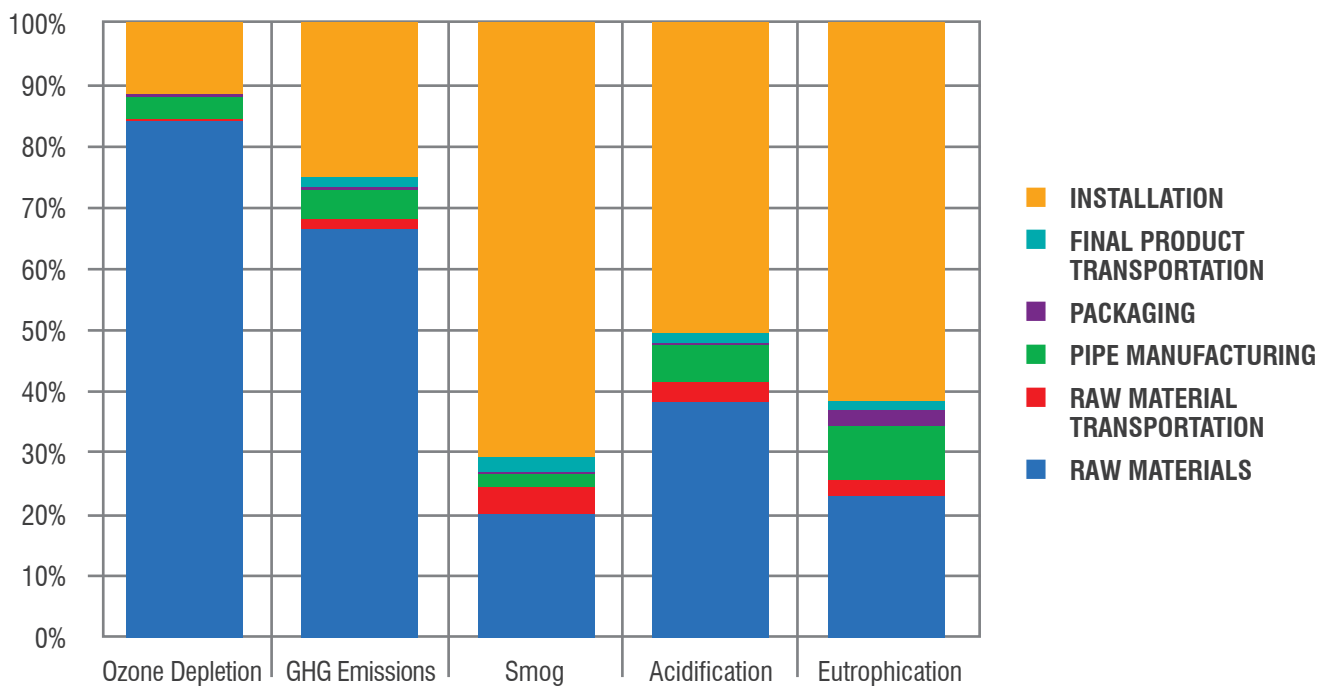
**FIGURE 4.3 : ENVIRONMENTAL IMPACTS OF 8" PVC DR25 PC165 C900 PRESSURE PIPE (TRACI IMPACT ASSESSMENT METHODOLOGY)**

- INSTALLATION
- FINAL PRODUCT TRANSPORTATION
- PACKAGING
- PIPE MANUFACTURING
- RAW MATERIAL TRANSPORTATION
- RAW MATERIALS

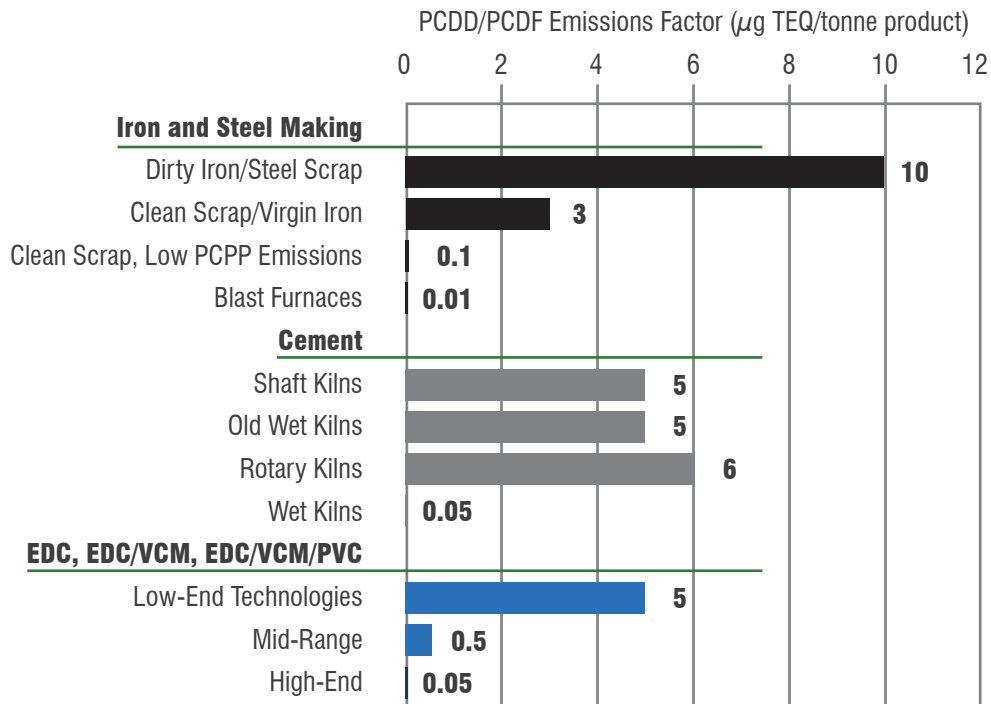
**FIGURE 5.1 : UNEP ESTIMATED DIOXIN EMISSIONS FACTORS FROM GIVEN PRODUCTION SOURCES**

According to the EPA and the United Nations Environment Programme (UNEP), metal sintering and magnesium production (both used in steel and iron production) and coal-fired electricity production are also major sources of dioxin emissions.<sup>30 31 32</sup> UNEP has standard emissions factors for facilities that are major sources of dioxin emissions.<sup>33</sup> A sample of these factors is shown in Figure 5.1. GreenSpec® has removed cast-iron drain pipe from their listings because of the high embodied energy and pollution emissions from coking plants.<sup>34</sup>

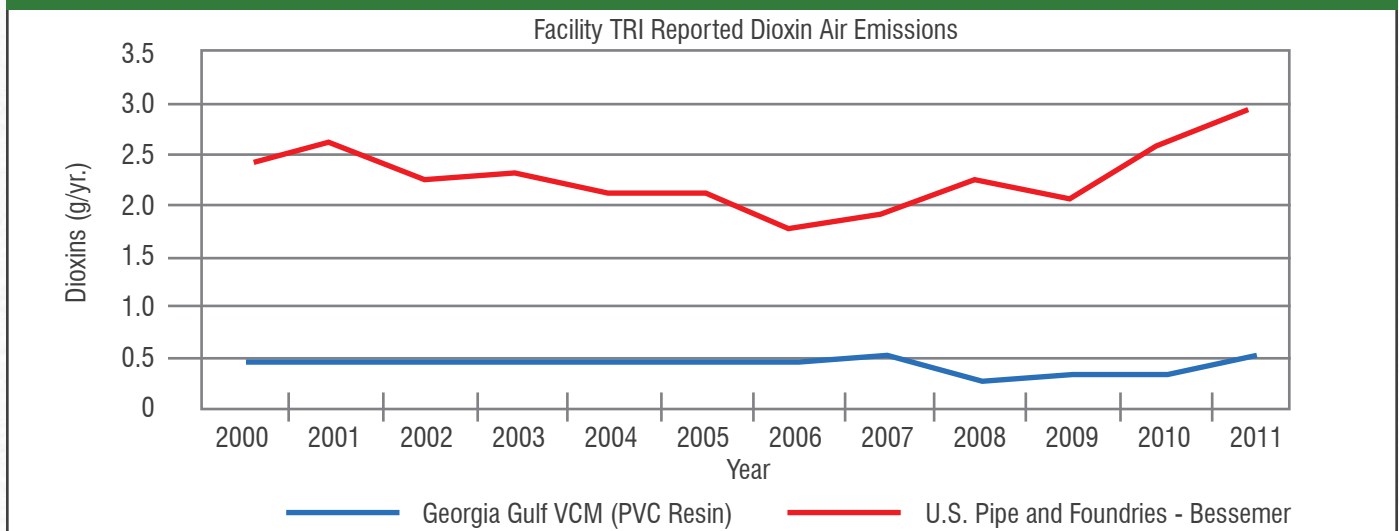
**FIGURE 5.2 : ANNUAL DIOXIN AIR EMISSIONS FROM A VCM PVC RESIN PLANT AND A DUCTILE IRON PIPE PLANT TO THE U.S. EPA TOXIC RELEASE INVENTORY**

Dioxin emissions are tracked by the U.S. EPA through the Toxic Release Inventory (TRI). TRI data are made publicly available. Figure 5.2 is a sampling of the dioxin air emissions reported by a VCM (PVC resin) manufacturer and a ductile iron manufacturer.<sup>35</sup>

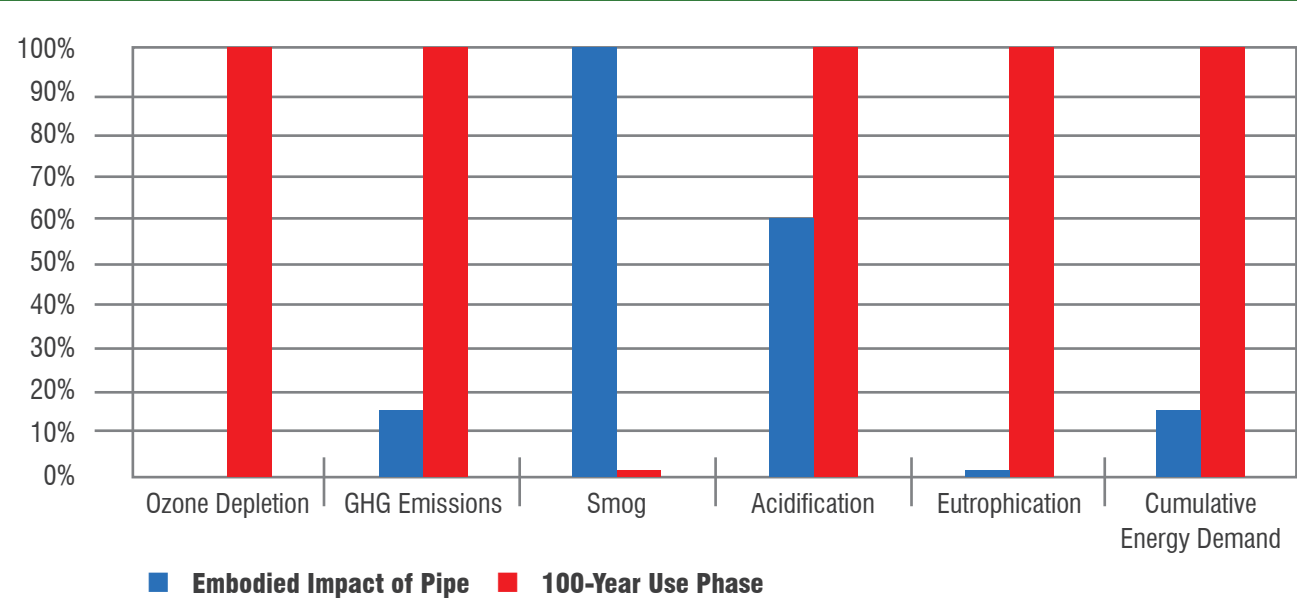
FIGURE 7.1 : ENVIRONMENTAL IMPACTS OF THE USE PHASE OF 8” PVC DR25 PC165 C900 PIPE VS. EMBODIED IMPACTS OF THE PIPE

The use phase of the pipe life cycle dominates as the primary cause of environmental impacts of PVC pipe with the exception of smog which is primarily caused by production of electricity and burning of fuel in the pipe installation equipment and from raw materials extraction and production.

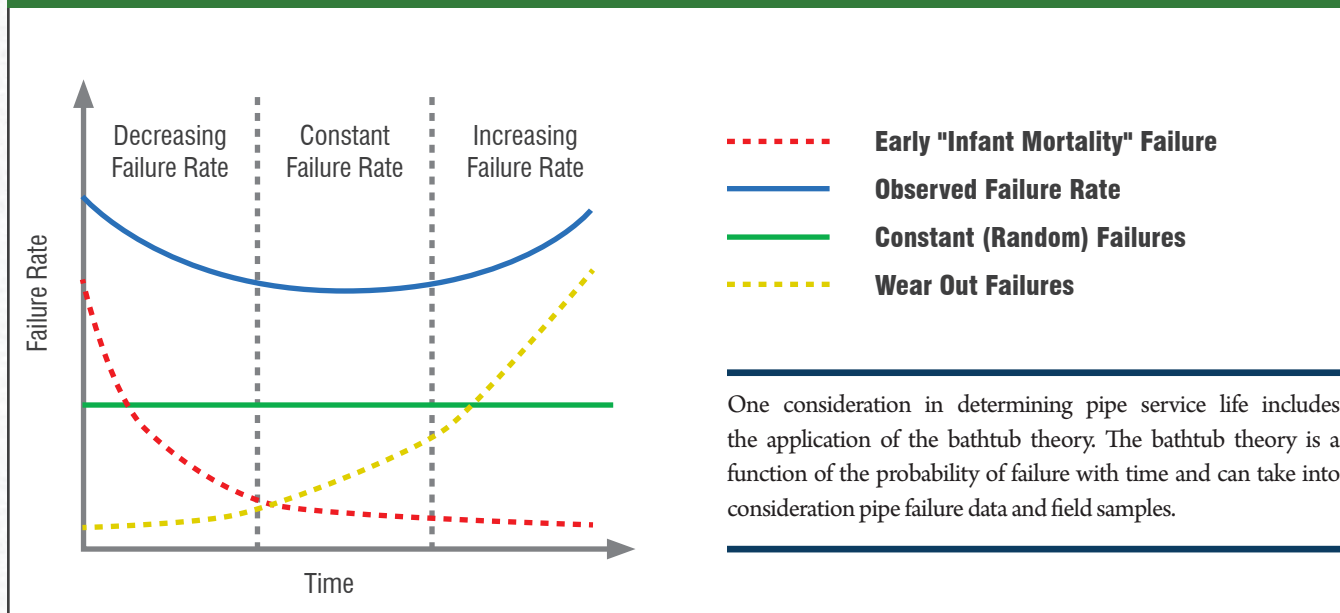
**FIGURE 8.1 : APPLYING THE “BATHTUB” THEORY TO DETERMINING PIPE SERVICE LIFE**

Another component of determining a service life is to assign a value to the various pipe materials for comparison purposes, which includes going beyond manufacturers' marketing claims and reviewing additional sources to better understand the expected service level of a pipe. The combination of performance and service delivery are critical in order to assign a value.<sup>61</sup> This takes into consideration when water main breaks begin to occur, water quality issues arise, or pipe degradation (internal and/or external) is a concern and needing attention. In these circumstances the pipe has effectively met its service life as a low cost managed asset and now its total life cycle cost or total cost of ownership will begin to drastically increase.

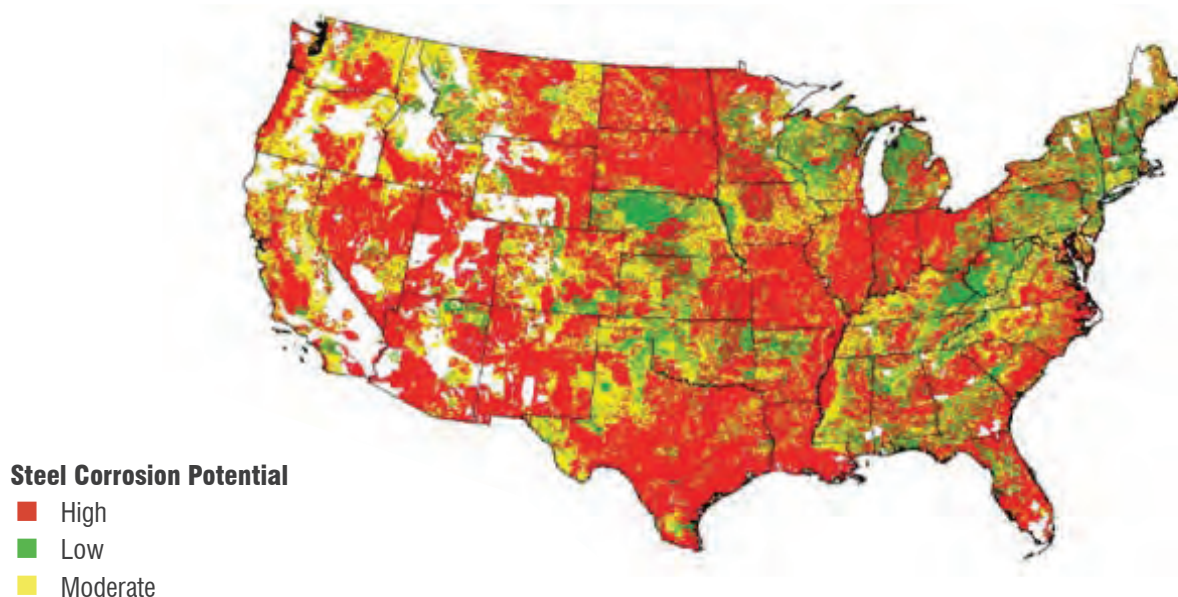
**FIGURE 8.2 : U.S. CORROSIVE SOILS MAP (CONUS POTENTIAL FOR STEEL CORROSION)**

Leakage from water infrastructure results in approximately 2.2 trillion gallons of water loss each year.<sup>70</sup> Most of this leakage is due to corroded and broken pipes. Corrosion and leakage increase pumping energy, can cause bacteria and other organisms to grow, and may result in the leaching of metals into the water supply. Studies estimate that PVC pipe has a life expectancy of over 100 years.<sup>71</sup> One reason for this longevity is that PVC pipe is resistant to both internal and external corrosion. In high pH soils, metal pipes are likely to corrode and fail well before the manufacturers' published life expectancy.

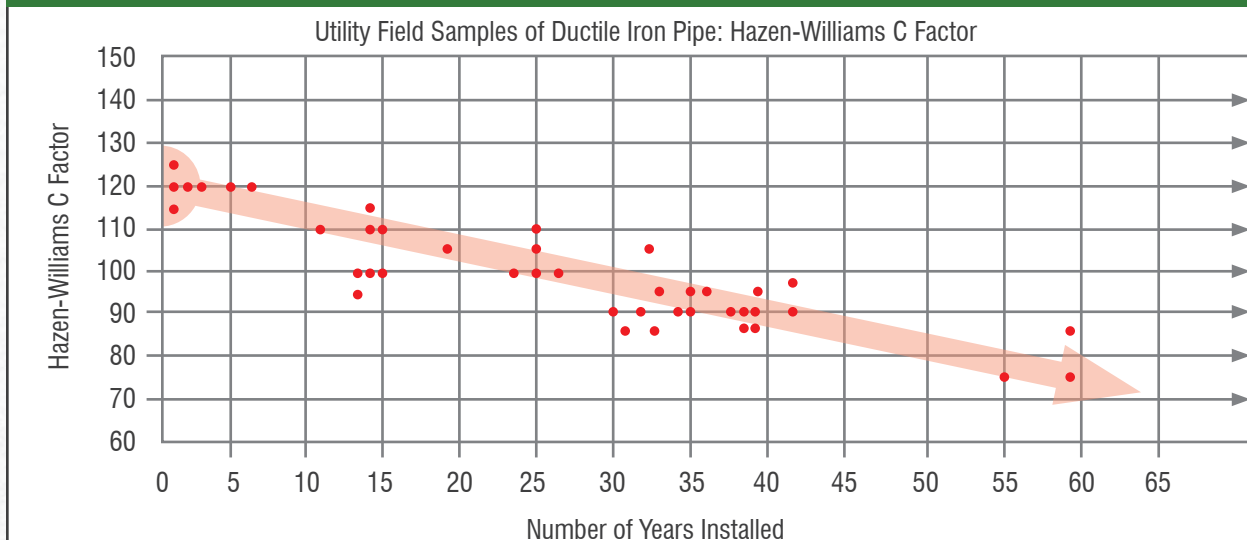
**FIGURE 8.5 : FIELD SAMPLES SHOWING DECLINING C FACTOR FOR DI PIPE**

Since PVC pipe does not corrode as it ages, the smoothness of the internal pipe wall surface does not decrease. PVC pipe has a smooth surface which reduces frictional energy loss over the pipe's life compared to metallic or concrete pipes. The Hazen-Williams coefficient (C factor) for new PVC pipe is 155-165 (the higher the value, the smoother the pipe).<sup>87</sup> A flow coefficient of  $C = 150$  is generally used as a conservative value for the design of PVC piping systems.<sup>88 89 90</sup> In contrast, new mortar-lined ductile iron pipes can have a C factor of 140 as claimed by the Ductile Iron Pipe Research Association (DIPRA). However, due to corrosion and deterioration of the lining material, the internal walls of iron pipes become significantly rougher over time, decreasing the C factor.<sup>91</sup> To prevent corrosion and provide a pipe wall that is listed for contact with potable water, cement lining is added to ductile iron water pipes. Concrete pipes and cement-mortar lined metallic pipes' C factors typically range from 120-140 for new pipe and 75-100 for older pipe as it degrades over time.<sup>92</sup> Field samples of over 60 mortar-lined

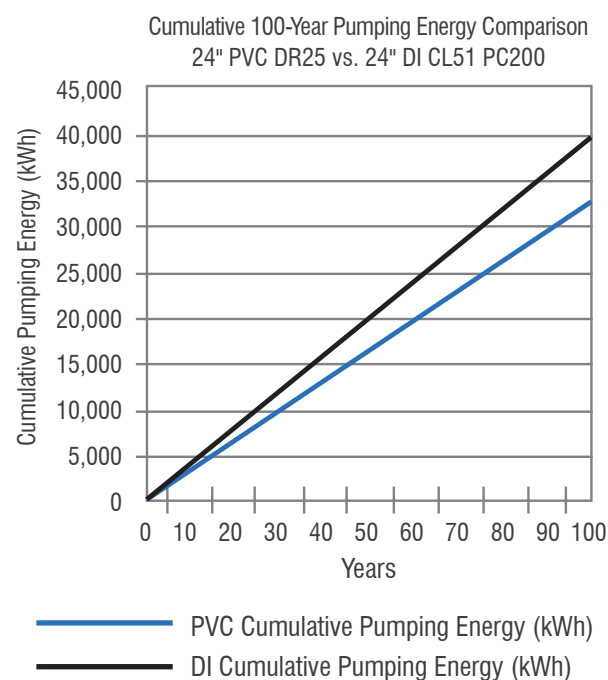
**FIGURE 9.2 : COMPARISON OF CUMULATIVE 100-YEAR PUMPING ENERGY FOR 24" PVC AND DI PIPE**

Note: Graph assumes replacement of DI pipe at 50 years.

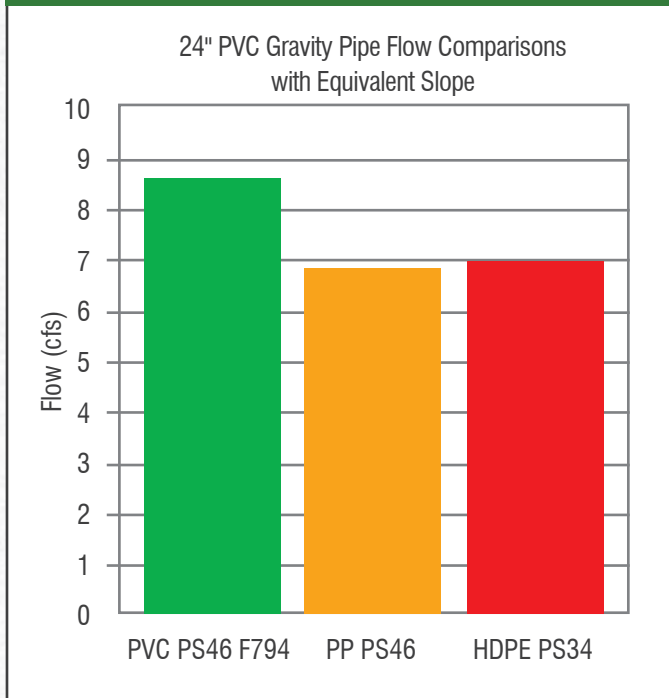
**FIGURE 9.7 : FLOW COMPARISON WITH EQUIVALENT SLOPE OF 24" PVC, PP AND HDPE PROFILE-WALL PIPES**

HDPE and PP pipes are subject to strain creep. Strain creep is a property of some materials whereby, when subjected to a load, the pipe will continue to slowly flex under the load over time. For buried HDPE and PP gravity pipes, strain creep means that the pipes will continue to deflect over time. The standards for HDPE and PP gravity pipes make allowances for strain creep over the expected lifetime of the pipes.

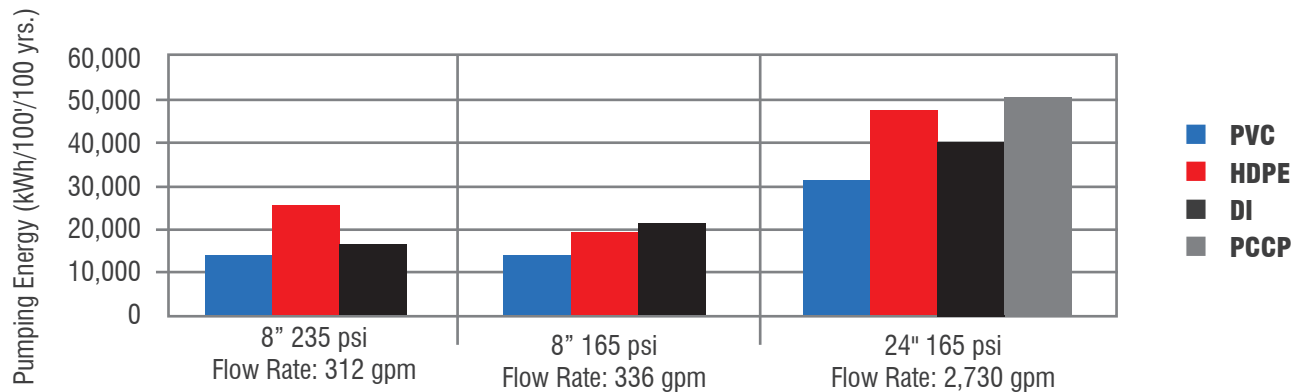
**FIGURE 10.1 : COMPARISON OF TOTAL 100-YEAR PUMPING ENERGY USE PER 100 FEET OF PIPE**

Note: Graph assumes replacement of HDPE pipe at 50 years, DI pipe at 50 years and PCCP at 75 years.

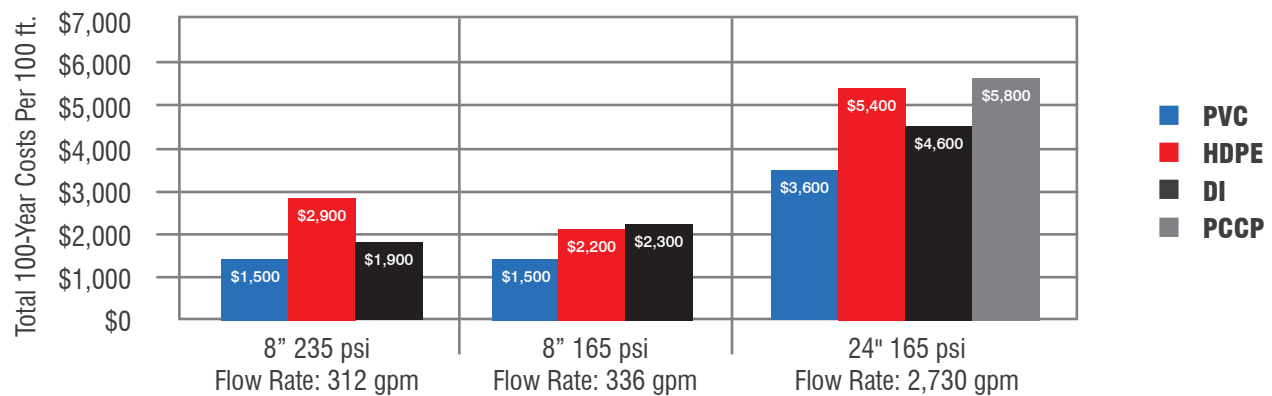
**FIGURE 10.2 : COMPARISON OF TOTAL 100-YEAR PUMPING ENERGY COSTS PER 100 FEET OF PIPE**

Note: Graph assumes replacement of HDPE pipe at 50 years, DI pipe at 50 years and PCCP at 75 years.

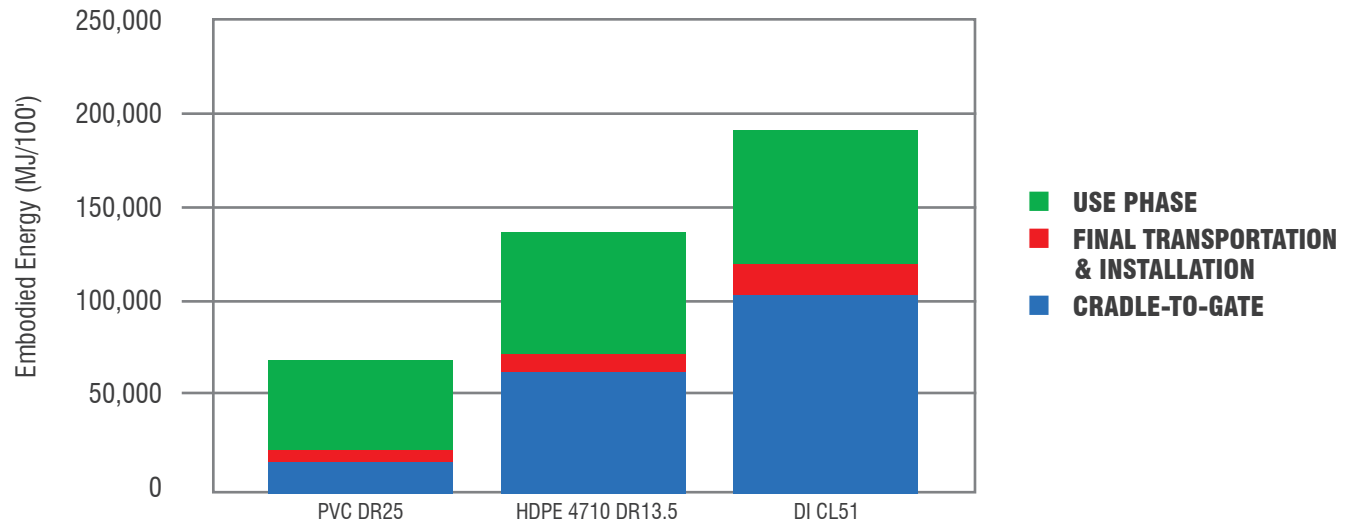
**FIGURE 12.2 : TOTAL 100-YEAR EMBODIED ENERGY FOR 8" PVC DR25 EQUIVALENT PRESSURE PIPES**

Figure 12.2 compares 8-inch PVC, HDPE and DI pipes with a pressure class at or equivalent to PVC DR25 PC165. As demonstrated, the total 100-year embodied energy for PVC pipe is 52 percent less than HDPE and 56 percent less than DI pipes.

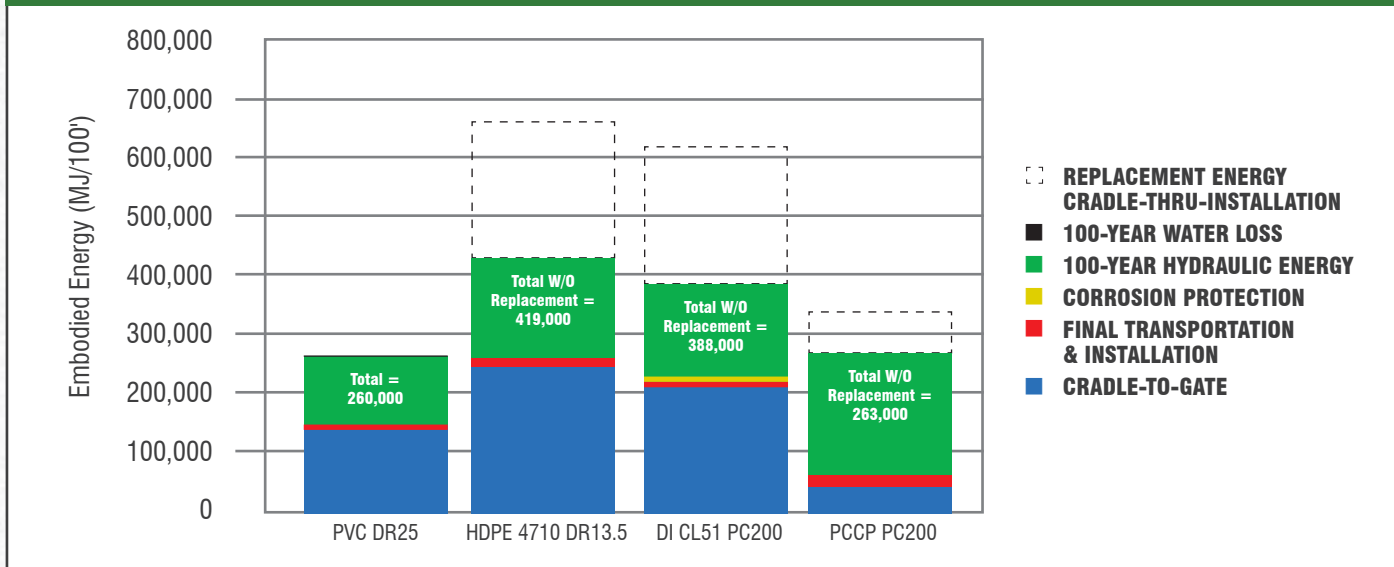
**FIGURE 12.4 : TOTAL 100-YEAR EMBODIED ENERGY FOR 24" PVC DR25 EQUIVALENT PRESSURE PIPES  
(HYDRAULIC ENERGY WITHOUT REPLACEMENT)**

Manufacturers of HDPE, DI and PCCP pressure pipes may claim that their pipes should not be replaced during the 100-year system design life and that this study unfairly represents their products. However, this study has demonstrated that these pipe products need replacement within 50 years. Moreover, even without replacement these pipe materials still have greater total embodied energy over 100 years than PVC pipe.

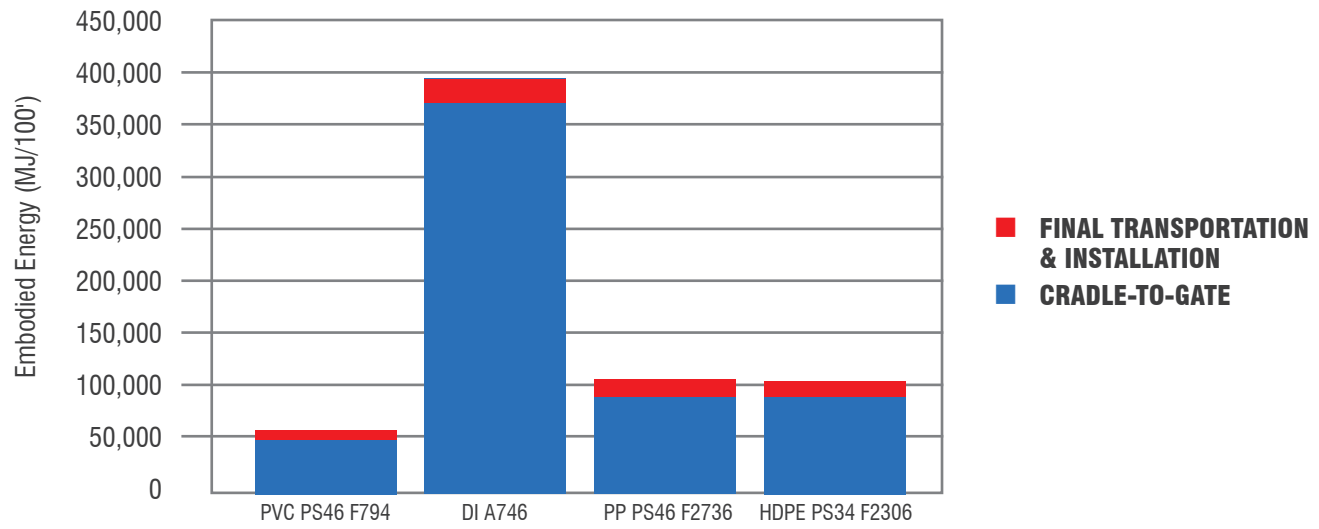
**FIGURE 12.7 : TOTAL 100-YEAR EMBODIED ENERGY FOR 24" PVC PS46 F794 PROFILE-WALL EQUIVALENT GRAVITY PIPES**

Figure 12.7 compares 24-inch PVC profile-wall, DI, PP and HDPE pipes equivalent to PVC PS46 F794 profile-wall pipe. The total 100-year embodied energy of PVC sewer pipe is 85 percent less than equivalent DI sewer pipe; 44 percent less than PP and 43 percent less than HDPE sewer pipes. It should be noted that the equivalent HDPE sewer pipe has a pipe stiffness that is 26 percent less than the pipe stiffness of PVC pipe.

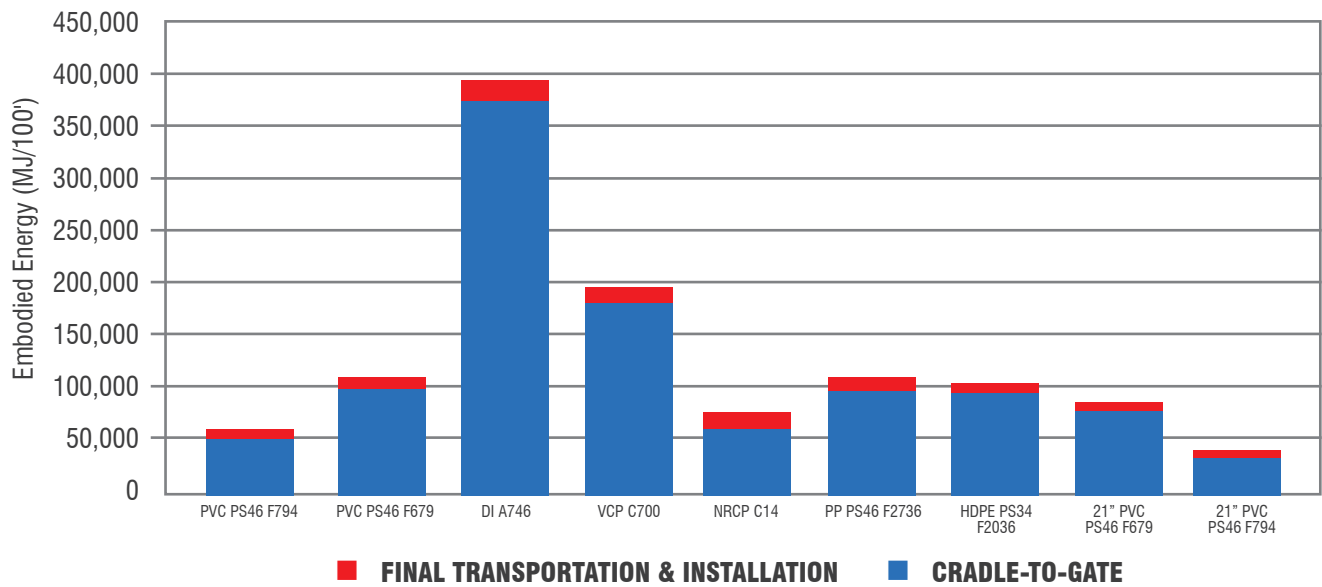
**FIGURE 12.9 : TOTAL 100-YEAR EMBODIED ENERGY FOR 24" PVC PS46 SOLID-WALL & PROFILE-WALL EQUIVALENT GRAVITY PIPES**

PVC has greater embodied energy compared to NRCP pipe, but NRCP is highly susceptible to deterioration from gases produced by wastewater. Due to this deterioration, NRCP would likely be required to be replaced two or more times during a 100-year design life for the pipe system. The corrosion of the pipe wall would also lead to increased infiltration and possibly pipe collapse. Increased infiltration significantly increases energy requirements and costs of a wastewater system. A pipe collapse not only requires large costs to repair, but could cause significant environmental contamination and endanger the safety of the public by undermining the support structure for buildings and roads built near sewer lines.

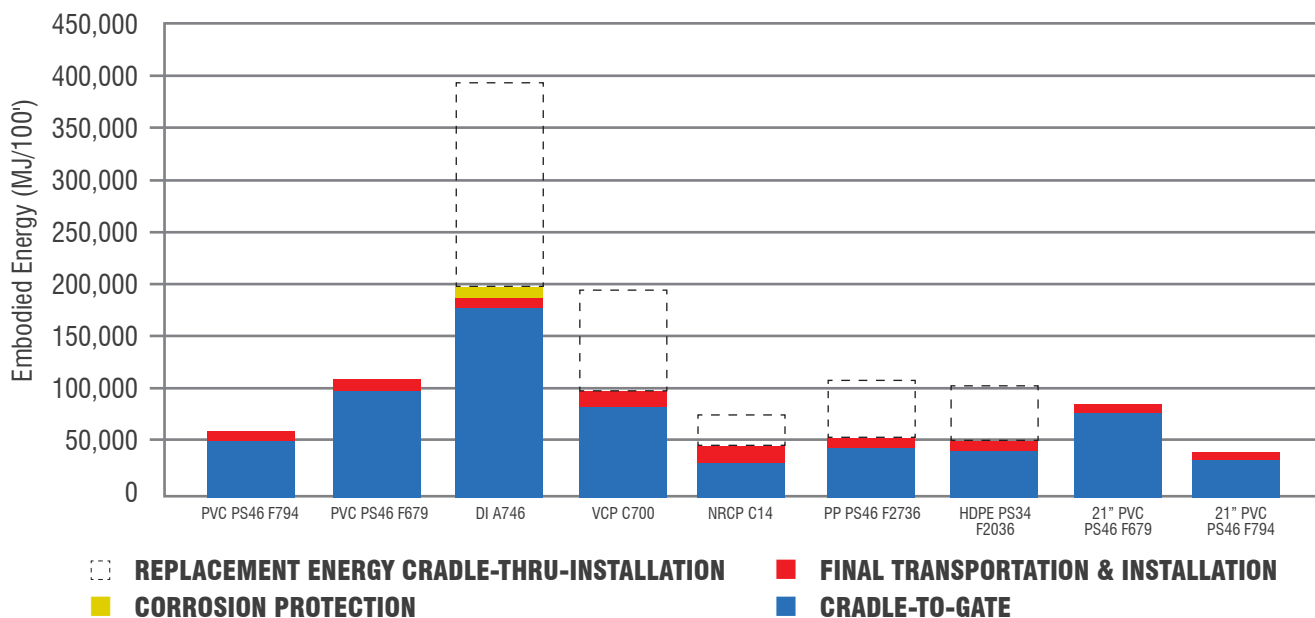
**FIGURE 12.10 : TOTAL 100-YEAR EMBODIED ENERGY FOR 24" PVC PS46 SOLID-WALL & PROFILE-WALL EQUIVALENT GRAVITY PIPES**

In order to be transparent, Figure 12.10 highlights the differences in embodied energy among the 24-inch gravity pipes without the needed replacements during the 100-year design life. Examination of Figure 12.10 reveals that 24-inch DI, VCP, PP and HDPE pipes have higher or equivalent 100-year embodied energies than PVC pipes even when replacement embodied energies are not considered.
