PVC PIPE

FALL 2007 • Volume 30 • Number 2

PVC WATER PIPE IS A CAPITAL IDEA

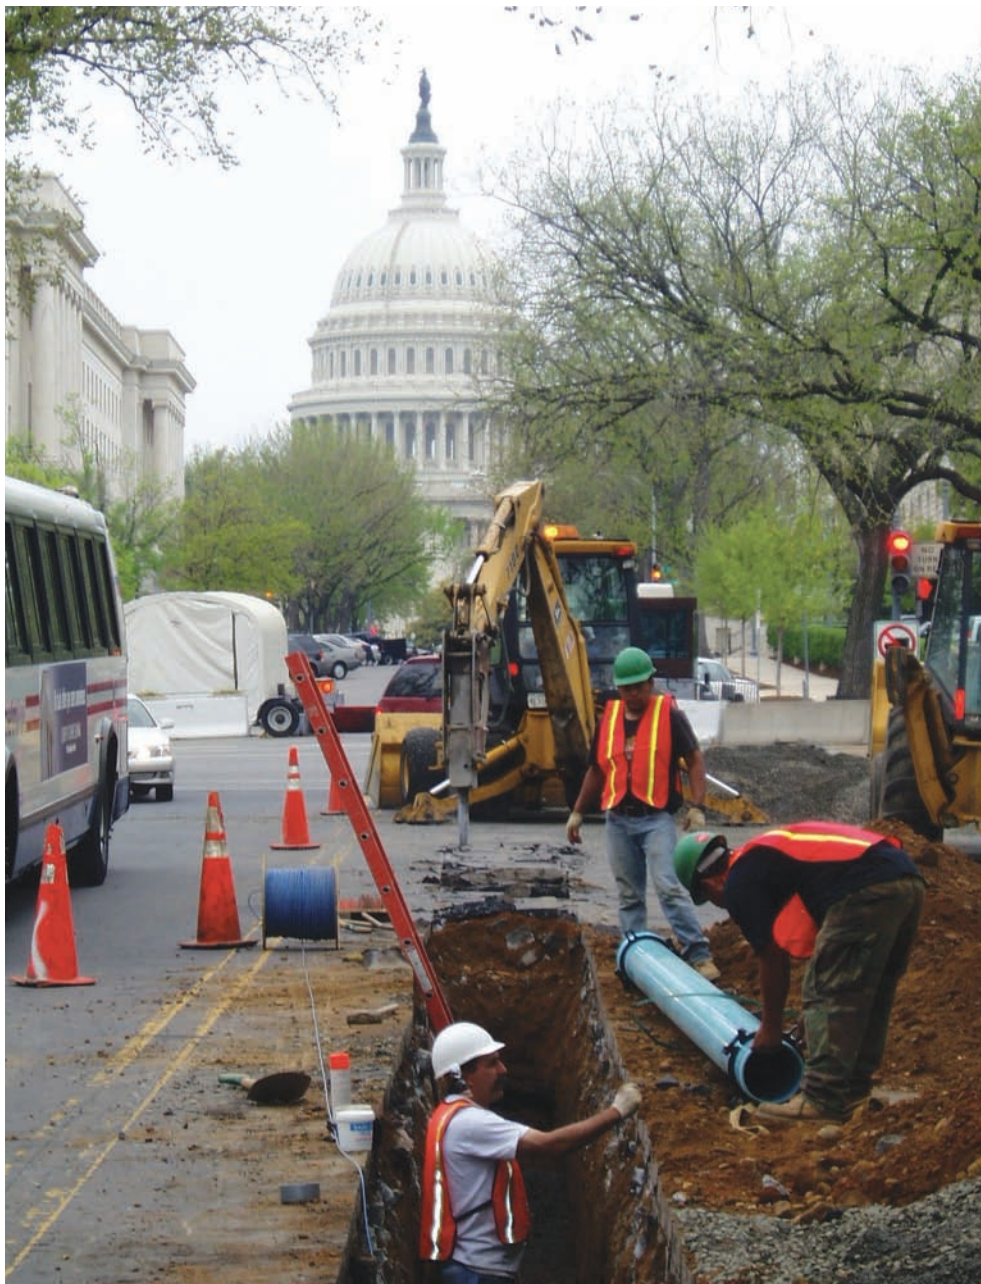
Fort Myer Construction workers install 8-inch PVC water main in downtown Washington D.C.

Last year, DCWASA initiated its first PVC water main project by replacing several 6-inch cast iron water mains on D Street, New Jersey Ave. and Ivy Street, SE, near the U.S. Capitol. Because of a significant history of water main breaks in this neighborhood, DCWASA engaged the services of corrosion engineers from DACCO SCI, Inc., located in Columbia, MD. The engineers reported that excessive stray currents and highly corrosive soils in the area were causing the pipes [cast iron water mains] to fail. Complete plans, details, and specifications were then developed by engineers from Hatch Mott MacDonald's offices in Washington, DC; Rockville, MD; and Milburn, NJ within six weeks of the notice to proceed in order to meet DCWASA's accelerated schedule. The old cast iron pipes were replaced with 3,315 feet of 8-inch PVC pipe. The new PVC water mains were installed 4 feet below finished grade by Fort Myer Construction Corporation of Washington, DC.

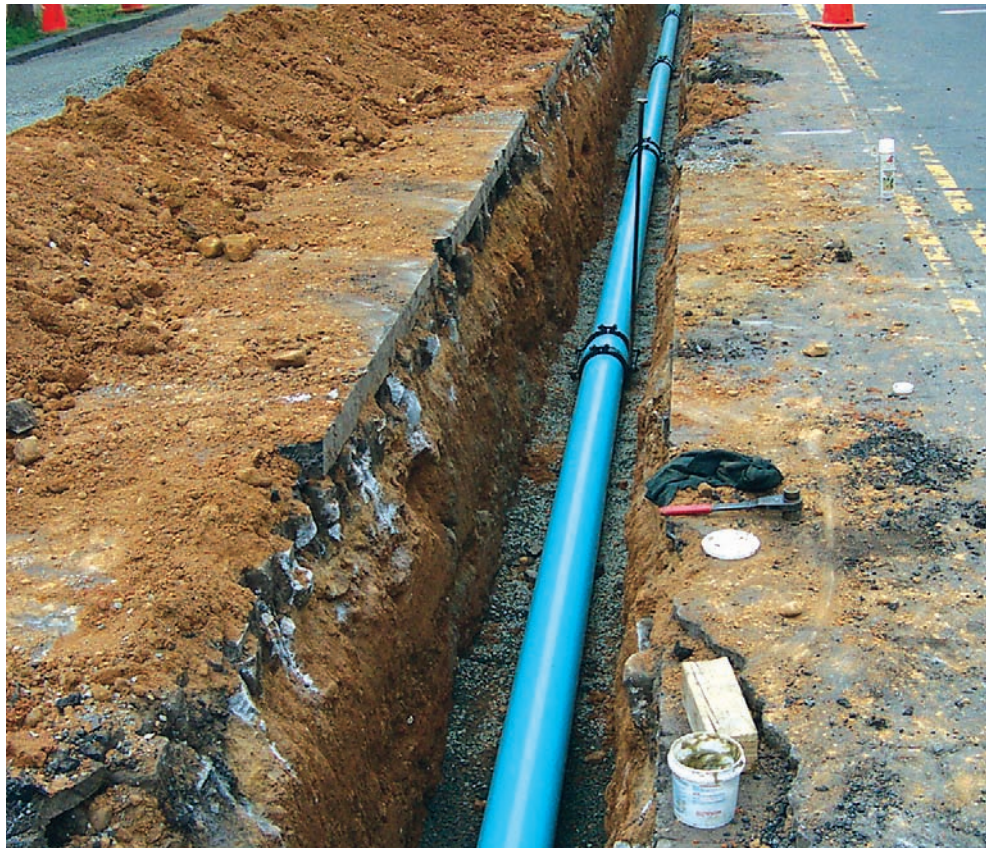
Figure 1b. The 8-inch PVC replacement mains were installed "quickly and smoothly" four-feet below grade.
