PVC PIPE LONGEVITY REPORT

Affordability & The 100+ Year Benchmark Standard

A Comprehensive Study on
PVC Pipe Excavations, Testing, & Life Cycle Analysis

UTAH STATE UNIVERSITY
BURIED STRUCTURES LABORATORY
STEVEN FOLKMAN, Ph.D., P.E.

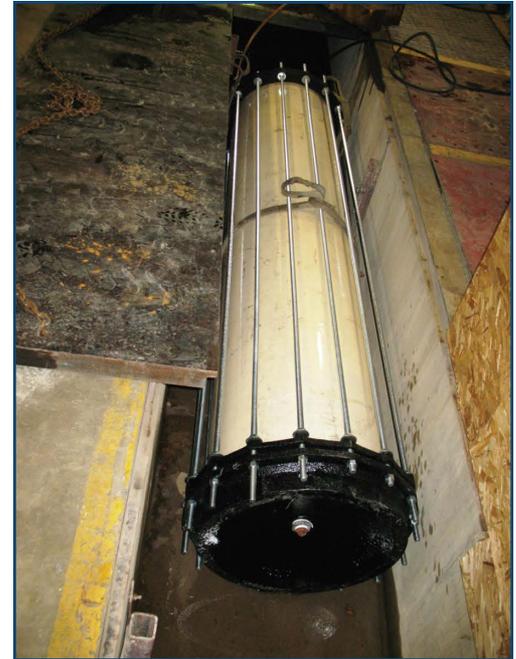
FIGURE 1 :
PHOTO OF
SAMPLE #3
PRIOR TO
STRUCTURAL
INTEGRITY
TESTING

In 2013, Folkman and Barfuss (20) reported on quality control tests on PVC pipe that had been in use for a number of years. The pipes tested are summarized in Table 1 and had been in continuous use for between 20 and 49 years. Note that sample #1 was manufactured under an early commercial standard CS 256. In 1964, the CS 256 standard became ASTM D2241. The tests included pipe dimensions, acetone immersion, and pressure tests. The burst pressure test was used for samples #1 and #2 that were manufactured to CS 256 and ASTM D2241 standards and the hydrostatic integrity test was applied to sample #3 which was made to the AWWA C905 standard. Table 2 lists the specifications used for these quality control tests. All three samples passed all of the quality control tests. Figure 1 is a photograph of Sample #3 prior to the hydrostatic integrity test.

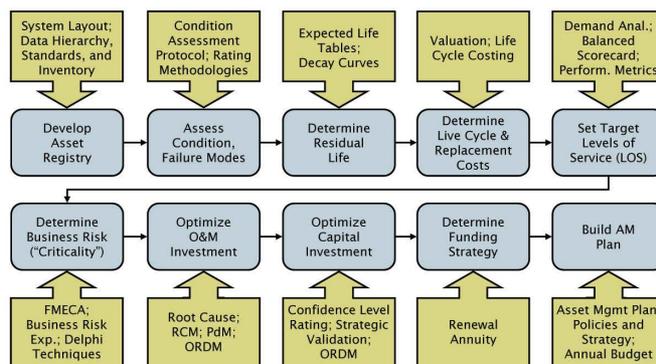
FIGURE 2 : EPA's Life Cycle Steps

The EPA’s 10 step process (25) for asset management programs supports the activity of life cycle costing.

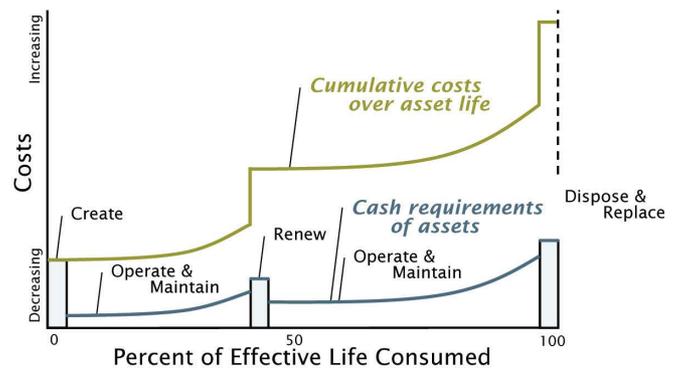
FIGURE 3 : . EPA Costs Over Lifetime

The life cycle costs according to the EPA include the total cost of an item throughout its life, including costs of planning, design, acquisition, operations, maintenance, and disposal, less any residual value, or the total cost of providing, owning and maintaining an asset over a predetermined evaluation period. The EPA asset management training charts (25) below in Figures 3 and 4 illustrate this concept.

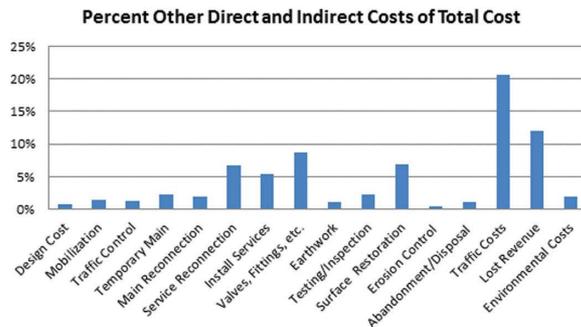
FIGURE 5 : WaterID Synthesis Report Example of Costs

Underground infrastructure projects have a number of different types of costs beyond the initial pipe price as demonstrated in Figure 5 from a Water ID synthesis report (26) on pipe costs and considerations.
